# DRAFT REPORT

100 Crossways Park Drive West, Ste 10- Woodbury, New York 11797	T: 516.364.0660 F: 516.364.0655	www.btnayerassociates.com	Assignment: <b>2</b>	Tree No.: <b>2</b>
Arborist Assessment Report		Location: North Hempstead Beach Park - Port Washington, NY		Date: 2/25/2016		
Inspector: Dan Maher		Weather: Mostly Cloudy	Lat/Long: N 40° 49' 41.06" W 73° 39' 2.16"		Time: 09:46	
Specimen:	Common Name: TREE OF HEAVEN		Scientific name: Ailanthus altissima			
Descriptor	Value	Range				
Girth	8"	Trunk Diameter Measured at Breast Height (DBH)				
Approx. Height	15'-20'	Approximate Height to top of Canopy				
Canopy	N 12', S 6', E 9', W 8'	Canopy Radius in Feet - North South East West				
Condition	3	Health of Specimen - 1 Dead - 2 Declining - 3 Moderate - 4 Good - 5 Excellent				
Approx. Age	M	NP=Newly Planted Within 5yrs M=Moderate 10-20 yrs old E=Existing before development				
Tree/Root Base/Pit	Growing almost entirely in sand that is eroding away and exposing roots.

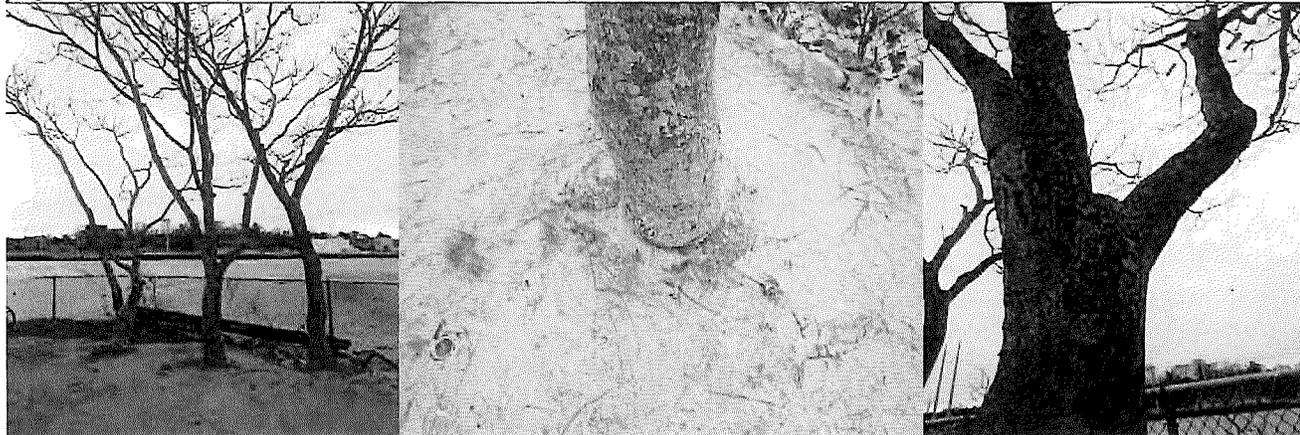
Trunk Condition and Main Scaffold Branches	Codominant leaders, moss and lichen growth on trunk, Included bark at trunk union.					
Crown/Structure, Branches & Leaves	Minor broken branches, tree was not assessed during full leaf.					
Pest / Disease	Moss and lichen growth on trunk.					
Setting	Far east end of park in picnic area with high wind exposure.					
Character	Y	Does the tree make an important contribution to the character or amenity of the area?				
	Invasive	Is the tree indigenous, rare, endangered, invasive or exotic?				
Habitat	N	Does the tree represent important habitat for native fauna?				
	N	Is the tree part of a wildlife Corridor, Buffer, etc?				
<b>Notes:</b> Tree of Heaven is considered an invasive tree species in New York State. Sand bank is eroding and exposing the roots. Tree is growing just a few feet away from tree #1.						
<b>Recommendations:</b> It is recommended to implement a program that continues to monitor this tree by an ISA Arborist and If condition continues to decline, consider removal. For recommended treatment, proper corrective pruning that follows ANSI A300 standards should be performed to remove dead branches. The Town should implement a comprehensive program of tree management including soil testing.						Level of Urgency

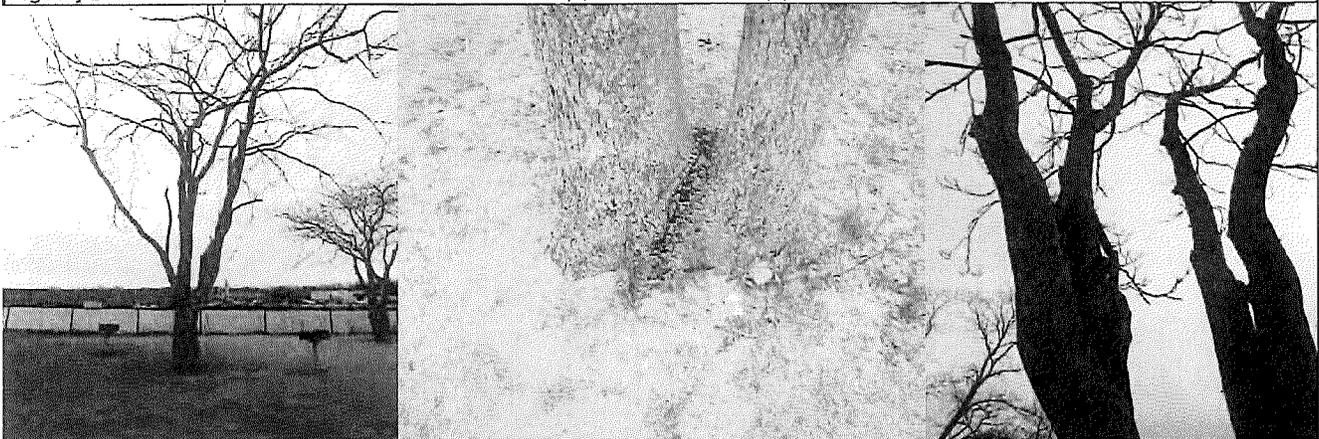
100 Crossways Park Drive West, Ste 104 Woodbury, New York 11797 t: 516 364 0667 f: 516 364 0668 www.bthayerassociates.com		Assignment	Tree No.
		2	5
3rd Inel Assessment Entry		Location: North Hempstead Beach Park - Port Washington, NY	
Inspector: Dan Maher		Weather: Mostly Cloudy	Date: 2/25/2016
		Lat/Long: N 40° 49' 41.23" W 73° 39' 2.53"	
Time: 10:05			
Specimen:	Common Name: TREE OF HEAVEN		Scientific name: Ailanthus altissima
Descriptor	Value	Range	
Girth	15", 13"	Trunk Diameter Measured at Breast Height (DBH)	
Approx. Height	30'-35'	Approximate Height to top of Canopy	
Canopy	N 15', S 20', E 14', W 17'	Canopy Radius in Feet - North South East West	
Condition	3	Health of Specimen - 1 Dead - 2 Declining - 3 Moderate - 4 Good - 5 Excellent	
Approx. Age	M	NP=Newly Planted Within 5yrs M=Moderate 10-20 yrs old E=Existing before development	
Tree/Root Base/Pit	Growing in grass area with a lot of sand around the base, major moss and lichen growth at base.

Trunk Condition and Main Scaffold Branches	Multi-stem trunk, included bark at trunk unions that reach the base of the tree, major moss and lichen growth on included bark and trunk, scaffold wounds from pruned branches have not entirely healed.		
Crown/Structure, Branches & Leaves	Thin crown, broken branches hanging in crown, tree was not assessed during full leaf.		
Pest / Disease	Moss and lichen growth on trunk.		
Setting	Far east end of park in picnic area with high wind exposure.		
Character	Y	Does the tree make an important contribution to the character or amenity of the area?	
	Invasive	Is the tree indigenous, rare, endangered, invasive or exotic?	
Habitat	N	Does the tree represent important habitat for native fauna?	
	N	Is the tree part of a wildlife Corridor, Buffer, etc?	
<b>Notes:</b> Tree of Heaven is considered an invasive tree species in New York State. Included bark at trunk unions are still wet from rainfall the night before, major moss and lichen growth at the trunk unions from the moisture. Minor dead and broken branches directly above two barbeques.

<b>Recommendations:</b> It is recommended to implement a program that continues to monitor this tree by an ISA Arborist and if condition continues to decline, consider removal. For recommended treatment, proper corrective pruning that follows ANSI A300 standards should be performed to remove dead and damaged branches. Vertical mulching is recommended for mitigation, this is a technique that benefits stressed trees by improving the movement of water, air, and nutrients in the root zone and should be performed by a qualified tree care professional. Additionally, it is recommended to form a mulch collar around the base of the tree that will prevent any future damage caused by landscape maintenance and provide additional benefits to the tree. The Town should implement a comprehensive program of tree management including soil testing.			Level of Urgency
Urgency Level: 1 - Requires Immediate Attention 2 - Within (1) Month 3 - Within (6) Months 4 - Within the year 5 - None			1

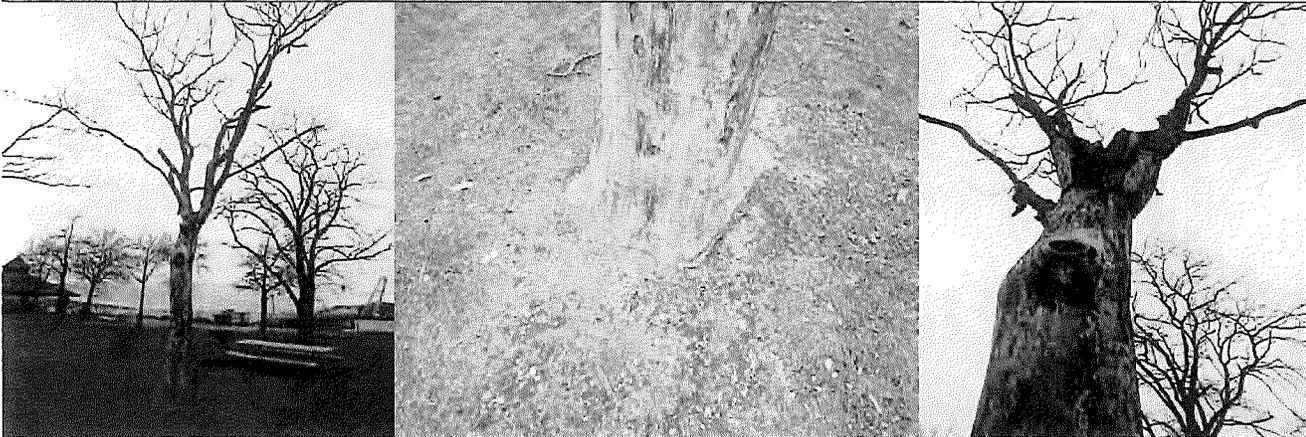
100 Crossway Park Drive West, Ste 104 Yonkers, New York 10797		T: 916.364.0660 F: 916.364.0668	www.bthayerassociates.com	Assignment: <b>2</b>	Tree No.: <b>6</b>
<b>Arboretist Assessment Agency</b>		Location: North Hempstead Beach Park - Port Washington, NY		Date: 2/25/2016	
Inspector: Dan Maher		Weather: Mostly Cloudy	Lat/Long: N 40° 49' 41.23" W 73° 39' 2.53"		Time: 10:35
Specimen:	Common Name: TREE OF HEAVEN		Scientific name: Ailanthus altissima		
<b>Descriptor</b>	<b>Value</b>	<b>Range</b>			
Girth	15"	Trunk Diameter Measured at Breast Height (DBH)			
Approx. Height	25'-30'	Approximate Height to top of Canopy			
Canopy	N 11', S 7', E 13', W 14'	Canopy Radius in Feet - North South East West			
Condition	1	Health of Specimen - 1 Dead - 2 Declining - 3 Moderate - 4 Good - 5 Excellent			
Approx. Age	M	NP=Newly Planted Within 5yrs M=Moderate 10-20 yrs old E=Existing before development			
Tree/Root Base/Pit	Growing in sandy soil, dead wood at base.

Trunk Condition and Main Scaffold Branches	Trunk is all dead wood, major scaffold branches recently broken off are lying on the ground.				
Crown/Structure, Branches & Leaves	Dead crown.				
Pest / Disease	No noticeable signs.				
Setting	Far east end of park in picnic area with high wind exposure.				
Character	Y	Does the tree make an important contribution to the character or amenity of the area?			
	Invasive	Is the tree indigenous, rare, endangered, invasive or exotic?			
Habitat	N	Does the tree represent important habitat for native fauna?			
	N	Is the tree part of a wildlife Corridor, Buffer, etc?			
<b>Notes:</b> Major scaffold branch recently broke off, small branches covering the ground that have recently fallen. Picnic tables and barbeque grill surrounding dead tree.					
<b>Recommendations:</b> Remove dead tree. For tree replacement it is recommended to use XXX. Replacements should be planted immediately following removals and it is recommended to form a mulch collar around the base of the tree that will prevent any future damage caused by landscape maintenance and provide additional benefits to the tree. The Town should implement a comprehensive program of tree management including soil testing.					Level of Urgency

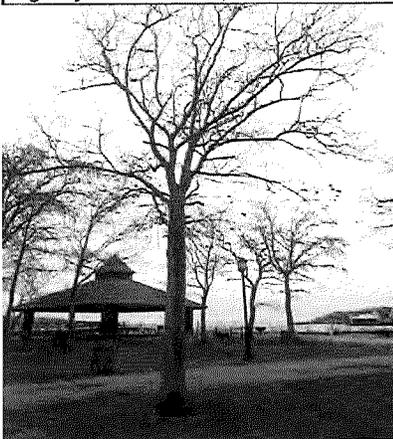
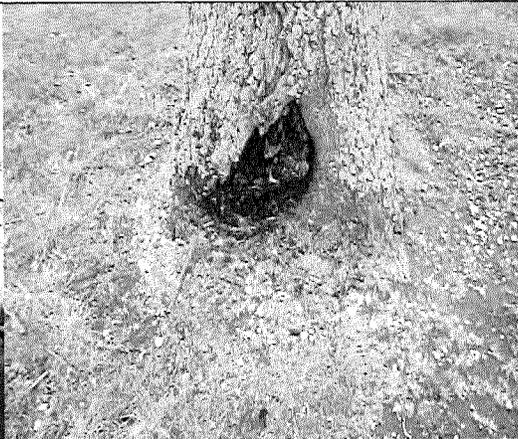
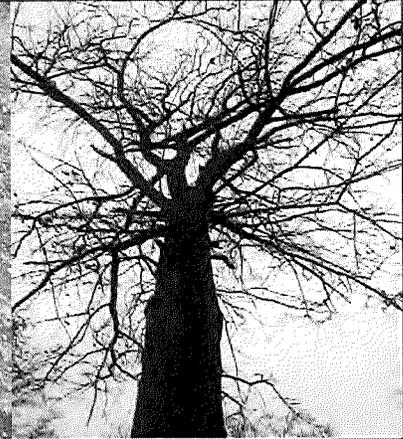
<b>Tree/Root Base/Pit</b>	Growing in grass area, basal canker with wood rot due to mechanical damage from landscape maintenance.				
<b>Trunk Condition and Main Scaffold Branches</b>	Major moss and lichen growth on trunk, trunk damage with open cavity, multiple broken scaffold branches.				
<b>Crown/Structure, Branches &amp; Leaves</b>	Broken lower branches, major dead and broken branches in canopy, tree was not assessed during full leaf.				
<b>Pest / Disease</b>	Moss and lichen growth on trunk.				
<b>Setting</b>	Far east end of park in picnic area along path with high wind exposure.				
<b>Character</b>	Y	<i>Does the tree make an important contribution to the character or amenity of the area?</i>			
	Indigenous	<i>Is the tree indigenous, rare, endangered, invasive or exotic?</i>			
<b>Habitat</b>	N	<i>Does the tree represent important habitat for native fauna?</i>			
	N	<i>Is the tree part of a wildlife Corridor, Buffer, etc?</i>

<b>Notes:</b> Major damage to the tree is evident from the amount of broken branches in the tree crown. Picnic bench in close proximity to tree with dead and broken branches in crown.					
<b>Recommendations:</b> It is recommended to implement a program that continues to monitor this tree by an ISA Arborist and if condition continues to decline, consider removal. For recommended treatment, proper corrective pruning that follows ANSI A300 standards should be performed to remove dead and damaged branches. Additionally, it is recommended to form a mulch collar around the base of the tree that will prevent any future damage caused by landscape maintenance and provide additional benefits to the tree. Vertical mulching is recommended for mitigation, this is a technique that benefits stressed trees by improving the movement of water, air, and nutrients in the root zone and should be performed by a qualified tree care professional. The Town should implement a comprehensive program of tree management including soil testing.					<b>Level of Urgency</b>

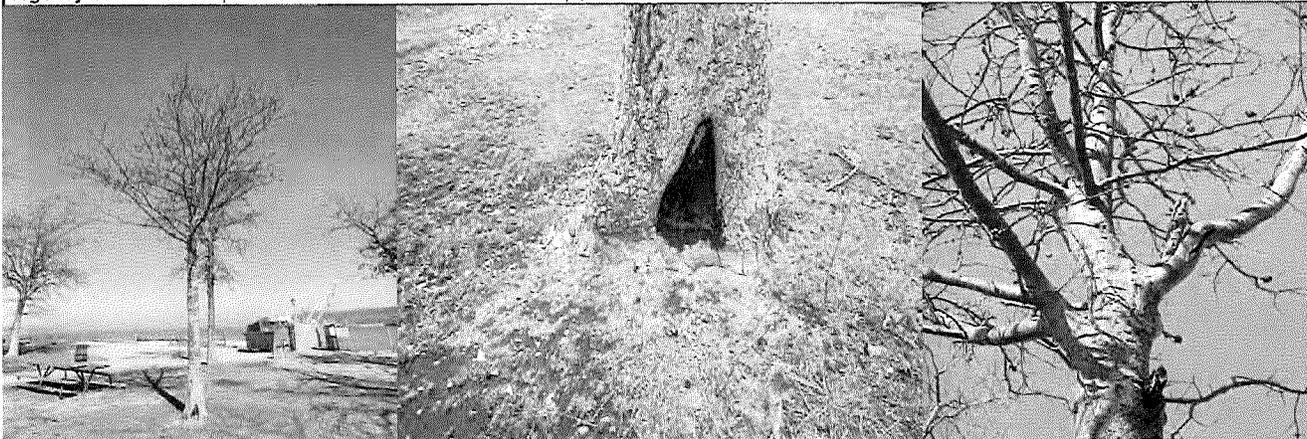
<b>Tree/Root Base/Pit</b>	Growing in a grass area, basal canker with wood rot due to vehicle or mechanical damage from landscape maintenance.								
<b>Trunk Condition and Main Scaffold Branches</b>	Moss and lichen growth on trunk, trunk wounds from broken scaffold branches.								
<b>Crown/Structure, Branches &amp; Leaves</b>	Minor dead and broken branches, infestation of gouty and horned oak galls growing on small branches are causing them to break and fall off tree, tree was not assessed during full leaf.								
<b>Pest / Disease</b>	Moss and lichen growth on trunk, gouty and horned oak galls growing on small branches.								
<b>Setting</b>	Far east end of park in picnic area along path with high wind exposure.								
<b>Character</b>	Y	<i>Does the tree make an important contribution to the character or amenity of the area?</i>							
	Indigenous	<i>Is the tree indigenous, rare, endangered, invasive or exotic?</i>

<b>Habitat</b>	N	<i>Does the tree represent important habitat for native fauna?</i>							
	N	<i>Is the tree part of a wildlife Corridor, Buffer, etc?</i>							
<b>Notes:</b>	Infestation of gouty and horned oak galls on majority of small branches in crown are causing them to break and fall off tree. While the oak galls are unsightly, they pose no major threat to the health of the tree other than weighing down and breaking the smaller branches. Infested trees may benefit from the application of fertilizer through vertical mulching.								
<b>Recommendations:</b>	It is recommended to implement a program that continues to monitor this tree by an ISA Arborist and if condition continues to decline, consider removal. For recommended treatment, proper corrective pruning that follows ANSI A300 standards should be performed to remove dead and damaged branches. Additionally, it is recommended to form a mulch collar around the base of the tree that will prevent any future damage caused by landscape maintenance and provide additional benefits to the tree. Vertical mulching is recommended for mitigation, this is a technique that benefits stressed trees by improving the movement of water, air, and nutrients in the root zone and should be performed by a qualified tree care professional. The Town should implement a comprehensive program of tree management including soil testing.							Level of Urgency

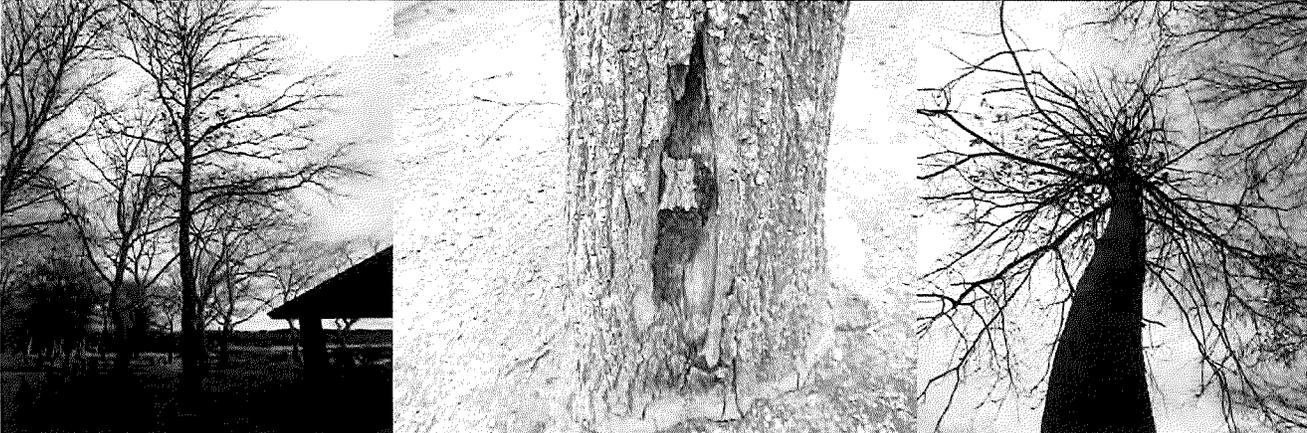
<b>Tree/Root Base/Pit</b>						
Growing in sandy soil, vehicle or mechanical damage at the base and trunk.						
<b>Trunk Condition and Main Scaffold Branches</b>						
Trunk damage near base of trunk is showing signs of wood rot, slightly leaning to the east, moss and lichen growth on trunk, dead lower scaffold branches.						
<b>Crown/Structure, Branches &amp; Leaves</b>						
Minor dead branches, moss and lichen growth on trunk, minor gouty and horned oak galls on outer branches, tree was not assessed during full leaf.						
<b>Pest / Disease</b>						
Moss and lichen growth on trunk, gouty and horned oak galls on small branches.						
<b>Setting</b>						
Far east end of park inside of fenced in picnic area with pavilion.						
<b>Character</b>						
	Y	Does the tree make an important contribution to the character or amenity of the area?				
	Indigenous	Is the tree indigenous, rare, endangered, invasive or exotic?

<b>Habitat</b>						
	N	Does the tree represent important habitat for native fauna?				
	N	Is the tree part of a wildlife Corridor, Buffer, etc?				
<b>Notes:</b>						
Minor evidence of gouty and horned oak galls growing on small branches. To help prevent or reduce trees from being heavily infested with gouty or horned oak galls, where possible, prune small infested branches when galls are just developing in the spring. Maintain the health of the tree by watering during dry periods and fertilizing if needed.						
<b>Recommendations:</b>						
It is recommended to implement a program that continues to monitor this tree by an ISA Arborist. For recommended treatment, proper corrective pruning that follows ANSI A300 standards should be performed to remove dead and damaged branches. Additionally, it is recommended to form a mulch collar around the base of the tree that will prevent any future damage caused by landscape maintenance and provide additional benefits to the tree. Vertical mulching is recommended for mitigation, this is a technique that benefits stressed trees by improving the movement of water, air, and nutrients in the root zone and should be performed by a qualified tree care professional. The Town should implement a comprehensive program of tree management including soil testing.						Level of Urgency

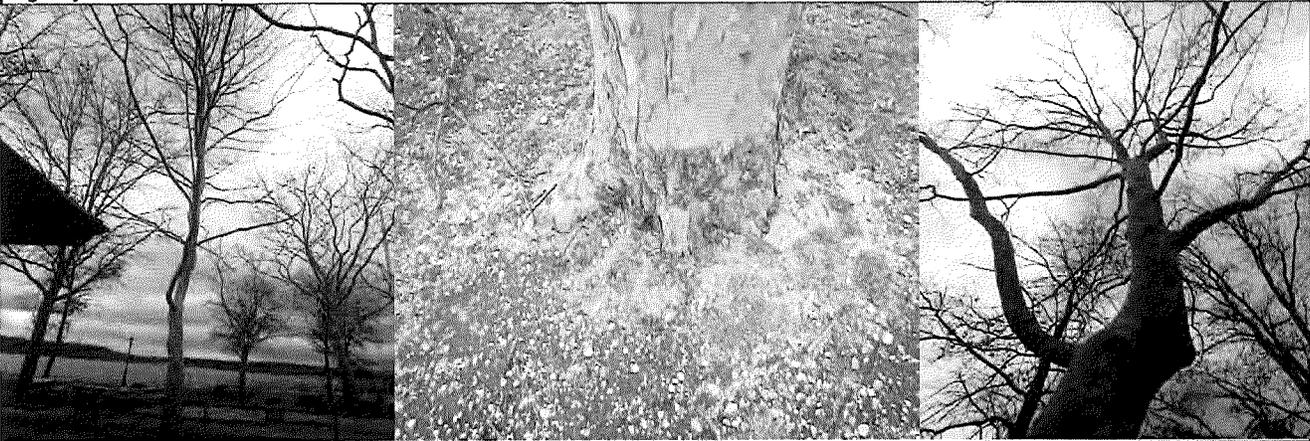
Tree/Root Base/Pit		Growing in sandy soil.							
Trunk Condition and Main Scaffold Branches		Minor trunk damage, old pruning cuts on trunk not entirely healed.							
Crown/Structure, Branches & Leaves		Thin crown, moderate fruiting only at the top of tree crown, tree was not assessed during full leaf.							
Pest / Disease		No noticeable signs.							
Setting		Far east end of park inside of fenced in picnic area with pavilion.							
Character		Y		Does the tree make an important contribution to the character or amenity of the area?					
		Indigenous		Is the tree indigenous, rare, endangered, invasive or exotic?					
Habitat		N		Does the tree represent important habitat for native fauna?					
		N		Is the tree part of a wildlife Corridor, Buffer, etc?					
<b>Notes:</b> Tree exhibits heavy pruning of a large number of lower branches and inner branches resulting in "Lion's-tailing" appearance which increases the risk of branch failure by weakening tree roots and decreasing the dampening effect that interior limbs provide during storms.

<b>Recommendations:</b> It is recommended to implement a program that continues to monitor this tree by an ISA Arborist. Vertical mulching is recommended for mitigation, this is a technique that benefits stressed trees by improving the movement of water, air, and nutrients in the root zone and should be performed by a qualified tree care professional. The Town should implement a comprehensive program of tree management including soil testing.								Level of Urgency	
								3	
Urgency Level: 1 - Requires Immediate Attention 2 - Within (1) Month 3 - Within (6) Months 4 - Within the year 5 - None

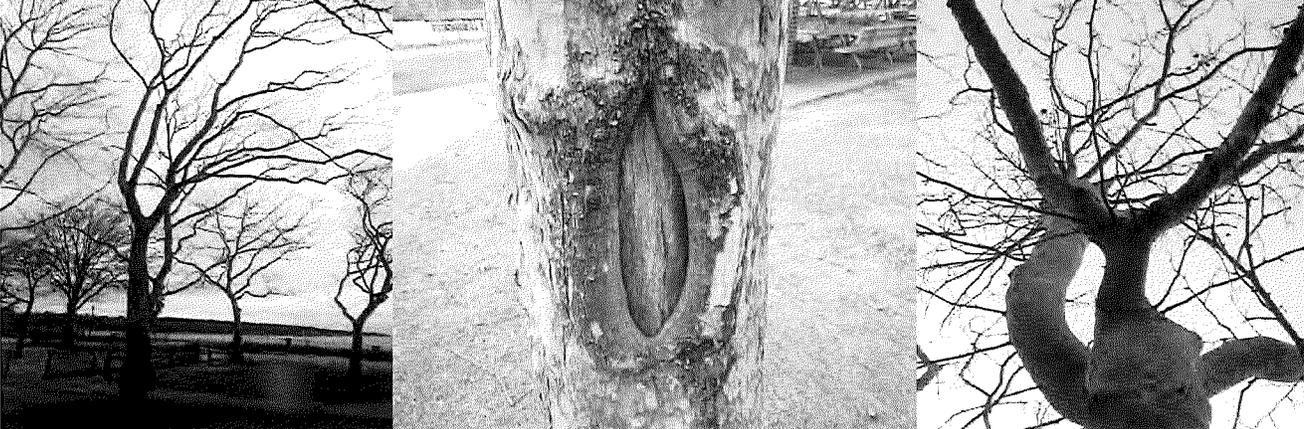
<b>Tree/Root Base/Pit</b>		Growing in a grass area, buried root collar.							
<b>Trunk Condition and Main Scaffold Branches</b>		Codominant leaders, trunk damage from vehicle or mechanical equipment, water sprouting on trunk and scaffold branches, minor dead scaffold branches.							
<b>Crown/Structure, Branches &amp; Leaves</b>		Thin crown, poor fruiting only evident at the top of tree crown, dead small branches, tree was not assessed during full leaf.							
<b>Pest / Disease</b>		No noticeable signs.							
<b>Setting</b>		Far east end of park inside of fenced in picnic area with pavilion.							
<b>Character</b>		Y		Does the tree make an important contribution to the character or amenity of the area?					
		Indigenous		Is the tree indigenous, rare, endangered, invasive or exotic?					
<b>Habitat</b>		N		Does the tree represent important habitat for native fauna?					
		N		Is the tree part of a wildlife Corridor, Buffer, etc?

<b>Notes:</b> Tree exhibits heavy pruning of a large number of lower branches and inner branches resulting in "Lion's-tailing" appearance which increases the risk of branch failure by weakening tree roots and decreasing the dampening effect that interior limbs provide during storms. Dead scaffold branches are hanging over walkway leading to adjacent pavilion.									
<b>Recommendations:</b> It is recommended to implement a program that continues to monitor this tree by an ISA Arborist and if condition continues to decline, consider removal. For recommended treatment, proper corrective pruning that follows ANSI A300 standards should be performed to remove dead and damaged branches particularly over the adjacent pavilion. It is recommended to perform root crown excavation by a qualified tree care professional, which is a treatment that involves the removal of excess soil from a tree's root flare and main lateral roots. Additionally, it is recommended to form a mulch collar around the base of the tree that will prevent any future damage caused by landscape maintenance and provide additional benefits to the tree. Vertical mulching is recommended for mitigation, this is a technique that benefits stressed trees by improving the movement of water, air, and nutrients in the root zone and should be performed by a qualified tree care professional. The Town should implement a comprehensive program of tree management including soil testing.								Level of Urgency

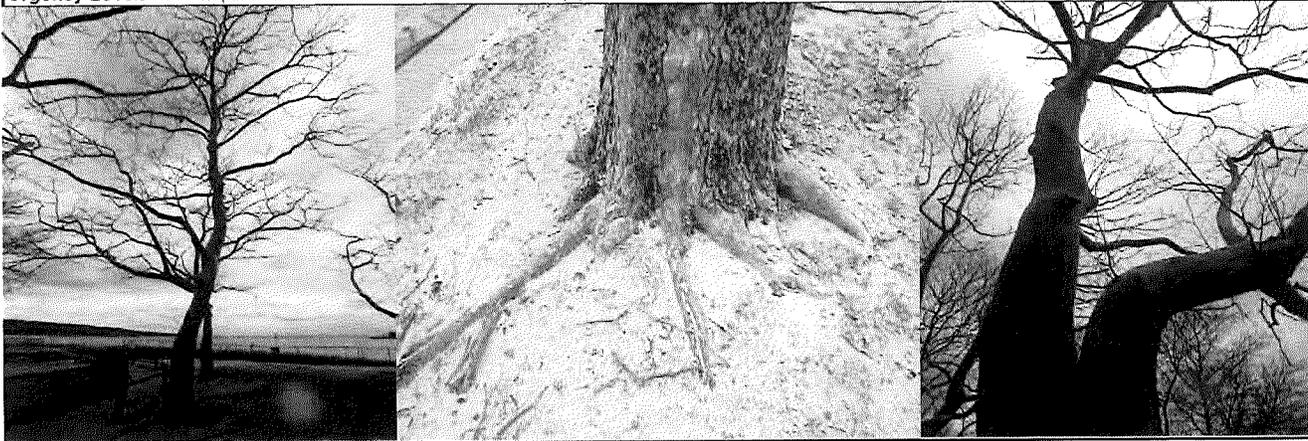
<b>Tree/Root Base/Pit</b>	Growing in sandy soil, mechanical damage at base and to exposed roots from landscape maintenance.					
<b>Trunk Condition and Main Scaffold Branches</b>	Codominant leaders, included bark at trunk union, one major leader is growing horizontally and has multiple dead scaffold branches.					
<b>Crown/Structure, Branches &amp; Leaves</b>	Good small branch structure, minor dead branches, moderate fruiting only at the top of tree crown, tree was not assessed during full leaf.					
<b>Pest / Disease</b>	Moss and lichen growth on trunk.					
<b>Setting</b>	Far east end of park inside of fenced in picnic area with structure.					
<b>Character</b>	Y	Does the tree make an important contribution to the character or amenity of the area?				
	Indigenous	Is the tree indigenous, rare, endangered, invasive or exotic?				
<b>Habitat</b>	N	Does the tree represent important habitat for native fauna?

N	Is the tree part of a wildlife Corridor, Buffer, etc?				
<b>Notes:</b> The leader growing horizontally with dead scaffold branches is directly above a walkway between the fenced in picnic area and playground, it appears to be putting stress on the union between the other major leader.						
<b>Recommendations:</b> It is recommended to implement a program that continues to monitor this tree by an ISA Arborist and if condition continues to decline, consider removal. For recommended treatment, proper corrective pruning that follows ANSI A300 standards should be performed to remove dead and damaged branches particularly on the leader growing over the walkway and playground area. Additionally, it is recommended to form a mulch collar around the base of the tree that will prevent any future damage caused by landscape maintenance and provide additional benefits to the tree. Vertical mulching is recommended for mitigation, this is a technique that benefits stressed trees by improving the movement of water, air, and nutrients in the root zone and should be performed by a qualified tree care professional. The Town should implement a comprehensive program of tree management including soil testing.						Level of Urgency

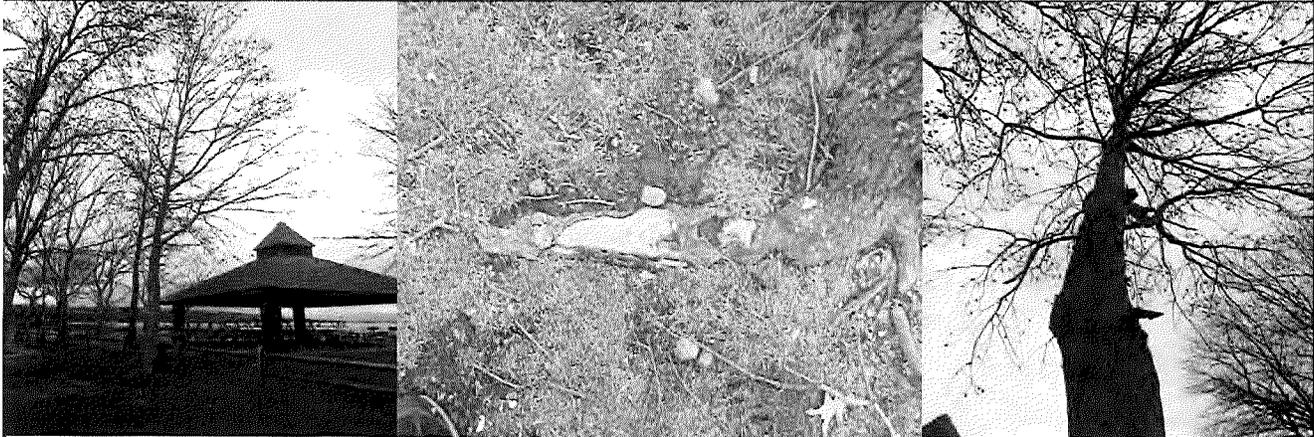
<b>Tree/Root Base/Pit</b>		Growing in a grass area, mechanical damage to exposed roots from landscape maintenance.							
<b>Trunk Condition and Main Scaffold Branches</b>		Moss and lichen growth on trunk, trunk wounds from broken scaffold branches have not entirely healed.							
<b>Crown/Structure, Branches &amp; Leaves</b>		Broken lower branches, infestation of gouty and horned oak galls growing on small branches are causing them to break and fall off, tree was not assessed during full leaf.							
<b>Pest / Disease</b>		Moss and lichen growth on trunk, gouty and horned oak galls growing on small branches.							
<b>Setting</b>		Far east end of park in picnic area with high wind exposure.							
<b>Character</b>		Y		Does the tree make an important contribution to the character or amenity of the area?					
		Indigenous		Is the tree indigenous, rare, endangered, invasive or exotic?					
<b>Habitat</b>		N		Does the tree represent important habitat for native fauna?

N		Is the tree part of a wildlife Corridor, Buffer, etc?					
<b>Notes:</b> Infestation of gouty and horned oak galls on majority of small branches in crown are causing them to break and fall off tree. While the oak galls are unsightly, they pose no major threat to the health of the tree other than weighing down and breaking the smaller branches. Infested trees may benefit from the application of fertilizer through vertical mulching.									
<b>Recommendations:</b> It is recommended to implement a program that continues to monitor this tree by an ISA Arborist and if condition continues to decline, consider removal. For recommended treatment, proper corrective pruning that follows ANSI A300 standards should be performed to remove dead and damaged branches. Additionally, it is recommended to form a mulch collar around the base of the tree that will prevent any future damage caused by landscape maintenance and provide additional benefits to the tree. Vertical mulching is recommended for mitigation, this is a technique that benefits stressed trees by improving the movement of water, air, and nutrients in the root zone and should be performed by a qualified tree care professional. The Town should implement a comprehensive program of tree management including soil testing.								Level of Urgency

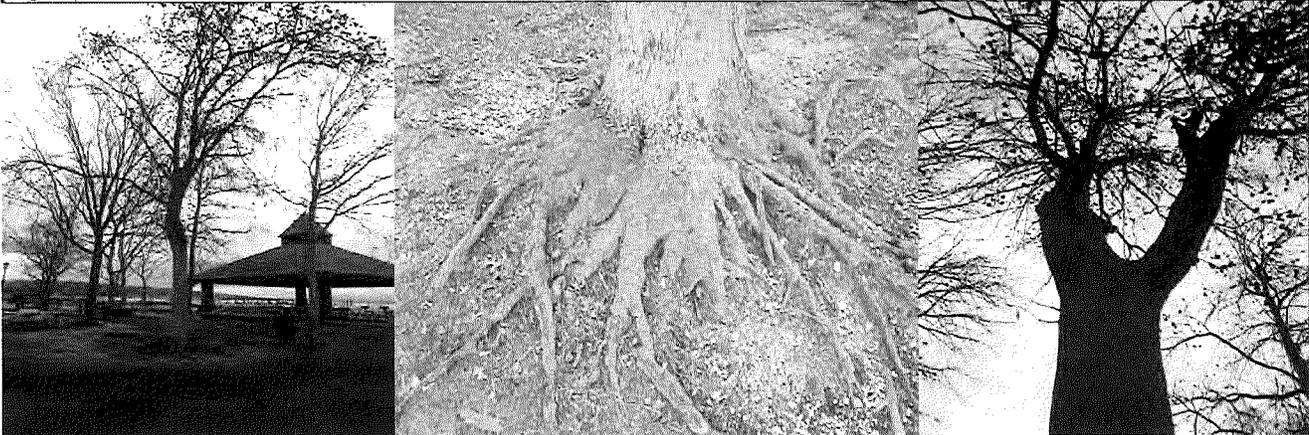
<b>Tree/Root Base/Pit</b>		Growing in a grass area, mechanical damage to exposed roots from landscape maintenance.					
<b>Trunk Condition and Main Scaffold Branches</b>		Codominant leaders, moss and lichen growth on trunk, dead scaffold branches.					
<b>Crown/Structure, Branches &amp; Leaves</b>		Broken and dead lower branches, heavy infestation of gouty and horned oak galls growing on small branches are causing them to break and fall off, tree was not assessed during full leaf.					
<b>Pest / Disease</b>		Moss and lichen growth on trunk, gouty and horned oak galls growing on small branches.					
<b>Setting</b>		Far east end of park in picnic area with high wind exposure.					
<b>Character</b>		Y		<i>Does the tree make an important contribution to the character or amenity of the area?</i>			
<b>Habitat</b>		Indigenous		<i>Is the tree indigenous, rare, endangered, invasive or exotic?</i>			
<b>Habitat</b>		N		<i>Does the tree represent important habitat for native fauna?</i>

<b>Habitat</b>		N		<i>Is the tree part of a wildlife Corridor, Buffer, etc?</i>			
<b>Notes:</b> Infestation of gouty and horned oak galls on majority of small branches in crown are causing them to break and fall off tree. While the oak galls are unsightly, they pose no major threat to the health of the tree other than weighing down and breaking the smaller branches. Infested trees may benefit from the application of fertilizer through vertical mulching.							
<b>Recommendations:</b> It is recommended to implement a program that continues to monitor this tree by an ISA Arborist and if condition continues to decline, consider removal. For recommended treatment, proper corrective pruning that follows ANSI A300 standards should be performed to remove dead and damaged branches. Additionally, it is recommended to form a mulch collar around the base of the tree that will prevent any future damage caused by landscape maintenance and provide additional benefits to the tree. Vertical mulching is recommended for mitigation, this is a technique that benefits stressed trees by improving the movement of water, air, and nutrients in the root zone and should be performed by a qualified tree care professional. The Town should implement a comprehensive program of tree management including soil testing.							<b>Level of Urgency</b>  <b>2</b>

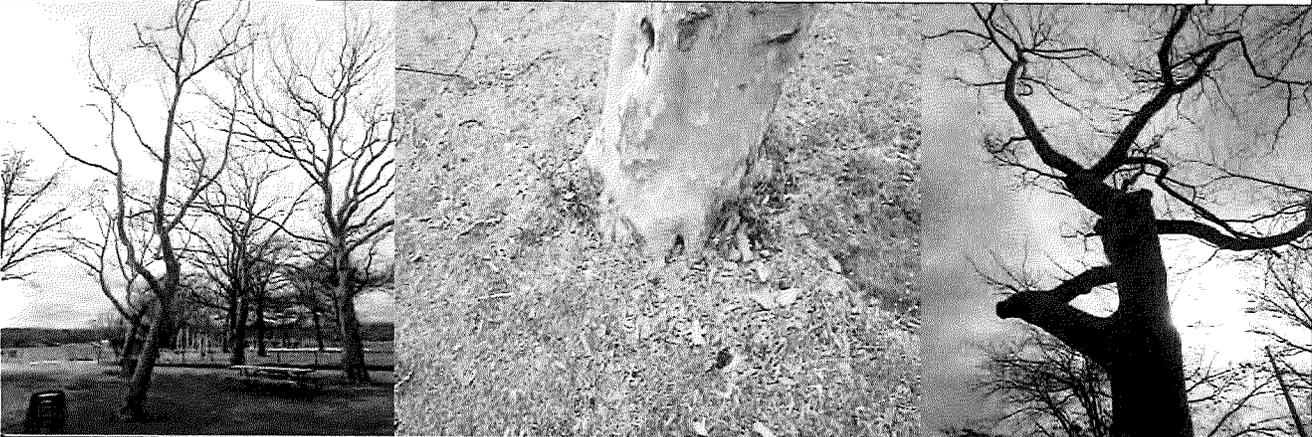
<b>Tree/Root Base/Pit</b>	Growing in a grass area, mechanical damage at base from landscape maintenance.		
<b>Trunk Condition and Main Scaffold Branches</b>	Codominant leaders, trunk leaning to the north, minor trunk wounds from broken scaffold branches, water sprouting on trunk and scaffold branches.		
<b>Crown/Structure , Branches &amp; Leaves</b>	Thin crown, poor fruiting only at the top of tree crown, dead small branches, tree was not assessed during full leaf.		
<b>Pest / Disease</b>	No noticeable signs.		
<b>Setting</b>	Far east end of park in picnic area with high wind exposure.		
<b>Character</b>	Y	<i>Does the tree make an important contribution to the character or amenity of the area?</i>	
	Indigenous	<i>Is the tree indigenous, rare, endangered, invasive or exotic?</i>	
<b>Habitat</b>	N	<i>Does the tree represent important habitat for native fauna?</i>	
	N	<i>Is the tree part of a wildlife Corridor, Buffer, etc?</i>

<b>Notes:</b> Tree exhibits heavy pruning of a large number of lower branches and inner branches resulting in "Lion's-tailing" appearance which increases the risk of branch failure by weakening tree roots and decreasing the dampening effect that interior limbs provide during storms.			
<b>Recommendations:</b> It is recommended to implement a program that continues to monitor this tree by an ISA Arborist and If condition continues to decline, consider removal. For recommended treatment, proper corrective pruning that follows ANSI A300 standards should be performed to remove dead and damaged branches. It is recommended to perform root crown excavation by a qualified tree care professional, which is a treatment that involves the removal of excess soil from a trees root flare and main lateral roots. Additionally, it is recommended to form a mulch collar around the base of the tree that will prevent any future damage caused by landscape maintenance and provide additional benefits to the tree. Vertical mulching is recommended for mitigation, this is a technique that benefits stressed trees by improving the movement of water, air, and nutrients in the root zone and should be performed by a qualified tree care professional. The Town should implement a comprehensive program of tree management including soil testing.			<b>Level of Urgency</b>  2

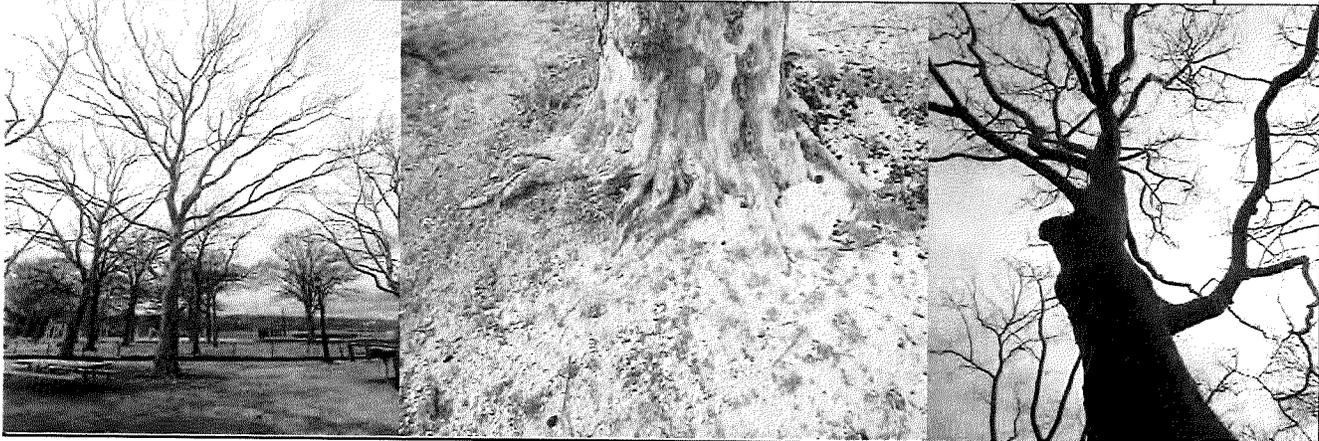
<b>Tree/Root Base/Pit</b>	Growing in a grass area, mechanical damage at base and to exposed roots from landscape maintenance, minor girdling roots.						
<b>Trunk Condition and Main Scaffold Branches</b>	Codominant leaders, trunk wounds from broken scaffold branches have not entirely healed.						
<b>Crown/Structure, Branches &amp; Leaves</b>	Dead branches, lower branches have been removed, poor fruiting only at the top of tree crown, tree was not assessed during full leaf.						
<b>Pest / Disease</b>	Moss and lichen growth on trunk.						
<b>Setting</b>	Far east end of park in picnic area with high wind exposure.						
<b>Character</b>	Y	<i>Does the tree make an important contribution to the character or amenity of the area?</i>					
<b>Habitat</b>	Indigenous	<i>Is the tree indigenous, rare, endangered, invasive or exotic?</i>					
<b>Habitat</b>	N	<i>Does the tree represent important habitat for native fauna?</i>

<b>Habitat</b>	N	<i>Is the tree part of a wildlife Corridor, Buffer, etc?</i>					
<b>Notes:</b> Tree exhibits heavy pruning of a large number of lower branches and inner branches resulting in "Lion's-tailing" appearance which increases the risk of branch failure by weakening tree roots and decreasing the dampening effect that interior limbs provide during storms.							
<b>Recommendations:</b> It is recommended to implement a program that continues to monitor this tree by an ISA Arborist and if condition continues to decline, consider removal. For recommended treatment, proper corrective pruning that follows ANSI A300 standards should be performed to remove dead and damaged branches. Additionally, it is recommended to form a mulch collar around the base of the tree that will prevent any future damage caused by landscape maintenance and provide additional benefits to the tree. Vertical mulching is recommended for mitigation, this is a technique that benefits stressed trees by improving the movement of water, air, and nutrients in the root zone and should be performed by a qualified tree care professional. The Town should implement a comprehensive program of tree management including soil testing.							<b>Level of Urgency</b>

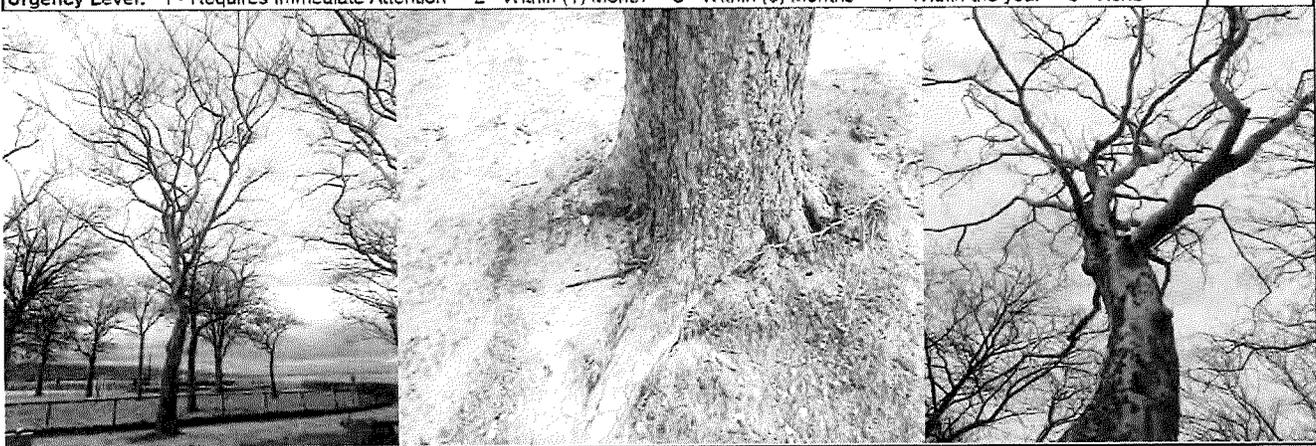
Tree/Root Base/Pit		Growing in sandy soil, mechanical damage at base and to exposed roots from landscape maintenance.					
Trunk Condition and Main Scaffold Branches		Trunk wounds from broken scaffold branches have not entirely healed, multiple dead scaffold branches.					
Crown/Structure, Branches & Leaves		Dead branches, poor fruiting only at the top of tree crown, tree was not assessed during full leaf.					
Pest / Disease		Moss and lichen growth on trunk.					
Setting		Far east end of park in picnic area with high wind exposure.					
Character		Y		Does the tree make an important contribution to the character or amenity of the area?			
		Indigenous		Is the tree indigenous, rare, endangered, invasive or exotic?			
Habitat		N		Does the tree represent important habitat for native fauna?			
		N		Is the tree part of a wildlife Corridor, Buffer, etc?			
<b>Notes:</b> Tree exhibits heavy pruning of a large number of lower branches and inner branches resulting in "Lion's-tailing" appearance which increases the risk of branch failure by weakening tree roots and decreasing the dampening effect that interior limbs provide during storms. Dead scaffold branches are directly above walkway and playground area.

<b>Recommendations:</b> It is recommended to implement a program that continues to monitor this tree by an ISA Arborist and if condition continues to decline, consider removal. For recommended treatment, proper corrective pruning that follows ANSI A300 standards should be performed to remove dead and damaged branches particularly above the walkway and playground. Additionally, it is recommended to form a mulch collar around the base of the tree that will prevent any future damage caused by landscape maintenance and provide additional benefits to the tree. Vertical mulching is recommended for mitigation, this is a technique that benefits stressed trees by improving the movement of water, air, and nutrients in the root zone and should be performed by a qualified tree care professional. The Town should implement a comprehensive program of tree management including soil testing.							Level of Urgency

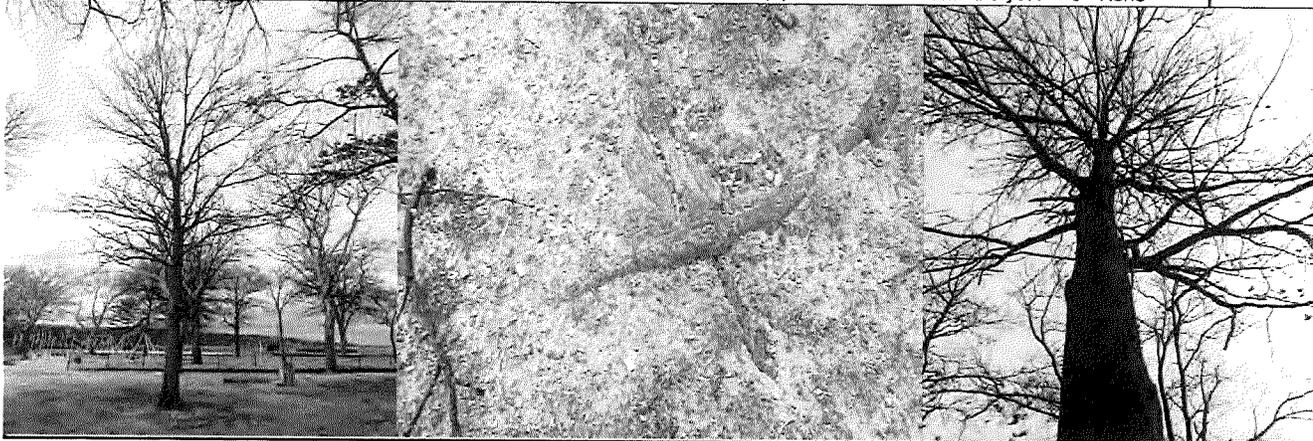
<b>Tree/Root Base/Pit</b>			
Growing in sandy soil, mechanical damage at base from landscape maintenance, minor girdling roots.			
<b>Trunk Condition and Main Scaffold Branches</b>			
Moss and lichen growth on trunk, dead lower scaffold branches.			
<b>Crown/Structure, Branches &amp; Leaves</b>			
Good crown structure, minor dead branches, very minor gouty and horned oak galls growing on small branches, tree was not assessed during full leaf.			
<b>Pest / Disease</b>			
Moss and lichen growth on trunk, gouty and horned oak galls growing on small branches.			
<b>Setting</b>			
Far east end of park in picnic area with high wind exposure.			
<b>Character</b>			
	Y	<i>Does the tree make an important contribution to the character or amenity of the area?</i>	
	Indigenous	<i>Is the tree indigenous, rare, endangered, invasive or exotic?</i>	
<b>Habitat</b>			
	N	<i>Does the tree represent important habitat for native fauna?</i>

N	<i>Is the tree part of a wildlife Corridor, Buffer, etc?</i>	
<b>Notes:</b>			
Minor Evidence of gouty and horned oak galls growing on small branches. To help prevent or reduce trees from being heavily infested with gouty or horned oak galls, where possible, prune small infested branches when galls are just developing in the spring. Maintain the health of the tree by watering during dry periods and fertilizing if needed.			
<b>Recommendations:</b>			
It is recommended to implement a program that continues to monitor this tree by an ISA Arborist. For recommended treatment, proper corrective pruning that follows ANSI A300 standards should be performed to remove dead and damaged branches. Additionally, it is recommended to form a mulch collar around the base of the tree that will prevent any future damage caused by landscape maintenance and provide additional benefits to the tree. Vertical mulching is recommended for mitigation, this is a technique that benefits stressed trees by improving the movement of water, air, and nutrients in the root zone and should be performed by a qualified tree care professional. The Town should implement a comprehensive program of tree management including soil testing.			<b>Level of Urgency</b>

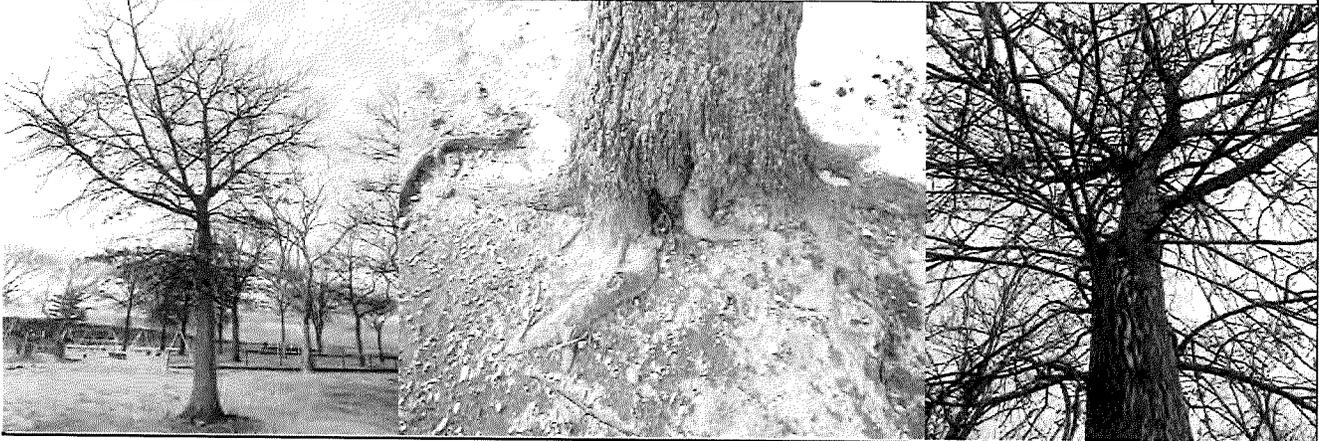
100 Crossways Park Drive West, Ste. 100 Woodbury, New York 11797		P: 516 364 0660 F: 516 364 0665		www.donayersassociates.com		Assignment:	Tree No.:
						2	39
Arboreal Assessment Report				Location: North Hempstead Beach Park - Port Washington, NY		Date: 2/25/2016	
Inspector: Dan Maher		Weather: Mostly Cloudy		Lat/Long: N 40° 49' 40.57" W 73° 39' 6.09"		Time: 15:12	
Specimen:	Common Name: OAK, PIN		Scientific name: Quercus palustris				
Descriptor	Value	Range					
Girth	15"	Trunk Diameter Measured at Breast Height (DBH)					
Approx. Height	35'-40'	Approximate Height to top of Canopy					
Canopy	N 15', S 15', E 9', W 12'	Canopy Radius in Feet - North South East West					
Condition	4	Health of Specimen - 1 Dead - 2 Declining - 3 Moderate - 4 Good - 5 Excellent					
Approx. Age	M	NP=Newly Planted Within 5yrs M=Moderate 10-20 yrs old E=Existing before development					
Tree/Root Base/Pit	Growing in sandy soil, mechanical damage at base and to exposed roots from landscape maintenance, minor girdling roots.

Trunk Condition and Main Scaffold Branches	Moss and lichen growth on trunk.						
Crown/Structure, Branches & Leaves	Uneven crown, minor dead branches, no signs of gouty and horned oak galls growing on small branches, tree was not assessed during full leaf.						
Pest / Disease	Moss and lichen growth on trunk.						
Setting	Far east end of park in picnic area with high wind exposure.						
Character	Y	Does the tree make an important contribution to the character or amenity of the area?					
	Indigenous	Is the tree indigenous, rare, endangered, invasive or exotic?					
Habitat	N	Does the tree represent important habitat for native fauna?					
	N	Is the tree part of a wildlife Corridor, Buffer, etc?					
<b>Notes:</b> Gap created between the branches at the top of crown and lower branches due to removed scaffold branches.							
<b>Recommendations:</b> It is recommended to implement a program that continues to monitor this tree by an ISA Arborist. For recommended treatment, proper corrective pruning that follows ANSI A300 standards should be performed to remove dead and damaged branches. Additionally, it is recommended to form a mulch collar around the base of the tree that will prevent any future damage caused by landscape maintenance and provide additional benefits to the tree. Vertical mulching is recommended for mitigation, this is a technique that benefits stressed trees by improving the movement of water, air, and nutrients in the root zone and should be performed by a qualified tree care professional. The Town should implement a comprehensive program of tree management including soil testing.							Level of Urgency

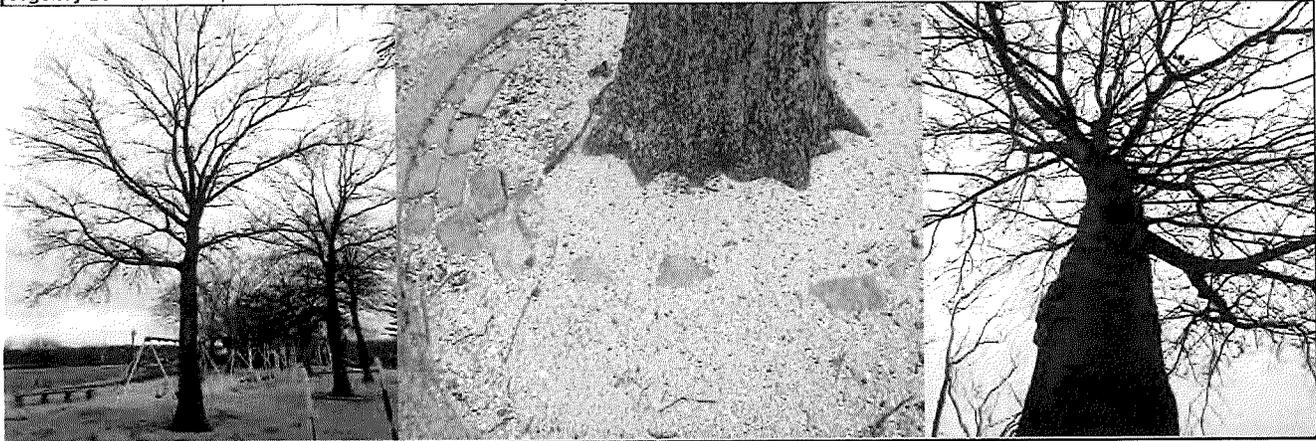
100 Crossways Park Drive West, Ste. 104 Woodbury, New York 11797		t: 516 364 0667 f: 516 364 0668		www.lbnayersassociates.com		Assignment: <b>2</b>	Tree No.: <b>44</b>
<b>ARBORIST ASSESSMENT REPORT</b>				Location: North Hempstead Beach Park - Port Washington, NY		Date: 2/25/2016	
Inspector: Dan Maher				Weather: Mostly Cloudy		Lat/Long: N 40° 49' 41.22" W 73° 39' 6.6"	
Specimen:		Common Name: OAK, PIN		Scientific name: Quercus palustris			
<b>Descriptor</b>	<b>Value</b>	<b>Range</b>					
Girth	16"	Trunk Diameter Measured at Breast Height (DBH)					
Approx. Height	35'-40'	Approximate Height to top of Canopy					
Canopy	N 19',S 21',E 14',W 13'	Canopy Radius in Feet - North South East West					
Condition	3	Health of Specimen - 1 Dead - 2 Declining - 3 Moderate - 4 Good - 5 Excellent					
Approx. Age	M	NP=Newly Planted Within 5yrs M=Moderate 10-20 yrs old E=Existing before development					
<b>Tree/Root Base/Pit</b>	Growing in sand and inside of a circular concrete curb, minor girdling roots.

<b>Trunk Condition and Main Scaffold Branches</b>	Moss and lichen growth on trunk, water sprouting on trunk.						
<b>Crown/Structure . Branches &amp; Leaves</b>	Dead lower branches, heavy infestation of gouty and horned oak galls growing on lower branches are causing them to break and fall off, tree was not assessed during full leaf.						
<b>Pest / Disease</b>	Moss and lichen growth on trunk, gouty and horned oak galls growing on small branches.						
<b>Setting</b>	Far east end of park inside of fenced in play area.						
<b>Character</b>	Y	Does the tree make an important contribution to the character or amenity of the area?					
	Indigenous	Is the tree indigenous, rare, endangered, invasive or exotic?					
<b>Habitat</b>	N	Does the tree represent important habitat for native fauna?					
	N	Is the tree part of a wildlife Corridor, Buffer, etc?					
<b>Notes:</b> Tree is inside of the fenced in play area, Infestation of gouty and horned oak galls on majority of small branches in crown are causing them to break and fall off tree. While the oak galls are unsightly, they pose no major threat to the health of the tree other than weighing down and breaking the smaller branches. Infested trees may benefit from the application of fertilizer through vertical mulching.

<b>Recommendations:</b> It is recommended to implement a program that continues to monitor this tree by an ISA Arborist and if condition continues to decline, consider removal. For recommended treatment, proper corrective pruning that follows ANSI A300 standards should be performed to remove dead and damaged branches. It is recommended to perform root crown excavation by a qualified tree care professional, which is a treatment that involves the removal of excess soil from a trees root flare and main lateral roots. Vertical mulching is recommended for mitigation, this is a technique that benefits stressed trees by improving the movement of water, air, and nutrients in the root zone and should be performed by a qualified tree care professional. The Town should implement a comprehensive program of tree management including soil testing.							Level of Urgency
<b>Urgency Level:</b> 1 - Requires Immediate Attention 2 - Within (1) Month 3 - Within (6) Months 4 - Within the year 5 - None							<b>2</b>

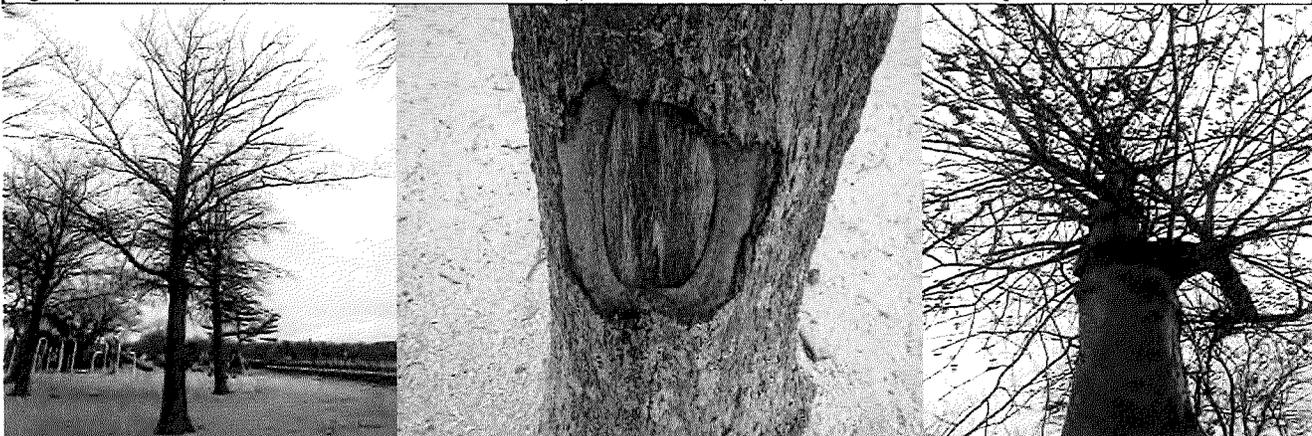
<b>Tree/Root Base/Pit</b>	Growing in sand.		
<b>Trunk Condition and Main Scaffold Branches</b>	Moss and lichen growth on trunk, major trunk damage from vehicle or mechanical equipment, trunk wounds from removed scaffold branches have not entirely healed, dead and broken scaffold branches.		
<b>Crown/Structure , Branches &amp; Leaves</b>	Dead and broken branches, minor gouty and horned oak galls beginning to grow on lower branches, tree was not assessed during full leaf.		
<b>Pest / Disease</b>	Moss and lichen growth on trunk, gouty and horned oak galls growing on small branches.		
<b>Setting</b>	Far east end of park inside of fenced in play area.		
<b>Character</b>	Y	<i>Does the tree make an important contribution to the character or amenity of the area?</i>	
	Indigenous	<i>Is the tree indigenous, rare, endangered, invasive or exotic?</i>	
<b>Habitat</b>	N	<i>Does the tree represent important habitat for native fauna?</i>

N	<i>Is the tree part of a wildlife Corridor, Buffer, etc?</i>	
<b>Notes:</b> Tree is inside of the fenced in play area, multiple dead scaffold branches. Minor evidence of gouty and horned oak galls growing on small branches. To help prevent or reduce trees from being heavily infested with gouty or horned oak galls, where possible, prune small infested branches when galls are just developing in the spring. Maintain the health of the tree by watering during dry periods and fertilizing if needed.			
<b>Recommendations:</b> It is recommended to implement a program that continues to monitor this tree by an ISA Arborist and if condition continues to decline, consider removal. For recommended treatment, proper corrective pruning that follows ANSI A300 standards should be performed to remove dead and damaged branches. Vertical mulching is recommended for mitigation, this is a technique that benefits stressed trees by improving the movement of water, air, and nutrients in the root zone and should be performed by a qualified tree care professional. The Town should implement a comprehensive program of tree management including soil testing.			<b>Level of Urgency</b>
