# DRAFT REPORT

100 Crossways Park Drive West, Ste 10- Woodbury, New York 11797	T: 516.364.0660 F: 516.364.0655	www.btnayerassociates.com	Assignment: <b>2</b>	Tree No.: <b>2</b>
Arborist Assessment Report		Location: North Hempstead Beach Park - Port Washington, NY		Date: 2/25/2016		
Inspector: Dan Maher		Weather: Mostly Cloudy	Lat/Long: N 40° 49' 41.06" W 73° 39' 2.16"		Time: 09:46	
Specimen:	Common Name: TREE OF HEAVEN		Scientific name: Ailanthus altissima			
Descriptor	Value	Range				
Girth	8"	Trunk Diameter Measured at Breast Height (DBH)				
Approx. Height	15'-20'	Approximate Height to top of Canopy				
Canopy	N 12', S 6', E 9', W 8'	Canopy Radius in Feet - North South East West				
Condition	3	Health of Specimen - 1 Dead - 2 Declining - 3 Moderate - 4 Good - 5 Excellent				
Approx. Age	M	NP=Newly Planted Within 5yrs M=Moderate 10-20 yrs old E=Existing before development				
Tree/Root Base/Pit	Growing almost entirely in sand that is eroding away and exposing roots.

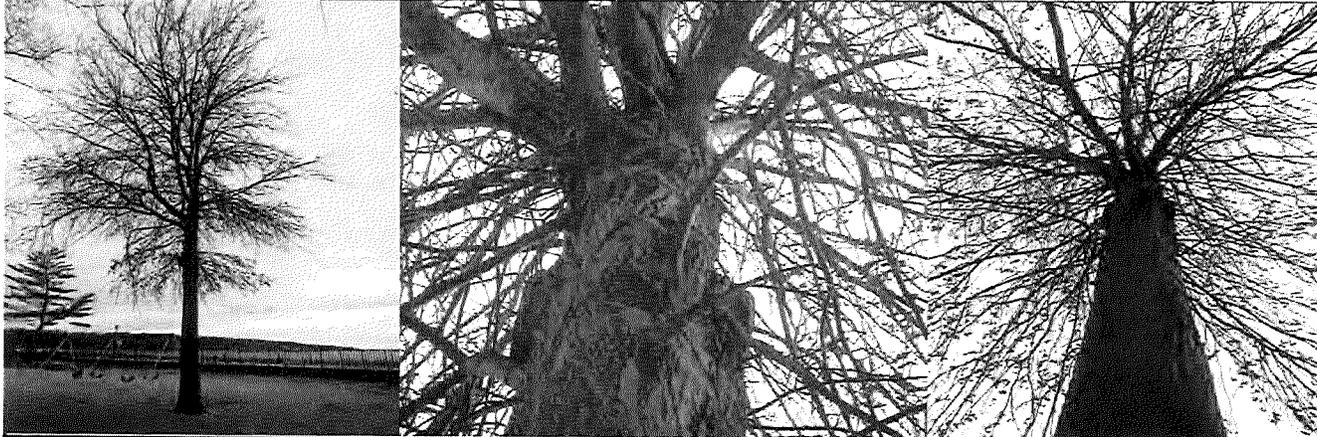
Growing in sand.							
<b>Trunk Condition and Main Scaffold Branches</b>							
Moss and lichen growth on trunk, minor broken scaffold branches.							
<b>Crown/Structure, Branches &amp; Leaves</b>							
Good crown and small branch structure, tree was not assessed during full leaf.							
<b>Pest / Disease</b>							
Moss and lichen growth on trunk.							
<b>Setting</b>							
Far east end of park inside of fenced in play area.							
<b>Character</b>							
Y Does the tree make an important contribution to the character or amenity of the area?							
Indigenous Is the tree indigenous, rare, endangered, invasive or exotic?							
<b>Habitat</b>							
N Does the tree represent important habitat for native fauna?							
N Is the tree part of a wildlife Corridor, Buffer, etc?							
<b>Notes:</b>							
Tree is inside of the fenced in play area, minor broken scaffold branches hanging in lower portion of crown.

<b>Recommendations:</b>							
It is recommended to implement a program that continues to monitor this tree by an ISA Arborist. For recommended treatment, proper corrective pruning that follows ANSI A300 standards should be performed to remove dead and damaged branches hanging in the crown. Vertical mulching is recommended for mitigation, this is a technique that benefits stressed trees by improving the movement of water, air, and nutrients in the root zone and should be performed by a qualified tree care professional. The Town should implement a comprehensive program of tree management including soil testing.							Level of Urgency
<b>Urgency Level:</b> 1 - Requires Immediate Attention 2 - Within (1) Month 3 - Within (6) Months 4 - Within the year 5 - None							<b>3</b>

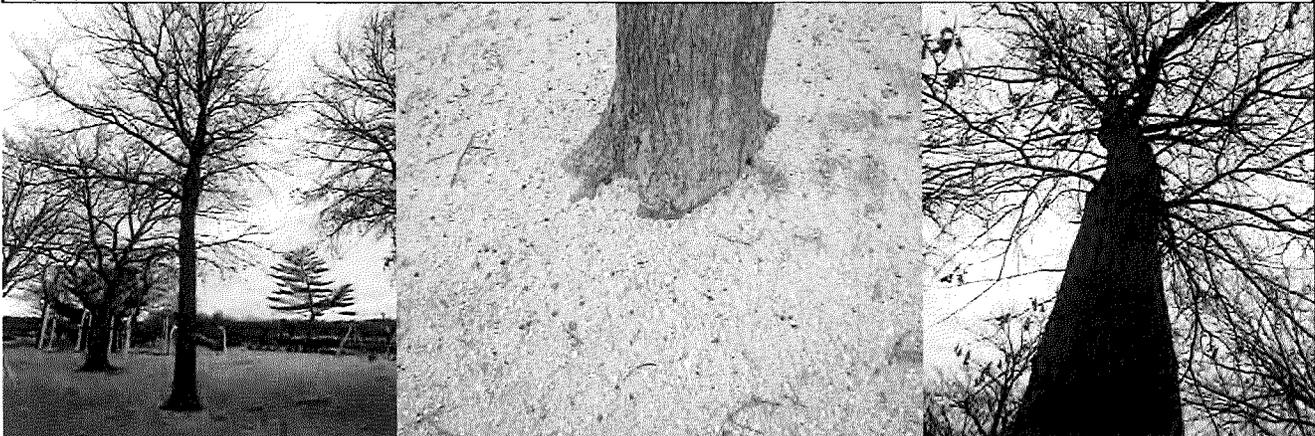
<b>Approx. Age</b>	M	<i>NP=Newly Planted Within 5yrs M=Moderate 10-20 yrs old E=Existing before development</i>					
<hr/>							
<b>Tree/Root Base/Pit</b>	Growing in sand.						
<b>Trunk Condition and Main Scaffold Branches</b>	Moss and lichen growth on trunk, minor dead scaffold branches.						
<b>Crown/Structure, Branches &amp; Leaves</b>	Uneven crown, minor dead and broken branches, no signs of gouty and horned oak galls growing on small branches, tree was not assessed during full leaf.						
<b>Pest / Disease</b>	Moss and lichen growth on trunk.						
<b>Setting</b>	Far east end of park inside of fenced in play area.						
<hr/>							
<b>Character</b>	Y	<i>Does the tree make an important contribution to the character or amenity of the area?</i>					
	Indigenous	<i>Is the tree indigenous, rare, endangered, invasive or exotic?</i>					
<b>Habitat</b>	N	<i>Does the tree represent important habitat for native fauna?</i>

N	<i>Is the tree part of a wildlife Corridor, Buffer, etc?</i>					
<hr/>							
<b>Notes:</b> Tree is inside of the fenced in play area, minor dead branches directly above swing set.							
<b>Recommendations:</b> It is recommended to implement a program that continues to monitor this tree by an ISA Arborist and if condition continues to decline, consider removal. For recommended treatment, proper corrective pruning that follows ANSI A300 standards should be performed to remove dead and damaged branches directly above childrens swing set. Vertical mulching is recommended for mitigation, this is a technique that benefits stressed trees by improving the movement of water, air, and nutrients in the root zone and should be performed by a qualified tree care professional. The Town should implement a comprehensive program of tree management including soil testing.							<b>Level of Urgency</b>
							1

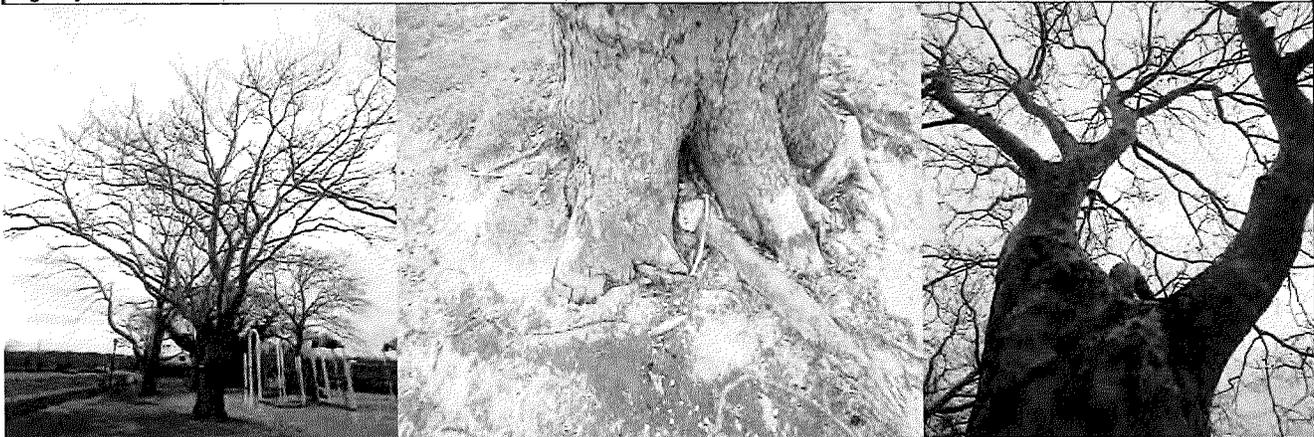
100 Crossways Park Drive West Ste 104 Woodbury, New York 11797		t: 516 364 0667 f: 516 364 0668		www.dnayersassociates.com		Assignment:	Tree No.:
						2	50
Arborist Assessment Report			Location: North Hempstead Beach Park - Port Washington, NY			Date: 2/25/2016	
Inspector: Dan Maher			Weather: Mostly Cloudy		Lat/Long: N 40° 49' 41.05" W 73° 39' 7.89"		Time: 16:19
Specimen:		Common Name: LONDON PLANETREE		Scientific name: Platanus x acerifolia			
<b>Descriptor</b>		<b>Value</b>		<b>Range</b>			
Girth		24"		Trunk Diameter Measured at Breast Height (DBH)			
Approx. Height		45'-50'		Approximate Height to top of Canopy			
Canopy		N 28',S 20',E 12',W 26'		Canopy Radius in Feet - North South East West			
Condition		4		Health of Specimen - 1 Dead - 2 Declining - 3 Moderate - 4 Good - 5 Excellent			
Approx. Age		E		NP=Newly Planted Within 5yrs M=Moderate 10-20 yrs old E=Existing before development			
<b>Tree/Root Base/Pit</b>		Growing in grass area, mechanical damage at base and to exposed roots from landscape maintenance, girdling roots.

<b>Trunk Condition and Main Scaffold Branches</b>		Codominant leaders, Moss and lichen growth on trunk, trunk wounds from removed scaffold branches have not entirely healed.					
<b>Crown/Structure . Branches &amp; Leaves</b>		Good crown structure, minor dead branches, moderate fruiting, tree was not assessed during full leaf.					
<b>Pest / Disease</b>		Moss and lichen growth on trunk.					
<b>Setting</b>		Far east end of park inside of fenced in play area.					
<b>Character</b>		Y		Does the tree make an important contribution to the character or amenity of the area?			
		Indigenous		Is the tree indigenous, rare, endangered, invasive or exotic?			
<b>Habitat</b>		N		Does the tree represent important habitat for native fauna?			
		N		Is the tree part of a wildlife Corridor, Buffer, etc?			
<b>Notes:</b> Evidence that smaller branches have recently broken and fallen out of tree crown.							
<b>Recommendations:</b> It is recommended to implement a program that continues to monitor this tree by an ISA Arborist. For recommended treatment, proper corrective pruning that follows ANSI A300 standards should be performed to remove dead and damaged branches. Additionally, it is recommended to form a mulch collar around the base of the tree that will prevent any future damage caused by landscape maintenance and provide additional benefits to the tree. Vertical mulching is recommended for mitigation, this is a technique that benefits stressed trees by improving the movement of water, air, and nutrients in the root zone and should be performed by a qualified tree care professional. The Town should implement a comprehensive program of tree management including soil testing.							<b>Level of Urgency</b>
