# DRAFT REPORT

100 Crossways Park Drive West Ste 100 Woodbury New York 11797		Tel: 516 364 0661 Fax: 516 364 0666		www.dmahayeresociates.com		Assignment:	Tree No.:
						2	61
<b>Arborist Assessment Report</b>			Location: North Hempstead Beach Park - Port Washington, NY			Date: 2/26/2016	
Inspector: Dan Maher			Weather: Partly Sunny		Lat/Long: N 40° 49' 40.44" W 73° 39' 10.7"		Time: 10:17
<b>Specimen:</b>		Common Name: LONDON PLANETREE		Scientific name: Platanus x acerifolia			
<b>Descriptor</b>		<b>Value</b>		<b>Range</b>			
<b>Girth</b>		23"		Trunk Diameter Measured at Breast Height (DBH)			
<b>Approx. Height</b>		40'-45'		Approximate Height to top of Canopy			
<b>Canopy</b>		N 16',S 22',E 14',W 18'		Canopy Radius in Feet - North South East West			
<b>Condition</b>		2		Health of Specimen - 1 Dead - 2 Declining - 3 Moderate - 4 Good - 5 Excellent			
<b>Approx. Age</b>		E		NP=Newly Planted Within 5yrs M=Moderate 10-20 yrs old E=Existing before development

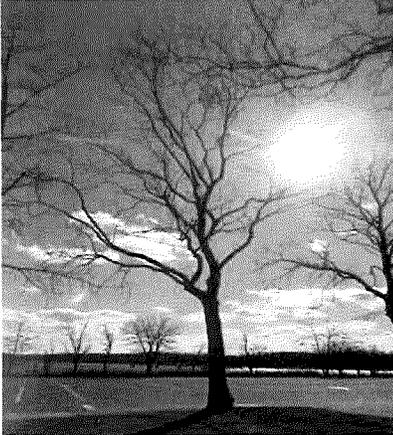
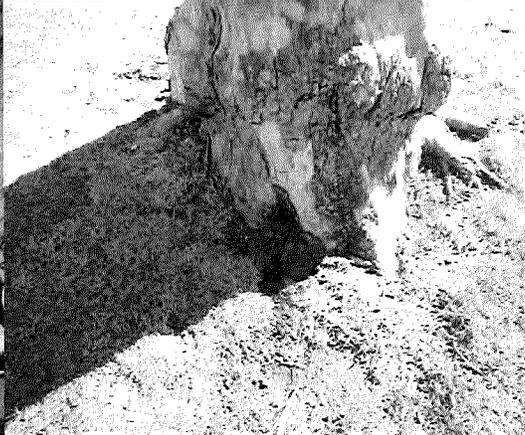
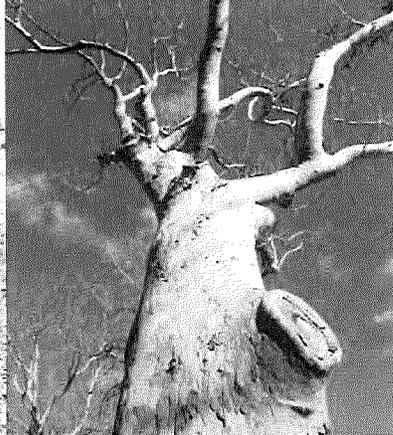
<b>Tree/Root Base/Pit</b>		Growing in grass area, mechanical damage at base from landscape maintenance.					
<b>Trunk Condition and Main Scaffold Branches</b>		Moss and lichen growth on trunk, water sprouting on trunk and scaffold branches, mjr discoloration on trunk and scaffold branches, major dead scaffold branches.					
<b>Crown/Structure , Branches &amp; Leaves</b>		Major dead branches, moderate fruiting on healthy branches, tree was not assessed during full leaf.					
<b>Pest / Disease</b>		Moss and lichen growth on trunk.					
<b>Setting</b>		Far east end of park, east of concession building along parking lot.					
<b>Character</b>		Y		Does the tree make an important contribution to the character or amenity of the area?			
		Indigenous		Is the tree indigenous, rare, endangered, invasive or exotic?			
<b>Habitat</b>		N		Does the tree represent important habitat for native fauna?			
		N		Is the tree part of a wildlife Corridor, Buffer, etc?

<b>Notes:</b> Major portions of the trunk and more than 1/3 of crown is partially or entirely dead.							
<b>Recommendations:</b> Remove tree due to current hazardous condition and anticipated decline. For tree replacement it is recommended to use XXX. Replacements should be planted immediately following removals and it is recommended to form a mulch collar around the base of the tree that will prevent any future damage caused by landscape maintenance and provide additional benefits to the tree. The Town should implement a comprehensive program of tree management including soil testing.							Level of Urgency
							1
<b>Urgency Level:</b> 1 - Requires Immediate Attention 2 - Within (1) Month 3 - Within (6) Months 4 - Within the year 5 - None

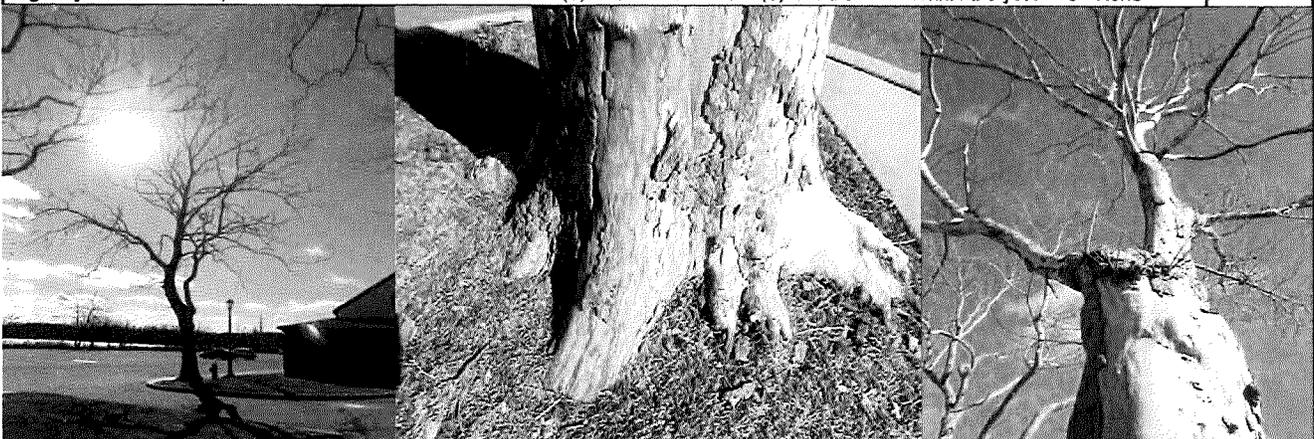
100 Crossways Park Drive West Ste 104 Woodbury New York 11797 516 364 0663 516 364 0665 www.ghayreassociates.com		Assignment:	Tree No.:
		2	62
Arboreal Assessment Report		Location: North Hempstead Beach Park - Port Washington, NY	
Inspector: Dan Maher		Weather: Partly Sunny	Date: 2/26/2016
		Lat/Long: N 40° 49' 40.37" W 73° 39' 11.11"	Time: 10:23
Specimen:	Common Name: LONDON PLANETREE		Scientific name: Platanus x acerifolia
Descriptor	Value	Range	
Girth	32"	Trunk Diameter Measured at Breast Height (DBH)	
Approx. Height	40'-45'	Approximate Height to top of Canopy	
Canopy	N 21', S 15', E 18', W 19'	Canopy Radius in Feet - North South East West	
Condition	2	Health of Specimen - 1 Dead - 2 Declining - 3 Moderate - 4 Good - 5 Excellent	
Approx. Age	E	NP=Newly Planted Within 5yrs M=Moderate 10-20 yrs old E=Existing before development	
Tree/Root Base/Pit	Growing in grass area, mechanical damage at base from landscape maintenance, major dead wood at base continuing up trunk.

Trunk Condition and Main Scaffold Branches	Moss and lichen growth on trunk, water sprouting on trunk and scaffold branches, major discoloration on trunk and scaffold branches, major dead scaffold branches.		
Crown/Structure, Branches & Leaves	Poor small branch structure, major dead branches, poor bud presence, tree was not assessed during full leaf.		
Pest / Disease	Moss and lichen growth on trunk.		
Setting	Far east end of park, east of concession building along parking lot.		
Character	Y	Does the tree make an important contribution to the character or amenity of the area?	
	Indigenous	Is the tree indigenous, rare, endangered, invasive or exotic?	
Habitat	N	Does the tree represent important habitat for native fauna?	
	N	Is the tree part of a wildlife Corridor, Buffer, etc?	
Notes:	Major portions of the trunk and more than 2/3 of crown is partially or entirely dead.		
Recommendations:	Remove tree due to current hazardous condition and anticipated decline. For tree replacement it is recommended to use XXX. Replacements should be planted immediately following removals and it is recommended to form a mulch collar around the base of the tree that will prevent any future damage caused by landscape maintenance and provide additional benefits to the tree. The Town should implement a comprehensive program of tree management including soil testing.		Level of Urgency

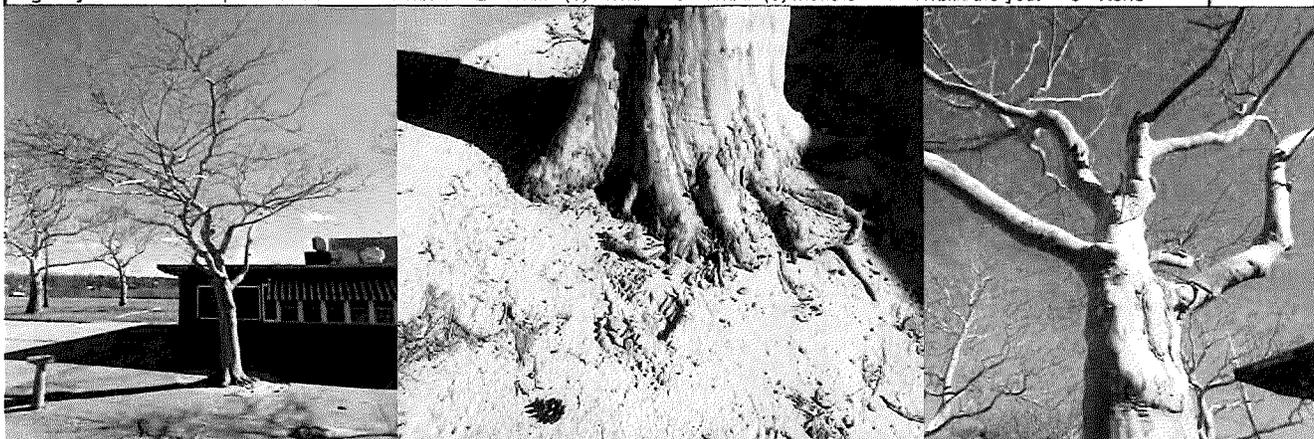
<b>Approx. Age</b>		E		<i>NP=Newly Planted Within 5yrs M=Moderate 10-20 yrs old E=Existing before development</i>			
<b>Tree/Root Base/Pit</b>		Growing in an 8' diameter circular tree pit in sand surrounded by concrete sidewalk, minor basal damage.					
<b>Trunk Condition and Main Scaffold Branches</b>		Codominant leaders with included bark at union, one of the leaders has been pruned back and is dead with a dead scaffold branch off of it, water sprouting on trunk and scaffold branches.					
<b>Crown/Structure, Branches &amp; Leaves</b>		minor dead branches, moderate fruiting, tree was not assessed during full leaf.					
<b>Pest / Disease</b>		No noticeable signs.					
<b>Setting</b>		Far east end of park, north of concession building.					
<b>Character</b>		Y		<i>Does the tree make an important contribution to the character or amenity of the area?</i>			
<b>Habitat</b>		Indigenous		<i>Is the tree indigenous, rare, endangered, invasive or exotic?</i>

<b>Habitat</b>		N		<i>Does the tree represent important habitat for native fauna?</i>			
<b>Habitat</b>		N		<i>Is the tree part of a wildlife Corridor, Buffer, etc?</i>			
<b>Notes:</b> dead scaffold branch and smaller branches are directly above concession area. It appears that the concrete sidewalk around the tree pit has been replaced. flexi pave recommended in tree pit to prevent tripping hazard... will this be maintenance issue with sand? Or just mulch?							
<b>Recommendations:</b> It is recommended to implement a program that continues to monitor this tree by an ISA Arborist and if condition continues to decline, consider removal. For recommended treatment, proper corrective pruning that follows ANSI A300 standards should be performed to remove dead and damaged branches. Additionally, it is recommended to form a mulch collar around the base of the tree that will prevent any future damage caused by landscape maintenance and provide additional benefits to the tree. Vertical mulching is recommended for mitigation, this is a technique that benefits stressed trees by improving the movement of water, air, and nutrients in the root zone and should be performed by a qualified tree care professional. The Town should implement a comprehensive program of tree management including soil testing.							<b>Level of Urgency</b>

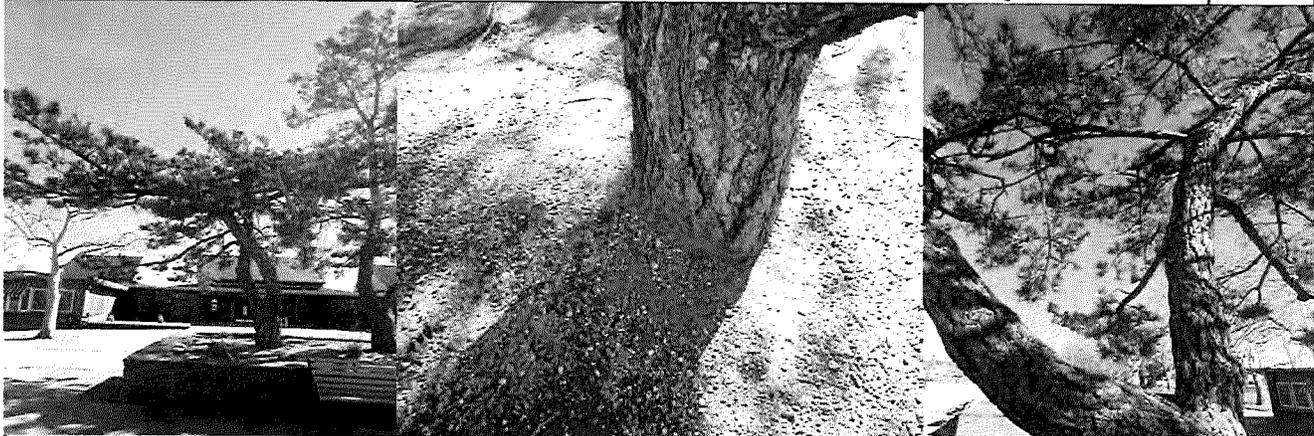
100 Crossways Park Drive West, Ste. 104 Woodbury, New York 11797 T: 516.364.0667 F: 516.364.0668 www.atlayerassociates.com		Assignment: <b>2</b>	Tree No.: <b>70</b>
Carbonet Assessment Report		Location: North Hempstead Beach Park - Port Washington, NY	
Inspector: Dan Maher		Weather: Partly Sunny	Date: 2/26/2016
		Lat/Long: N 40° 49' 41.49" W 73° 39' 12.41"	Time: 11:50
<b>Specimen:</b>	Common Name: PINE, RED		Scientific name: Pinus resinosa
<b>Descriptor</b>	<b>Value</b>	<b>Range</b>	
<b>Girth</b>	10", 12"	<i>Trunk Diameter Measured at Breast Height (DBH)</i>	
<b>Approx. Height</b>	15'-20'	<i>Approximate Height to top of Canopy</i>	
<b>Canopy</b>	N 12', S 10', E 4', W 8'	<i>Canopy Radius in Feet - North South East West</i>	
<b>Condition</b>	4	<i>Health of Specimen - 1 Dead - 2 Declining - 3 Moderate - 4 Good - 5 Excellent</i>	
<b>Approx. Age</b>	M	<i>NP=Newly Planted Within 5yrs M=Moderate 10-20 yrs old E=Existing before development</i>

<b>Tree/Root Base/Pit</b> Growing in raised planter with one other Red Pine, buried root collar.			
<b>Trunk Condition and Main Scaffold Branches</b> Codominant leaders, Moss and lichen growth on trunk.			
<b>Crown/Structure, Branches &amp; Leaves</b> Good crown structure, tree was not assessed during full leaf.			
<b>Pest / Disease</b> Moss and lichen growth on trunk.			
<b>Setting</b> Far east end of park in raised planter, north of concession building.			
<b>Character</b>			
	Y	<i>Does the tree make an important contribution to the character or amenity of the area?</i>	
	Indigenous	<i>Is the tree indigenous, rare, endangered, invasive or exotic?</i>	
<b>Habitat</b>			
	N	<i>Does the tree represent important habitat for native fauna?</i>	
	N	<i>Is the tree part of a wildlife Corridor, Buffer, etc?</i>	
<b>Notes:</b> Trees have been removed from raised planters on either side.			
<b>Recommendations:</b> It is recommended to implement a program that continues to monitor this tree by an ISA Arborist. For recommended treatment, till the soil inside of the planter, removing the existing turf and install mulch around the base of the tree that will prevent any future damage caused by landscape maintenance and provide additional benefits to the tree. Vertical mulching is recommended for mitigation, this is a technique that benefits stressed trees by improving the movement of water, air, and nutrients in the root zone and should be performed by a qualified tree care professional. The Town should implement a comprehensive program of tree management including soil testing.			<b>Level of Urgency</b>

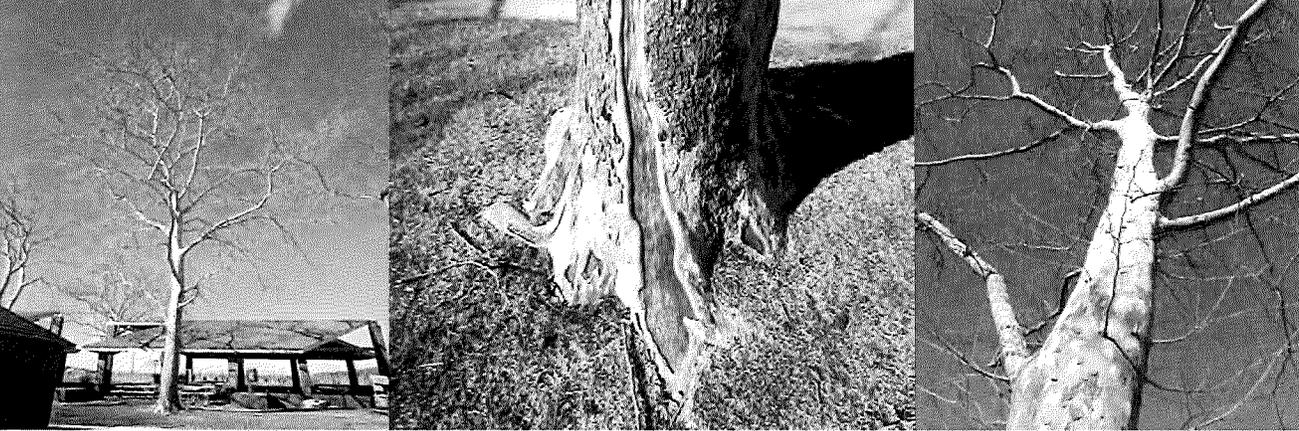
Trunk Condition and Main Scaffold Branches		Moss and lichen growth on trunk, trunk damage stemming from basal wounds, major water sprouting on trunk and scaffold branches.							
Crown/Structure, Branches & Leaves		Good crown structure, minor dead branches, broken branches hanging in crown, good fruiting, tree was not assessed during full leaf.							
Pest / Disease		Moss and lichen growth on trunk.							
Setting		Far east end of park, west of concession building near picnic pavilions.							
Character		Y		Does the tree make an important contribution to the character or amenity of the area?					
		Indigenous		Is the tree indigenous, rare, endangered, invasive or exotic?					
Habitat		N		Does the tree represent important habitat for native fauna?					
		N		Is the tree part of a wildlife Corridor, Buffer, etc?					
Notes: Minor dead and broken branches in tree crown are directly above walkway and pavilion area.

Recommendations: It is recommended to implement a program that continues to monitor this tree by an ISA Arborist. For recommended treatment, proper corrective pruning that follows ANSI A300 standards should be performed to remove dead and damaged branches. Additionally, it is recommended to form a mulch collar around the base of the tree that will prevent any future damage caused by landscape maintenance and provide additional benefits to the tree. Vertical mulching is recommended for mitigation, this is a technique that benefits stressed trees by improving the movement of water, air, and nutrients in the root zone and should be performed by a qualified tree care professional. The Town should implement a comprehensive program of tree management including soil testing.								Level of Urgency	
								2	
Urgency Level: 1 - Requires Immediate Attention 2 - Within (1) Month 3 - Within (6) Months 4 - Within the year 5 - None

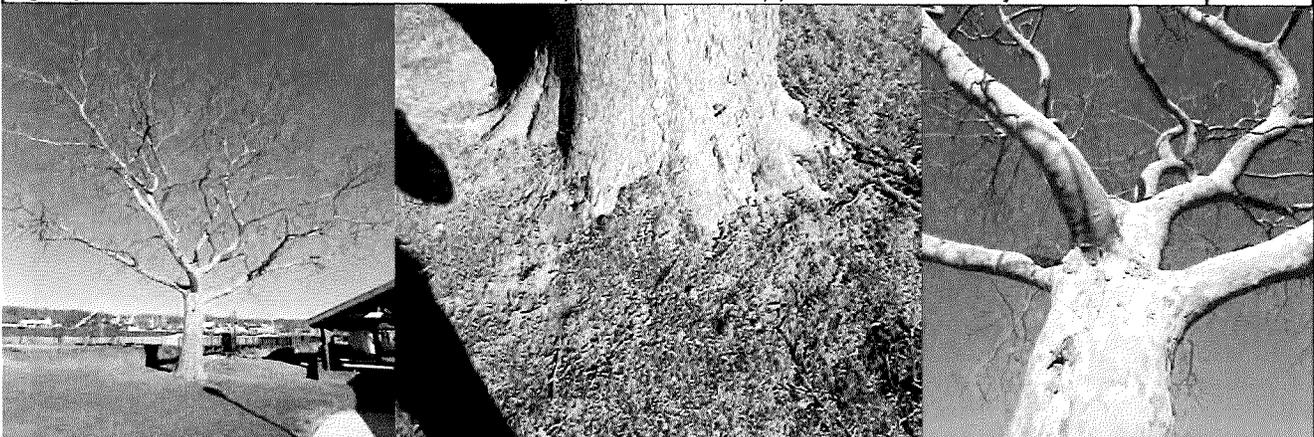
100 Crosswicks Park Drive West Ste. 104 Woodbury, New York 11797		P: 516 364 0661 F: 516 364 0668		www.dmaherassociates.com		Assignment:	Tree No.:
						2	80
<b>ADDITIONAL ASSESSMENT REPORT</b>				Location: North Hempstead Beach Park - Port Washington, NY		Date: 2/26/2016	
Inspector: Dan Maher				Weather: Partly Sunny		Lat/Long: N 40° 49' 41.51" W 73° 39' 16.43"	
Specimen:		Common Name: LONDON PLANETREE		Scientific name: Platanus x acerifolia			
<b>Descriptor</b>		<b>Value</b>		<b>Range</b>			
Girth		23"		Trunk Diameter Measured at Breast Height (DBH)			
Approx. Height		40'-45'		Approximate Height to top of Canopy			
Canopy		N 13', S 16', E 14', W 13'		Canopy Radius in Feet - North South East West			
Condition		5		Health of Specimen - 1 Dead - 2 Declining - 3 Moderate - 4 Good - 5 Excellent			
Approx. Age		E		NP=Newly Planted Within 5yrs M=Moderate 10-20 yrs old E=Existing before development			
<b>Tree/Root Base/Pit</b>		Growing in grass area, mechanical damage on exposed roots and at base from landscape maintenance.

<b>Trunk Condition and Main Scaffold Branches</b>		Codominant leaders, Moss and lichen growth on trunk.					
<b>Crown/Structure, Branches &amp; Leaves</b>		Good crown structure, good fruiting, tree was not assessed during full leaf.					
<b>Pest / Disease</b>		Moss and lichen growth on trunk.					
<b>Setting</b>		Far east end of park, west of concession building near picnic pavilions.					
<b>Character</b>		Y		Does the tree make an important contribution to the character or amenity of the area?			
<b>Habitat</b>		Indigenous		Is the tree indigenous, rare, endangered, invasive or exotic?			
<b>Habitat</b>		N		Does the tree represent important habitat for native fauna?			
<b>Habitat</b>		N		Is the tree part of a wildlife Corridor, Buffer, etc?			
<b>Notes:</b> Tree is in excellent condition and shows no signs of major damage.							
<b>Recommendations:</b> It is recommended to implement a program that continues to monitor this tree by an ISA Arborist. For recommended treatment, form a mulch collar around the base of the tree that will prevent any future damage caused by landscape maintenance and provide additional benefits to the tree. Vertical mulching is recommended for mitigation, this is a technique that benefits stressed trees by improving the movement of water, air, and nutrients in the root zone and should be performed by a qualified tree care professional. The Town should implement a comprehensive program of tree management including soil testing.							<b>Level of Urgency</b>

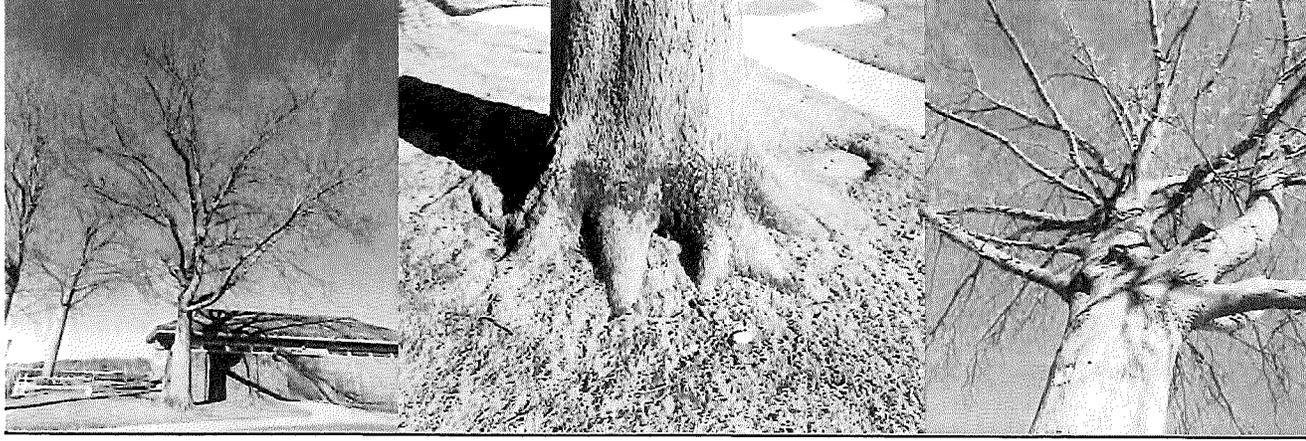
Descriptor	Value	Range
Girth	30"	Trunk Diameter Measured at Breast Height (DBH)
Approx. Height	50'-55'	Approximate Height to top of Canopy
Canopy	N 22',S 20',E 12',W 16'	Canopy Radius in Feet - North South East West
Condition	4	Health of Specimen - 1 Dead - 2 Declining - 3 Moderate - 4 Good - 5 Excellent
Approx. Age	E	NP=Newly Planted Within 5yrs M=Moderate 10-20 yrs old E=Existing before development

Tree/Root Base/Pit	Growing in grass area.
Trunk Condition and Main Scaffold Branches	Dead scaffold branches.
Crown/Structure, Branches & Leaves	Good crown structure, dead and broken branches, minor gouty and horned oak galls growing on small branches, tree was not assessed during full leaf.
Pest / Disease	gouty and horned oak galls growing on small branches.
Setting	East end of park, near bathrooms building.

**Recommendations:**  
 It is recommended to implement a program that continues to monitor this tree by an ISA Arborist. For recommended treatment, proper corrective pruning that follows ANSI A300 standards should be performed to remove dead and damaged branches. Additionally, it is recommended to form a mulch collar around the base of the tree that will prevent any future damage caused by landscape maintenance and provide additional benefits to the tree. Vertical mulching is recommended for mitigation, this is a technique that benefits stressed trees by improving the movement of water, air, and nutrients in the root zone and should be performed by a qualified tree care professional. The Town should implement a comprehensive program of tree management including soil testing.

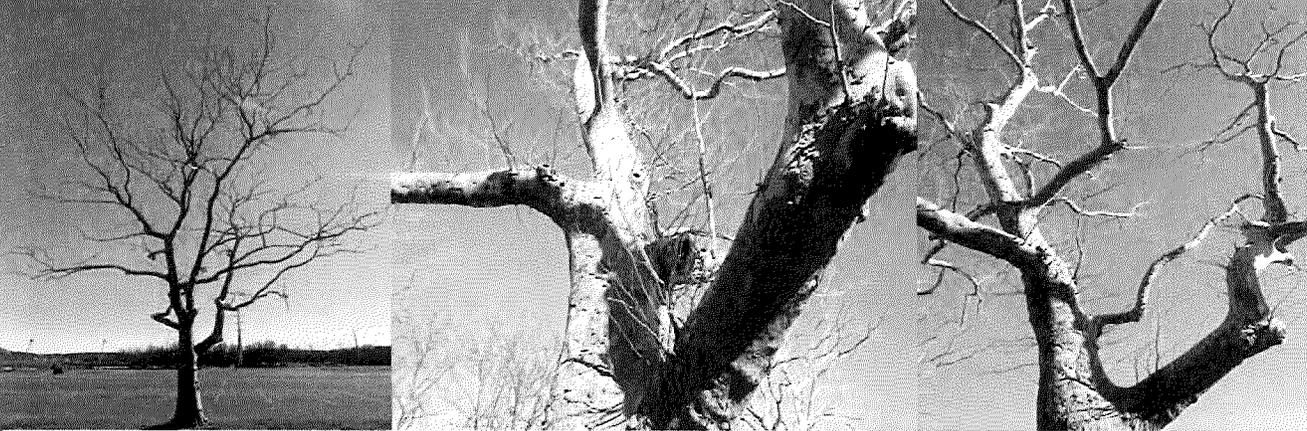
Tree/Root Base/Pit		Growing in grass area, mechanical damage at base from landscape maintenance.							
Trunk Condition and Main Scaffold Branches		Codominant leaders, discoloration on trunk and scaffold branches, majority of leaders and scaffold branches are dead.							
Crown/Structure, Branches & Leaves		Major dead branches, poor fruiting, tree was not assessed during full leaf.							
Pest / Disease		No noticeable signs.							
Setting		East end of park, near bathroom building along parking lot.							
Character		Y		Does the tree make an important contribution to the character or amenity of the area?					
		Indigenous		Is the tree indigenous, rare, endangered, invasive or exotic?					
Habitat		N		Does the tree represent important habitat for native fauna?					
		N		Is the tree part of a wildlife Corridor, Buffer, etc?					
Notes: The trunk and more than 2/3 of the crown is partially or entirely dead, dead scaffold branches hanging above walkway.

Recommendations: Remove tree due to current hazardous condition and anticipated decline. For tree replacement it is recommended to use XXX. Replacements should be planted immediately following removals and it is recommended to form a mulch collar around the base of the tree that will prevent any future damage caused by landscape maintenance and provide additional benefits to the tree. The Town should implement a comprehensive program of tree management including soil testing.								Level of Urgency	
								1	
Urgency Level: 1 - Requires Immediate Attention 2 - Within (1) Month 3 - Within (6) Months 4 - Within the year 5 - None

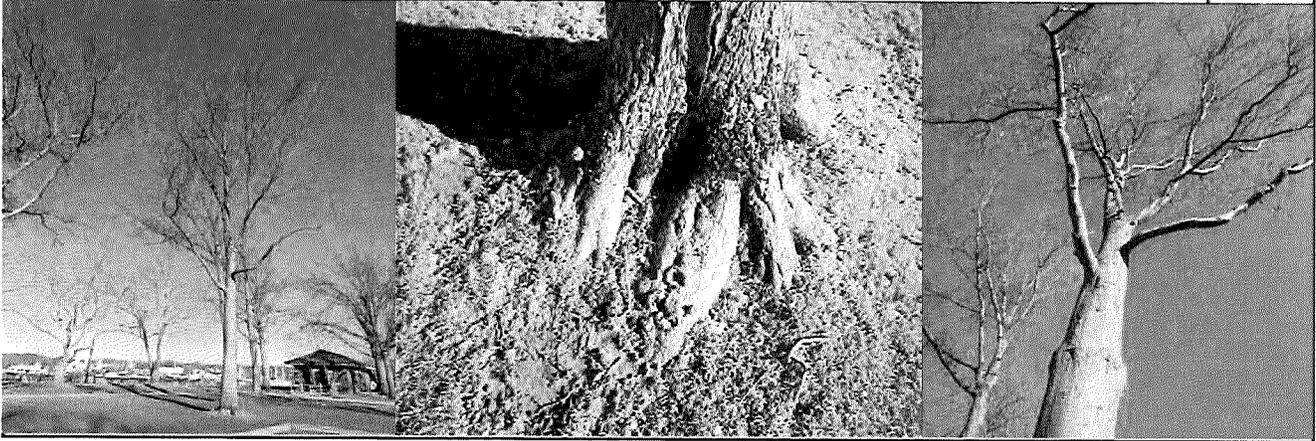
<b>Tree/Root Base/Pit</b>		Growing in grass area, mechanical damage at base from landscape maintenance.							
<b>Trunk Condition and Main Scaffold Branches</b>		Moss and lichen growth on trunk, water sprouting on scaffold branches.							
<b>Crown/Structure, Branches &amp; Leaves</b>		Uneven crown, minor dead branches, no evidence of gouty and horned oak galls growing on small branches, tree was not assessed during full leaf.							
<b>Pest / Disease</b>		Moss and lichen growth on trunk.							
<b>Setting</b>		East end of park, between the bathrooms building and basketball courts.							
<b>Character</b>		Y		<i>Does the tree make an important contribution to the character or amenity of the area?</i>					
		Indigenous		<i>Is the tree indigenous, rare, endangered, invasive or exotic?</i>					
<b>Habitat</b>		N		<i>Does the tree represent important habitat for native fauna?</i>					
		N		<i>Is the tree part of a wildlife Corridor, Buffer, etc?</i>

<b>Notes:</b> Evidence of major scaffold branch removal on northeast side of crown.									
<b>Recommendations:</b> It is recommended to implement a program that continues to monitor this tree by an ISA Arborist and if condition continues to decline, consider removal. For recommended treatment, proper corrective pruning that follows ANSI A300 standards should be performed to remove dead and damaged branches. Additionally, it is recommended to form a mulch collar around the base of the tree that will prevent any future damage caused by landscape maintenance and provide additional benefits to the tree. Vertical mulching is recommended for mitigation, this is a technique that benefits stressed trees by improving the movement of water, air, and nutrients in the root zone and should be performed by a qualified tree care professional. The Town should implement a comprehensive program of tree management including soil testing.								<b>Level of Urgency</b>

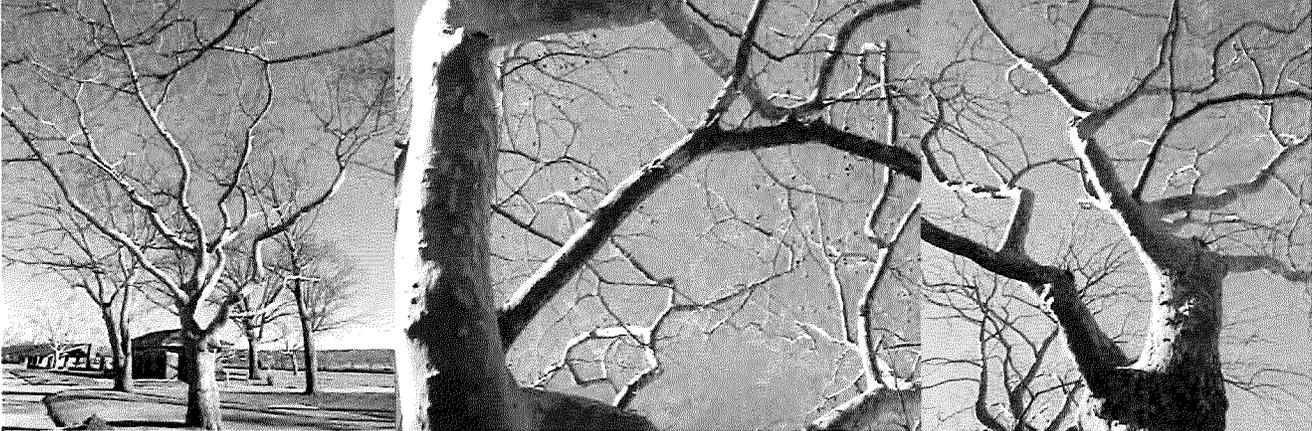
Tree/Root Base/Pit		Growing in grass area, mechanical damage at base from landscape maintenance.							
Trunk Condition and Main Scaffold Branches		Codominant leaders, moss and lichen growth on trunk, partially dead scaffold branches.							
Crown/Structure, Branches & Leaves		Dead branches, moderate fruiting, tree was not assessed during full leaf.							
Pest / Disease		Moss and lichen growth on trunk.							
Setting		East end of park, near bathrooms building and beach promenade.							
Character		Y		Does the tree make an important contribution to the character or amenity of the area?					
		Indigenous		Is the tree indigenous, rare, endangered, invasive or exotic?					
Habitat		N		Does the tree represent important habitat for native fauna?					
		N		Is the tree part of a wildlife Corridor, Buffer, etc?					
Notes: Partially dead scaffold branch directly above shuffleboard court.									
Recommendations: It is recommended to implement a program that continues to monitor this tree by an ISA Arborist and if condition continues to decline, consider removal. For recommended treatment, proper corrective pruning that follows ANSI A300 standards should be performed to remove dead and damaged branches. Additionally, it is recommended to form a mulch collar around the base of the tree that will prevent any future damage caused by landscape maintenance and provide additional benefits to the tree. Vertical mulching is recommended for mitigation, this is a technique that benefits stressed trees by improving the movement of water, air, and nutrients in the root zone and should be performed by a qualified tree care professional. The Town should implement a comprehensive program of tree management including soil testing.								Level of Urgency

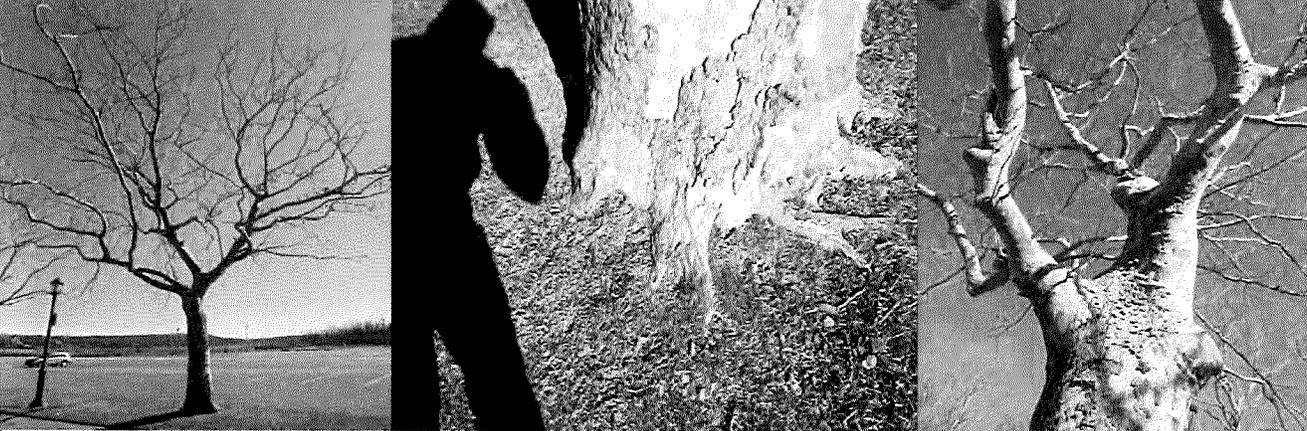
Tree/Root Base/Pit		Growing in grass area, mechanical damage at base from landscape maintenance.							
Trunk Condition and Main Scaffold Branches		Codominant leaders, discoloration on trunk and scaffold branches, major water sprouting on trunk and scaffold branches, multiple scaffold branches are dead.							
Crown/Structure, Branches & Leaves		Major dead branches, moderate fruiting, tree was not assessed during full leaf.							
Pest / Disease		No noticeable signs.							
Setting		East end of park, near bathroom building along parking lot.							
Character		Y		Does the tree make an important contribution to the character or amenity of the area?					
		Indigenous		Is the tree indigenous, rare, endangered, invasive or exotic?					
Habitat		N		Does the tree represent important habitat for native fauna?					
		N		Is the tree part of a wildlife Corridor, Buffer, etc?					
Notes: More than 1/3 of the crown is partially or entirely dead, dead scaffold branches hanging above walkway.

Recommendations: Remove tree due to current hazardous condition and anticipated decline. For tree replacement it is recommended to use XXX. Replacements should be planted immediately following removals and it is recommended to form a mulch collar around the base of the tree that will prevent any future damage caused by landscape maintenance and provide additional benefits to the tree. The Town should implement a comprehensive program of tree management including soil testing.								Level of Urgency	
								1	
Urgency Level: 1 - Requires Immediate Attention 2 - Within (1) Month 3 - Within (6) Months 4 - Within the year 5 - None

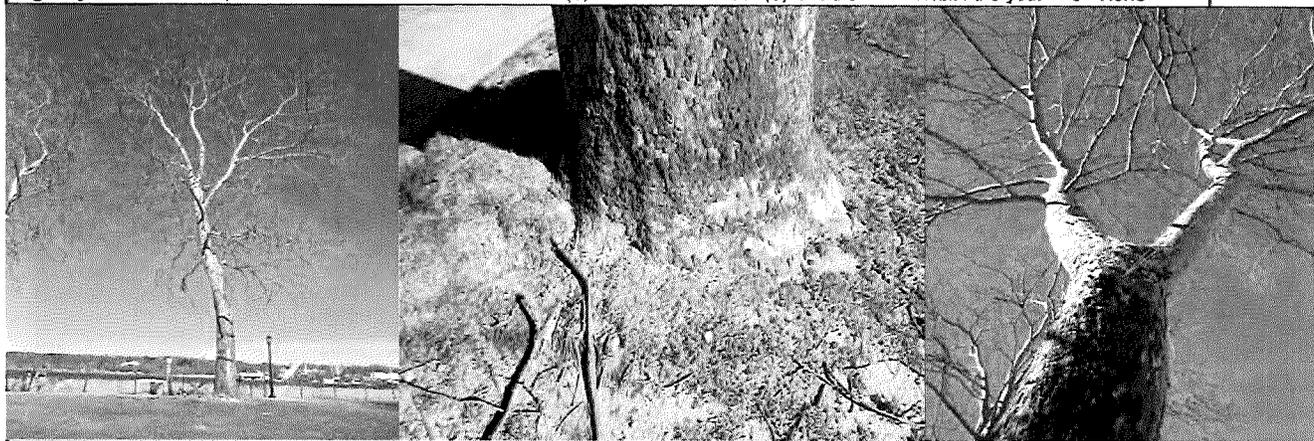
Trunk Condition and Main Scaffold Branches		Codominant leaders, moss and lichen growth on trunk.							
Crown/Structure, Branches & Leaves		Dead and broken branches hanging in crown, good fruiting, tree was not assessed during full leaf.							
Pest / Disease		Moss and lichen growth on trunk.							
Setting		East end of park, near basketball courts and beach promenade.							
Character		Y		Does the tree make an important contribution to the character or amenity of the area?					
		Indigenous		Is the tree indigenous, rare, endangered, invasive or exotic?					
Habitat		N		Does the tree represent important habitat for native fauna?					
		N		Is the tree part of a wildlife Corridor, Buffer, etc?					
Notes: Hanging branches directly above beach promenade.									
Recommendations: It is recommended to implement a program that continues to monitor this tree by an ISA Arborist and if condition continues to decline, consider removal. For recommended treatment, proper corrective pruning that follows ANSI A300 standards should be performed to remove dead and damaged branches. Additionally, it is recommended to form a mulch collar around the base of the tree that will prevent any future damage caused by landscape maintenance and provide additional benefits to the tree. Vertical mulching is recommended for mitigation, this is a technique that benefits stressed trees by improving the movement of water, air, and nutrients in the root zone and should be performed by a qualified tree care professional. The Town should implement a comprehensive program of tree management including soil testing.								Level of Urgency

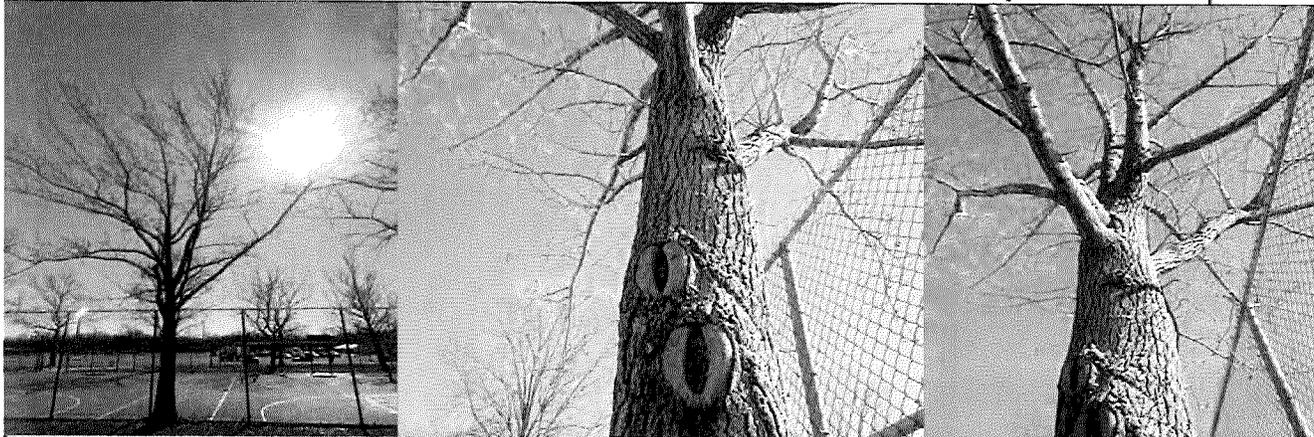
Tree/Root Base/Pit		Growing in grass area, mechanical damage at base and to exposed roots from landscape maintenance, girdling roots.							
Trunk Condition and Main Scaffold Branches		Moss and lichen growth on trunk, minor trunk wounds from removed scaffold branches have not entirely healed.							
Crown/Structure, Branches & Leaves		Minor dead branches, good fruiting, tree was not assessed during full leaf.							
Pest / Disease		Moss and lichen growth on trunk.							
Setting		East end of park, near basketball courts.							
Character		Y		Does the tree make an important contribution to the character or amenity of the area?					
		Indigenous		Is the tree indigenous, rare, endangered, invasive or exotic?					
Habitat		N		Does the tree represent important habitat for native fauna?					
		N		Is the tree part of a wildlife Corridor, Buffer, etc?					
<b>Notes:</b> Tunk is two feet away from basketball court chain link fence, half of tree crown hangs over courts.

<b>Recommendations:</b> It is recommended to implement a program that continues to monitor this tree by an ISA Arborist. For recommended treatment, form a mulch collar around the base of the tree that will prevent any future damage caused by landscape maintenance and provide additional benefits to the tree. Vertical mulching is recommended for mitigation, this is a technique that benefits stressed trees by improving the movement of water, air, and nutrients in the root zone and should be performed by a qualified tree care professional. The Town should implement a comprehensive program of tree management including soil testing.								Level of Urgency	
								<b>1</b>	
Urgency Level: 1 - Requires Immediate Attention 2 - Within (1) Month 3 - Within (6) Months 4 - Within the year 5 - None

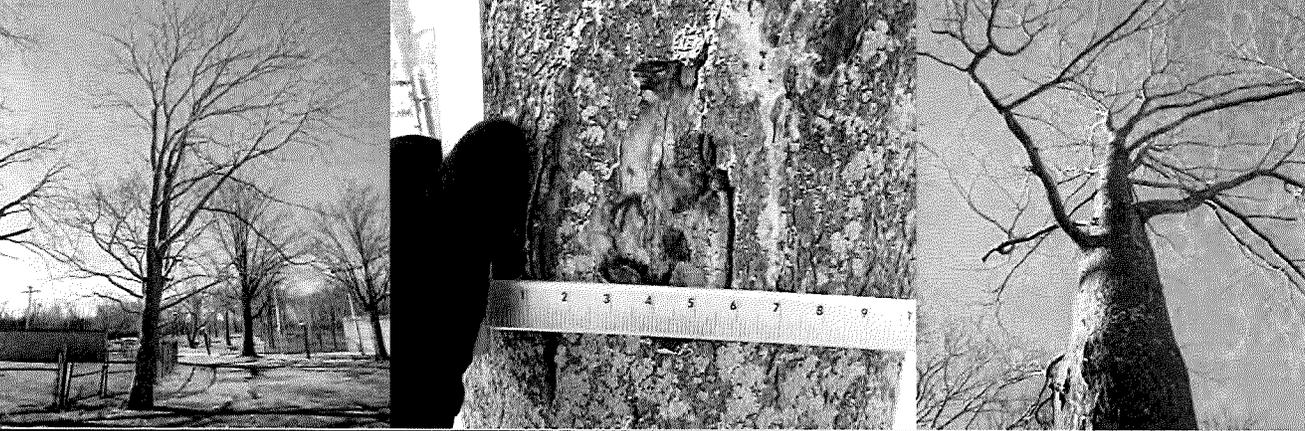
<b>Canopy</b>		N 19',S 7',E 14',W 12'		<i>Canopy Radius in Feet - North South East West</i>					
<b>Condition</b>		4		<i>Health of Specimen - 1 Dead - 2 Declining - 3 Moderate - 4 Good - 5 Excellent</i>					
<b>Approx. Age</b>		E		<i>NP=Newly Planted Within 5yrs M=Moderate 10-20 yrs old E=Existing before development</i>					
<b>Tree/Root Base/Pit</b>		Growing in grass area, mechanical damage at base from landscape maintenance.							
<b>Trunk Condition and Main Scaffold Branches</b>		Codominant leaders, moss and lichen growth on trunk and scaffold branches, trunk damage, evidence of insect activity underneath shedding bark.							
<b>Crown/Structure, Branches &amp; Leaves</b>		Uneven crown, tree was not assessed during full leaf.							
<b>Pest / Disease</b>		Moss and lichen growth on trunk, evidence of insect activity.							
<b>Setting</b>		East end of park, between basketball courts and handball courts.

<b>Character</b>		Y		<i>Does the tree make an important contribution to the character or amenity of the area?</i>					
<b>Habitat</b>		Indigenous		<i>Is the tree indigenous, rare, endangered, invasive or exotic?</i>					
		N		<i>Does the tree represent important habitat for native fauna?</i>					
		N		<i>Is the tree part of a wildlife Corridor, Buffer, etc?</i>					
<b>Notes:</b> Evidence of multiple fallen lower scaffold branches. White sap leaking from trunk wounds and site of insect damage.									
<b>Recommendations:</b> It is recommended to implement a program that continues to monitor this tree by an ISA Arborist. The Town should implement a comprehensive program of tree management including soil testing.								<b>Level of Urgency</b>	
<b>Urgency Level:</b> 1 - Requires Immediate Attention 2 - Within (1) Month 3 - Within (6) Months 4 - Within the year 5 - None								3

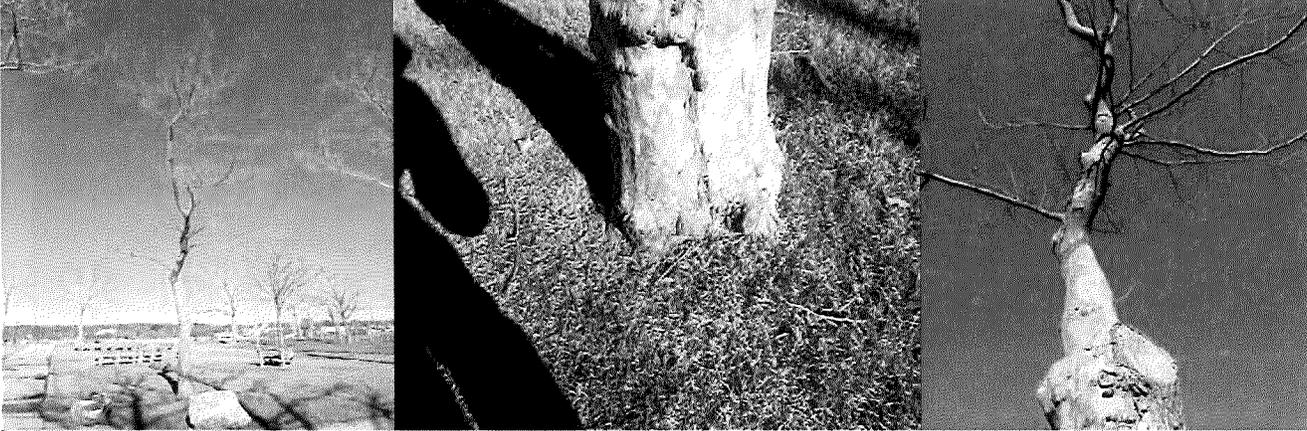
Trunk Condition and Main Scaffold Branches		Moss and lichen growth on trunk, water sprouting on scaffold branches, major leader and scaffold branches have been removed and has not entirely healed causing wood rot.							
Crown/Structure, Branches & Leaves		Thin and uneven crown, poor fruiting only at the top of the crown, tree was not assessed during full leaf.							
Pest / Disease		Moss and lichen growth on trunk.							
Setting		East end of park, between basketball courts and handball courts.							
Character		Y		Does the tree make an important contribution to the character or amenity of the area?					
		Indigenous		Is the tree indigenous, rare, endangered, invasive or exotic?					
Habitat		N		Does the tree represent important habitat for native fauna?					
		N		Is the tree part of a wildlife Corridor, Buffer, etc?					
<b>Notes:</b> Tree exhibits heavy pruning of a large number of lower branches and inner branches resulting in "Lion's-tailing" appearance which increases the risk of branch failure by weakening tree roots and decreasing the dampening effect that interior limbs provide during storms. According to Town employees, multiple trees to the north had fallen or were removed following Hurricane Sandy, exposing the remaining trees to additional wind exposure. Broken limbs remain on the north side of the crown and will not properly heal unless pruned correctly

<b>Recommendations:</b> Remove tree due to current condition and anticipated decline. For tree replacement it is recommended to use XXX. Replacements should be planted immediately following removals and it is recommended to form a mulch collar around the base of the tree that will prevent any future damage caused by landscape maintenance and provide additional benefits to the tree. The Town should implement a comprehensive program of tree management including soil testing.								Level of Urgency	
								1	
<b>Urgency Level:</b> 1 - Requires Immediate Attention 2 - Within (1) Month 3 - Within (6) Months 4 - Within the year 5 - None
