DRAFT REPORT

100 Crossways Park Drive West, Ste 10A Woodbury, New York 11797		T 516 363 0661 F 516 363 0663		www.obayerassociates.com		Assignment:	Tree No.:
				2	122		
Arborist Assessment Report			Location: North Hempstead Beach Park - Port Washington, NY			Date: 3/2/2016	
Inspector: Dan Maher			Weather: Partly Sunny		Lat/Long: N 40° 49' 41.46" W 73° 39' 21.55"		Time: 13:28
Specimen:		Common Name: LONDON PLANETREE		Scientific name: Platanus x acerifolia			
Descriptor		Value		Range			
Girth		23"		Trunk Diameter Measured at Breast Height (DBH)			
Approx. Height		35'-40'		Approximate Height to top of Canopy			
Canopy		N 15', S 10', E 13', W 11'		Canopy Radius in Feet - North South East West			
Condition		3		Health of Specimen - 1 Dead - 2 Declining - 3 Moderate - 4 Good - 5 Excellent			
Approx. Age		E		NP=Newly Planted Within 5yrs M=Moderate 10-20 yrs old E=Existing before development			
Tree/Root Base/Pit		Growing in grass area, mechanical damage at base and on exposed roots from landscape maintenance.

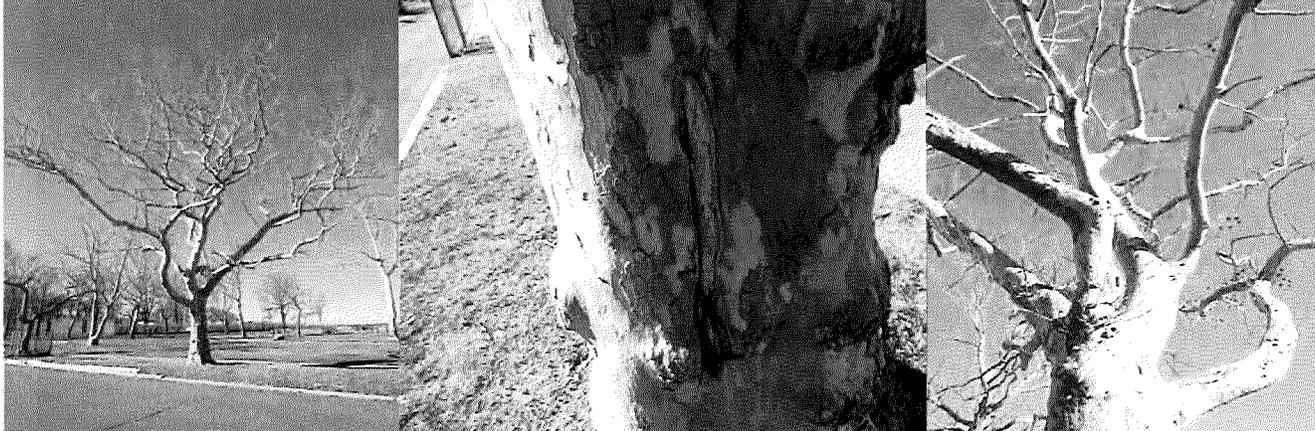
100 Crossways Park Drive West Ste 100 Woodbury New York 11797	Tel: 516 364 0660 Fax: 516 364 0668	www.danmaherassociates.com	Assignment: 2	Tree No.: 125
Arborist Assessment Report		Location: North Hempstead Beach Park - Port Washington, NY			Date: 3/2/2016	
Inspector: Dan Maher		Weather: Partly Sunny	Lat/Long: N 40° 49' 41.4" W 73° 39' 22.99"		Time: 13:49	
Specimen:	Common Name: LONDON PLANETREE		Scientific name: Platanus x acerifolia			
Descriptor	Value	Range				
Girth	24"	Trunk Diameter Measured at Breast Height (DBH)				
Approx. Height	35'-40'	Approximate Height to top of Canopy				
Canopy	N 20',S 19',E 17',W 16'	Canopy Radius in Feet - North South East West				
Condition	2	Health of Specimen - 1 Dead - 2 Declining - 3 Moderate - 4 Good - 5 Excellent				
Approx. Age	E	NP=Newly Planted Within 5yrs M=Moderate 10-20 yrs old E=Existing before development				
Tree/Root Base/Pit						
Growing in grass area, mechanical damage at base from landscape maintenance.

Trunk Condition and Main Scaffold Branches						
Discoloration on trunk and scaffold branches, entire tree is dead besides one scaffold branch, major water sprouting on the scaffold branches that are still alive.						
Crown/Structure, Branches & Leaves						
Major dead branches, poor fruiting, tree was not assessed during full leaf.						
Pest / Disease						
No noticeable signs.						
Setting						
East end of park, near basketball courts, along parking lot.						
Character						
Y Does the tree make an important contribution to the character or amenity of the area?						
Indigenous Is the tree indigenous, rare, endangered, invasive or exotic?						
Habitat						
N Does the tree represent important habitat for native fauna?						
N Is the tree part of a wildlife Corridor, Buffer, etc?						
Notes:						
More than 2/3 of the crown is partially or entirely dead, dead scaffold branches hanging above walkway and parking lot.

Recommendations:						Level of Urgency
Remove tree due to current condition and anticipated decline. For tree replacement it is recommended to use XXX. Replacements should be planted immediately following removals and it is recommended to form a mulch collar around the base of the tree that will prevent any future damage caused by landscape maintenance and provide additional benefits to the tree. The Town should implement a comprehensive program of tree management including soil testing.						
Urgency Level: 1 - Requires Immediate Attention 2 - Within (1) Month 3 - Within (6) Months 4 - Within the year 5 - None						1

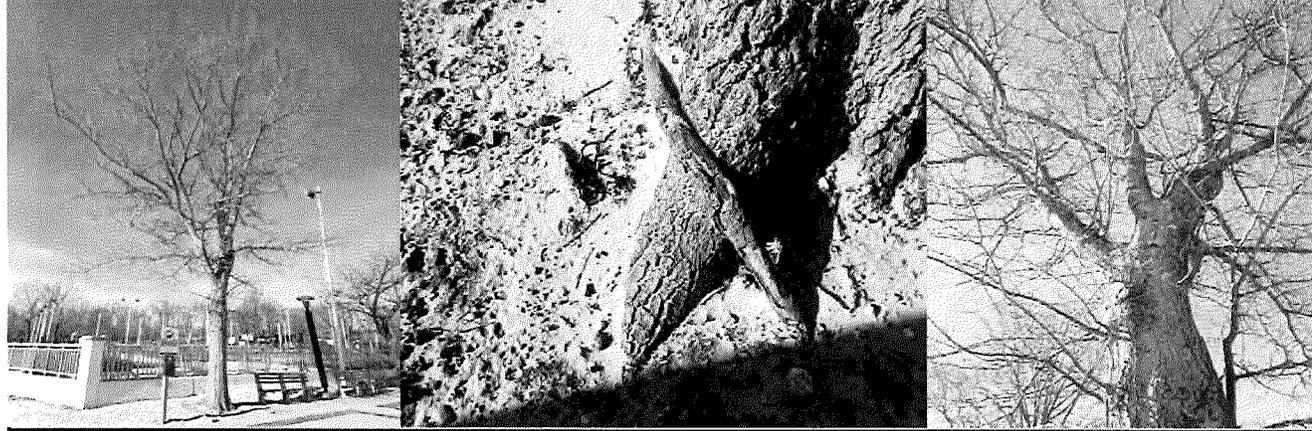
Trunk Condition and Main Scaffold Branches	Moss and lichen growth on trunk, trunk wound from removed scaffold branches has not entirely healed.
--	--

Crown/Structure, Branches & Leaves	Good crown structure, minor dead branches, broken branches hanging in crown, low branches, tree was not assessed during full leaf.
------------------------------------	--

<p>Recommendations: It is recommended to implement a program that continues to monitor this tree by an ISA Arborist. For recommended treatment, proper corrective pruning that follows ANSI A300 standards should be performed to remove dead and damaged branches. Additionally, it is recommended to remove the sand within the tree pit using pneumatic methods if possible and replace it with mulch that will provide additional benefits to the tree. The Town should implement a comprehensive program of tree management including soil testing.</p>	Level of Urgency 2
---	--

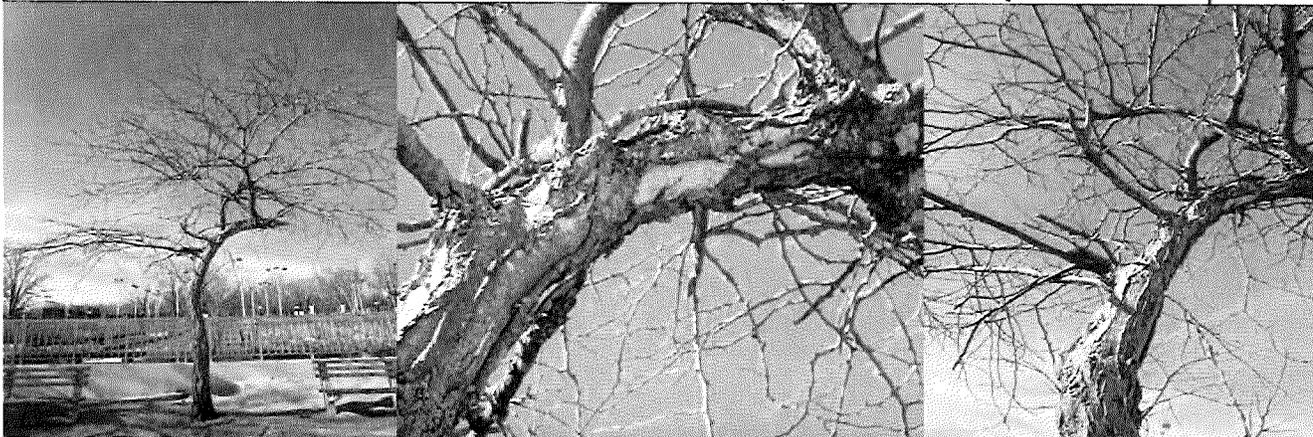
Trunk Condition and Main Scaffold Branches		Moss and lichen growth on trunk, poor central leader structure, minor dead scaffold branch.							
Crown/Structure, Branches & Leaves		Minor dead branches, tree was not assessed during full leaf.							
Pest / Disease		Moss and lichen growth on trunk.							
Setting		Along beach promenade, exposed to high winds.							
Character		Y		Does the tree make an important contribution to the character or amenity of the area?					
		Invasive		Is the tree indigenous, rare, endangered, invasive or exotic?					
Habitat		N		Does the tree represent important habitat for native fauna?					
		N		Is the tree part of a wildlife Corridor, Buffer, etc?					
Notes: Sand has been building up against the wall behind the tree and is covering the tree pit.									
Recommendations: It is recommended to implement a program that continues to monitor this tree by an ISA Arborist. For recommended treatment, is to remove the sand within the tree pit using pneumatic methods if possible and replace it with mulch that will provide additional benefits to the tree. The Town should implement a comprehensive program of tree management including soil testing.								Level of Urgency

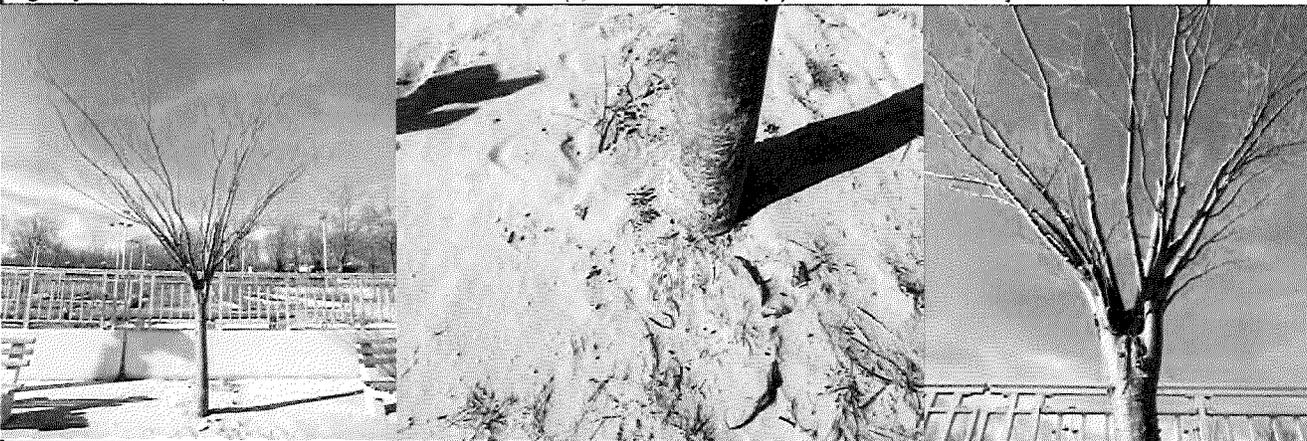
Growing in a 5' wide concrete tree pit, buried root collar.						
Trunk Condition and Main Scaffold Branches						
Minor moss and lichen growth on trunk, included bark at scaffold unions, recently pruned scaffold branches.						
Crown/Structure, Branches & Leaves						
Thin crown from pruning, good bud condition on small branches, tree was not assessed during full leaf.						
Pest / Disease						
Moss and lichen growth on trunk.						
Setting						
Along beach promenade, exposed to high winds.						
Character						
	Y	<i>Does the tree make an important contribution to the character or amenity of the area?</i>				
	Exotic	<i>Is the tree indigenous, rare, endangered, invasive or exotic?</i>				
Habitat						
	N	<i>Does the tree represent important habitat for native fauna?</i>				
	N	<i>Is the tree part of a wildlife Corridor, Buffer, etc?</i>				
Notes:						
Evidence of heavy pruning to the crown after Hurricane Sandy. Sand has been building up against the wall behind the tree and is covering the tree pit.

Recommendations:						Level of Urgency
It is recommended to implement a program that continues to monitor this tree by an ISA Arborist and if condition continues to decline, consider removal. For recommended treatment, perform root crown excavation by a qualified tree care professional, which is a treatment that involves the removal of excess soil from a tree's root flare and main lateral roots. Additionally, it is recommended to remove the sand within the tree pit using pneumatic methods if possible and replace it with mulch that will provide additional benefits to the tree. The Town should implement a comprehensive program of tree management including soil testing.						
Urgency Level: 1 - Requires Immediate Attention 2 - Within (1) Month 3 - Within (6) Months 4 - Within the year 5 - None						3

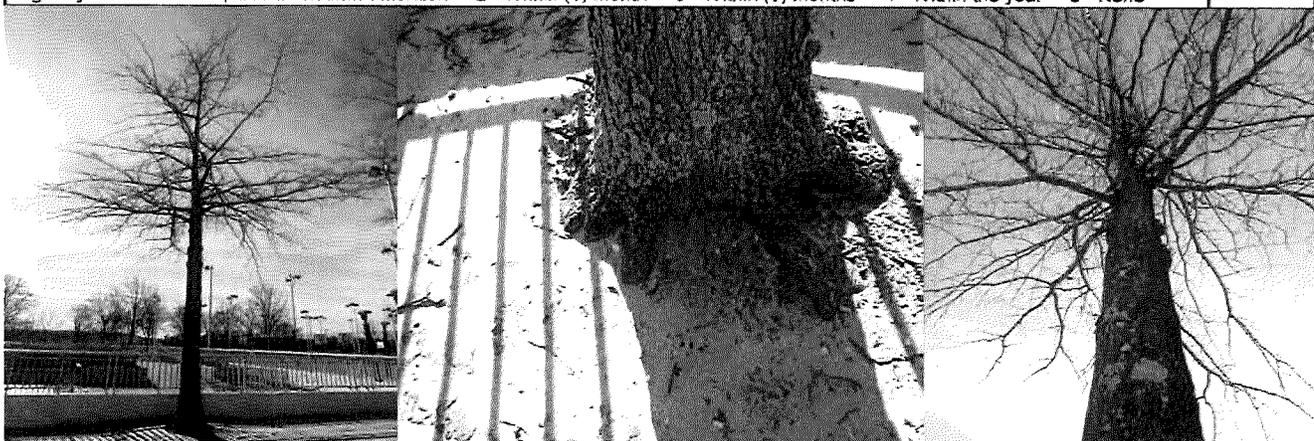
Crown/Structure, Branches & Leaves	Good crown structure, minor dead branches, minor broken branches hanging in crown, tree was not assessed during full leaf.		
Pest / Disease	Moss and lichen growth on trunk.		
Setting	Along beach promenade, exposed to high winds.		
Character	Y	Does the tree make an important contribution to the character or amenity of the area?	
	Indigenous	Is the tree indigenous, rare, endangered, invasive or exotic?	
Habitat	N	Does the tree represent important habitat for native fauna?	
	N	Is the tree part of a wildlife Corridor, Buffer, etc?	
Notes: Sand has been building up against the wall behind the tree and is covering the tree pit.			
Recommendations: It is recommended to implement a program that continues to monitor this tree by an ISA Arborist. For recommended treatment, proper corrective pruning that follows ANSI A300 standards should be performed to remove dead and damaged branches. The Town should implement a comprehensive program of tree management including soil testing.			Level of Urgency

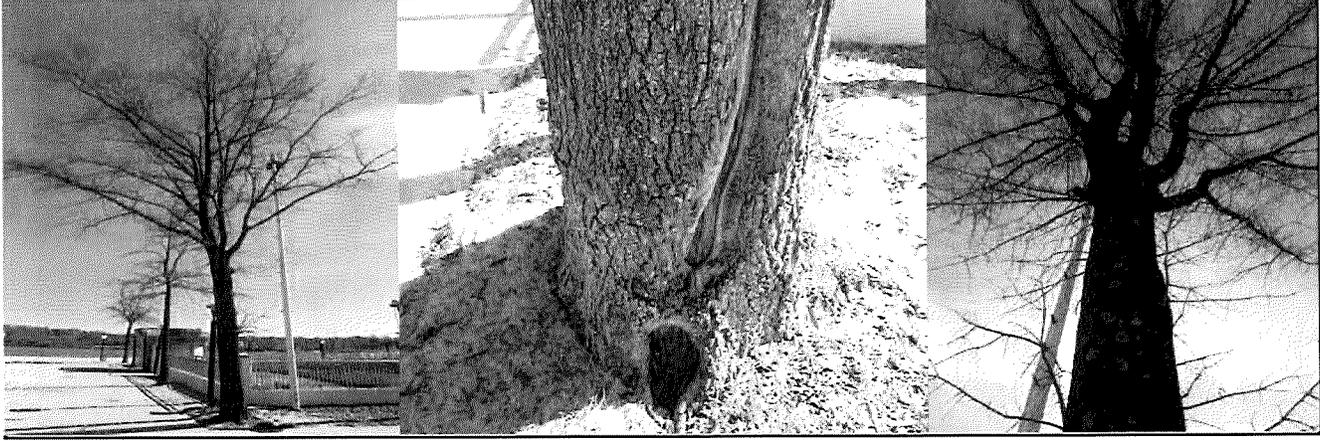
Tree/Root Base/Pit	Growing in grass area, basal damage from vehicle or landscape maintenance.
Trunk Condition and Main Scaffold Branches	Minor moss and lichen growth on trunk, trunk damage stemming from basal wound, water sprouting on trunk and scaffold branches.
Crown/Structure, Branches & Leaves	Good crown structure, broken branches hanging in crown, low branches forming from water sprouting, tree was not assessed during full leaf.
Pest / Disease	Moss and lichen growth on trunk.
Setting	Along beach promenade, exposed to high winds.

Notes:
Broken branches in crown are directly above walkway near volleyball court.

<p>Recommendations: It is recommended to implement a program that continues to monitor this tree by an ISA Arborist. For recommended treatment, proper corrective pruning that follows ANSI A300 standards should be performed to remove dead and damaged branches. The Town should implement a comprehensive program of tree management including soil testing.</p>	<p>Level of Urgency</p> <p style="text-align: center; font-size: 2em;">2</p>
---	--

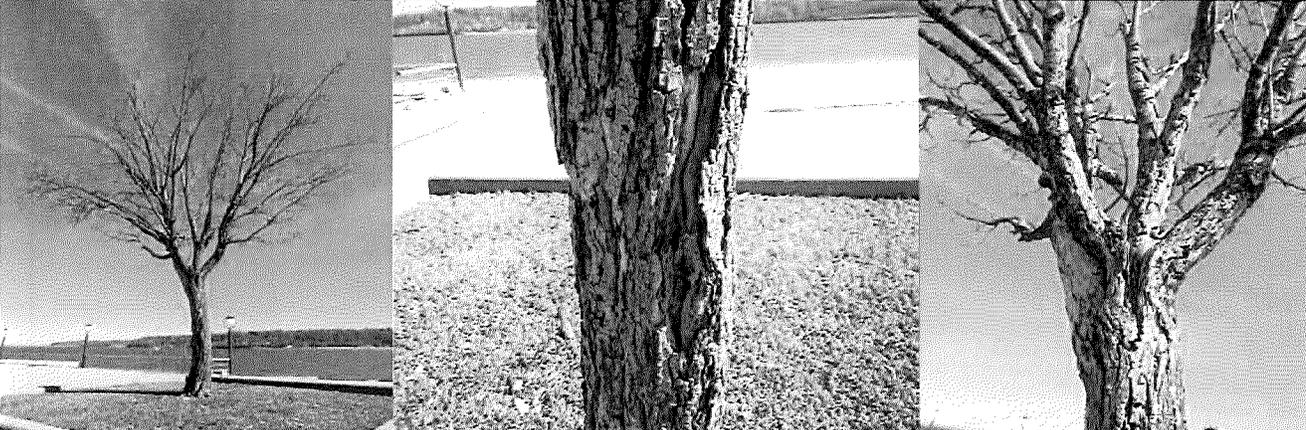
Tree/Root Base/Pit		Growing in a raised planter, grass growing in planter, major mechanical damage at base from landscape maintenance.							
Trunk Condition and Main Scaffold Branches		Codominant leaders, moss and lichen growth on trunk, major trunk damage and wood rot, major dead scaffold branches.							
Crown/Structure, Branches & Leaves		Major dead branches, branch die-back on outer branches, tree was not assessed during full leaf.							
Pest / Disease		Moss and lichen growth on trunk.							
Setting		Along beach promenade in raised planter, exposed to high winds.							
Character		Y		<i>Does the tree make an important contribution to the character or amenity of the area?</i>					
		Indigenous		<i>Is the tree indigenous, rare, endangered, invasive or exotic?</i>					
Habitat		N		<i>Does the tree represent important habitat for native fauna?</i>					
		N		<i>Is the tree part of a wildlife Corridor, Buffer, etc?</i>

Notes: Other trees in raised planters have similar issues, more than 2/3 of crown is dead, it is anticipated that this tree will continue to decline.									
Recommendations: Remove tree due to current condition and anticipated decline. For tree replacement it is recommended to use XXX. Replacements should be planted immediately following removals and it is recommended to form a mulch collar around the base of the tree that will prevent any future damage caused by landscape maintenance and provide additional benefits to the tree. The Town should implement a comprehensive program of tree management including soil testing.								Level of Urgency	
								1	
Urgency Level: 1 - Requires Immediate Attention 2 - Within (1) Month 3 - Within (6) Months 4 - Within the year 5 - None

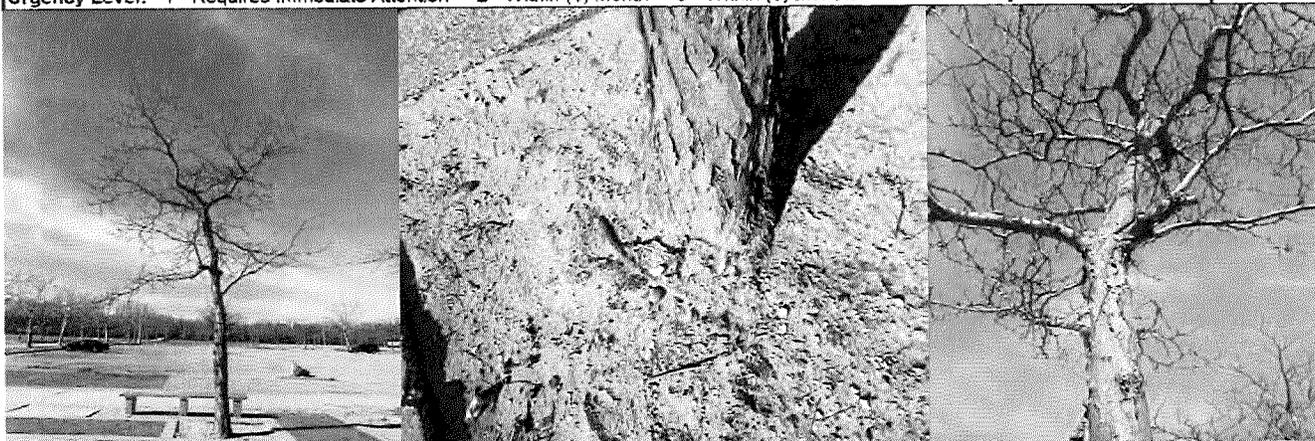
Trunk Condition and Main Scaffold Branches	Minor moss and lichen growth on trunk and scaffold branches, trunk scars from removed scaffold branches have not entirely healed.					
Crown/Structure, Branches & Leaves	Tree was not assessed during full leaf.					
Pest / Disease	Moss and lichen growth on trunk.					
Setting	Along beach promenade in tree pits, exposed to high winds.					
Character	Y	Does the tree make an important contribution to the character or amenity of the area?				
Habitat	Indigenous	Is the tree indigenous, rare, endangered, invasive or exotic?				
	N	Does the tree represent important habitat for native fauna?				
	N	Is the tree part of a wildlife Corridor, Buffer, etc?				
Notes: Tree pit is filled with sand, benches directly below tree crown, a tree has been removed from another tree pit 5' away.						
Recommendations: It is recommended to implement a program that continues to monitor this tree by an ISA Arborist. For recommended treatment, remove the sand within the tree pit using pneumatic methods if possible and replace it with mulch that will provide additional benefits to the tree. The Town should implement a comprehensive program of tree management including soil testing.						Level of Urgency

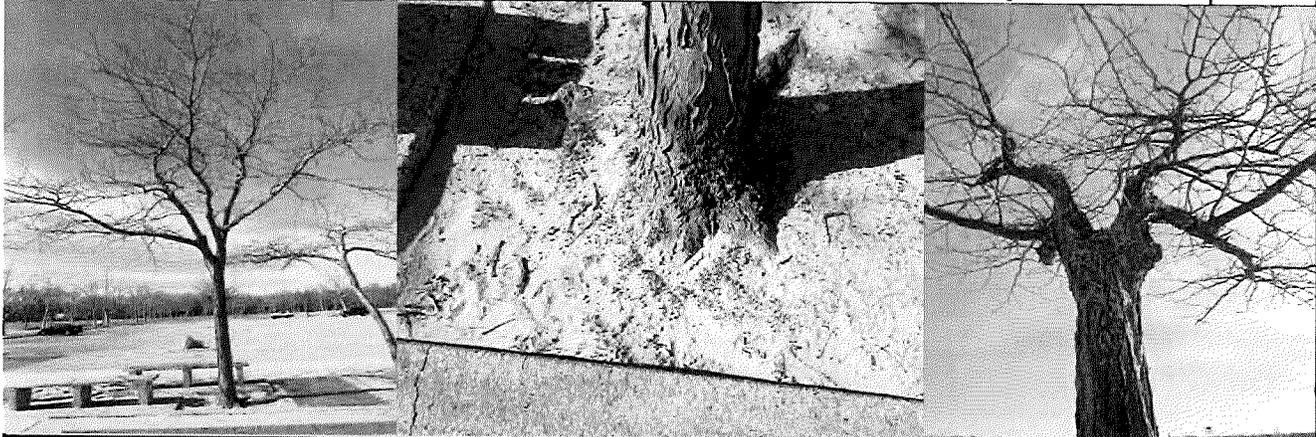
Trunk Condition and Main Scaffold Branches		Codominant leaders, included bark at trunk union, moss and lichen growth on trunk and scaffold branches, trunk scars from removed scaffold branches.							
Crown/Structure, Branches & Leaves		Tree was not assessed during full leaf.							
Pest / Disease		Moss and lichen growth on trunk.							
Setting		Along beach promenade in tree pits, exposed to high winds.							
Character		Y		Does the tree make an important contribution to the character or amenity of the area?					
		Indigenous		Is the tree indigenous, rare, endangered, invasive or exotic?					
Habitat		N		Does the tree represent important habitat for native fauna?					
		N		Is the tree part of a wildlife Corridor Buffer, etc?					
Notes: Tree pit is filled with sand, benches directly below tree crown, a tree has been removed from another tree pit 5' away.									
Recommendations: It is recommended to implement a program that continues to monitor this tree by an ISA Arborist. For recommended treatment, remove the sand within the tree pit using pneumatic methods if possible and replace it with mulch that will provide additional benefits to the tree. The Town should implement a comprehensive program of tree management including soil testing.								Level of Urgency

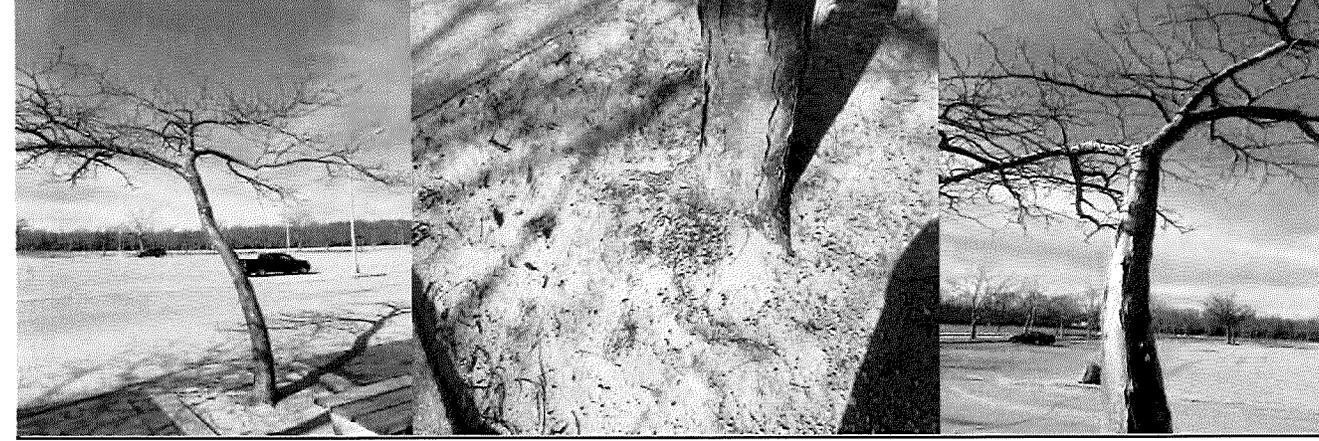
Trunk Condition and Main Scaffold Branches	Major trunk lean to the west, moss and lichen growth on trunk and scaffold branches, trunk damage, trunk scars from removed scaffold branches.
--	--

<p>Recommendations: It is recommended to implement a program that continues to monitor this tree by an ISA Arborist and If condition continues to decline, consider removal. For recommended treatment, remove the sand within the tree pit using pneumatic methods if possible and replace it with mulch that will provide additional benefits to the tree. The Town should implement a comprehensive program of tree management including soil testing.</p>	Level of Urgency
	3

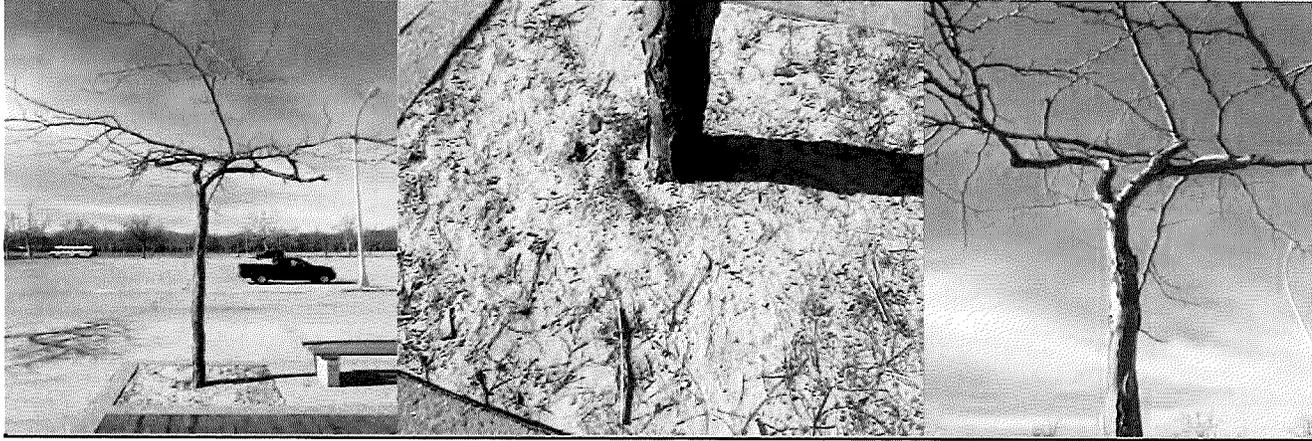
Tree/Root Base/Pit	Growing in a 5' wide concrete planter, buried root collar.
Trunk Condition and Main Scaffold Branches	Moss and lichen growth on trunk and scaffold branches, major trunk damage causing wood rot, evidence of insect activity on trunk, die-back on scaffold branches.
Crown/Structure, Branches & Leaves	Thin and poor crown structure, tree was not assessed during full leaf.
Pest / Disease	Moss and lichen growth on trunk, evidence of insect activity.
Setting	Along beach promenade in tree pits, exposed to high winds.

Recommendations: Remove tree due to current condition and anticipated decline. For tree replacement it is recommended to use XXX. Replacements should be planted immediately following removals and it is recommended to form a mulch collar around the base of the tree that will prevent any future damage caused by landscape maintenance and provide additional benefits to the tree. The Town should implement a comprehensive program of tree management including soil testing.	Level of Urgency 1
--	---------------------------

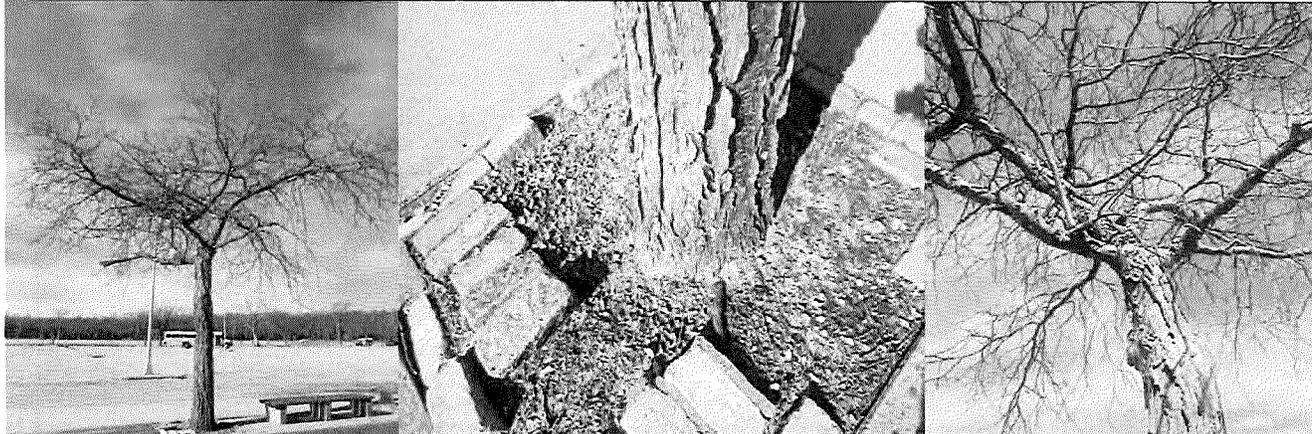
Trunk Condition and Main Scaffold Branches	Moss and lichen growth on trunk and scaffold branches, trunk scars from removed scaffold branches have not entirely healed.		
Crown/Structure, Branches & Leaves	Good crown structure, evidence of recent crown pruning, tree was not assessed during full leaf.		
Pest / Disease	Moss and lichen growth on trunk.		
Setting	Along beach promenade in tree pits, exposed to high winds.		
Character	Y	Does the tree make an important contribution to the character or amenity of the area?	
	Indigenous	Is the tree indigenous, rare, endangered, invasive or exotic?	
Habitat	N	Does the tree represent important habitat for native fauna?	
	N	Is the tree part of a wildlife Corridor, Buffer, etc?	
Notes: Mortared granite block pavers in tree pit, benches directly below tree crown, evidence of recent pruning to trunk and scaffold branches, tree removed from another tree pit 10' away.

Recommendations: It is recommended to implement a program that continues to monitor this tree by an ISA Arborist. The Town should implement a comprehensive program of tree management including soil testing.			Level of Urgency 3
Urgency Level: 1 - Requires Immediate Attention 2 - Within (1) Month 3 - Within (6) Months 4 - Within the year 5 - None

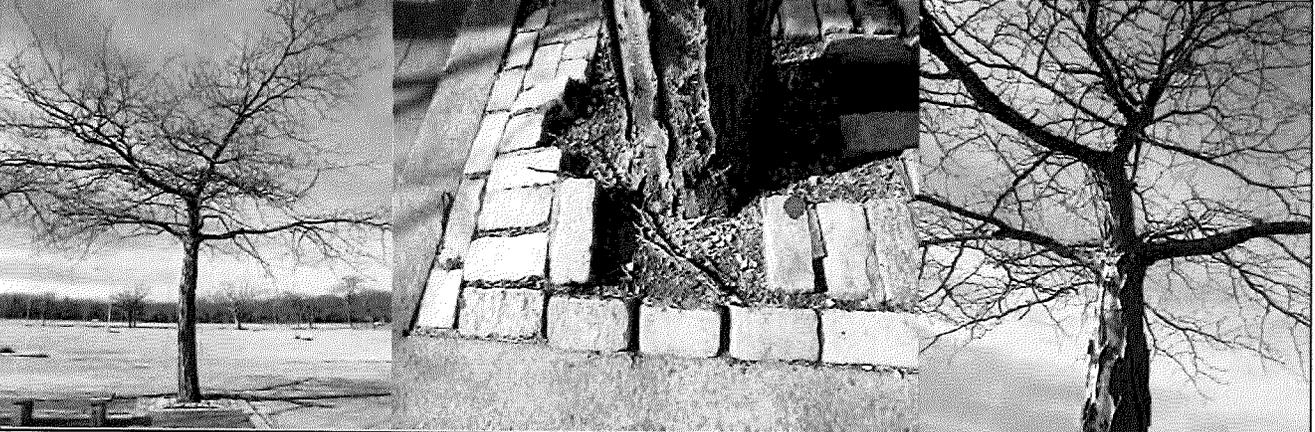
Trunk Condition and Main Scaffold Branches		Moss and lichen growth on trunk and scaffold branches, minor dead scaffold branch.							
Crown/Structure, Branches & Leaves		Very thin crown from pruning, tree was not assessed during full leaf.							
Pest / Disease		Moss and lichen growth on trunk.							
Setting		Along beach promenade in tree pits, exposed to high winds.							
Character		Y		Does the tree make an important contribution to the character or amenity of the area?					
		Indigenous		Is the tree indigenous, rare, endangered, invasive or exotic?					
Habitat		N		Does the tree represent important habitat for native fauna?					
		N		Is the tree part of a wildlife Corridor, Buffer, etc?					
Notes:									
Mortared granite block pavers in tree pit, benches directly below tree crown, evidence of pruning to trunk and scaffold branches.									
Recommendations:								Level of Urgency	
It is recommended to implement a program that continues to monitor this tree by an ISA Arborist and if condition continues to decline, consider removal. For recommended treatment, proper corrective pruning that follows ANSI A300 standards should be performed to remove dead and damaged branches. Additionally, it is recommended to remove the sand within the tree pit using pneumatic methods if possible and replace it with mulch that will provide additional benefits to the tree. The Town should implement a comprehensive program of tree management including soil testing.								2

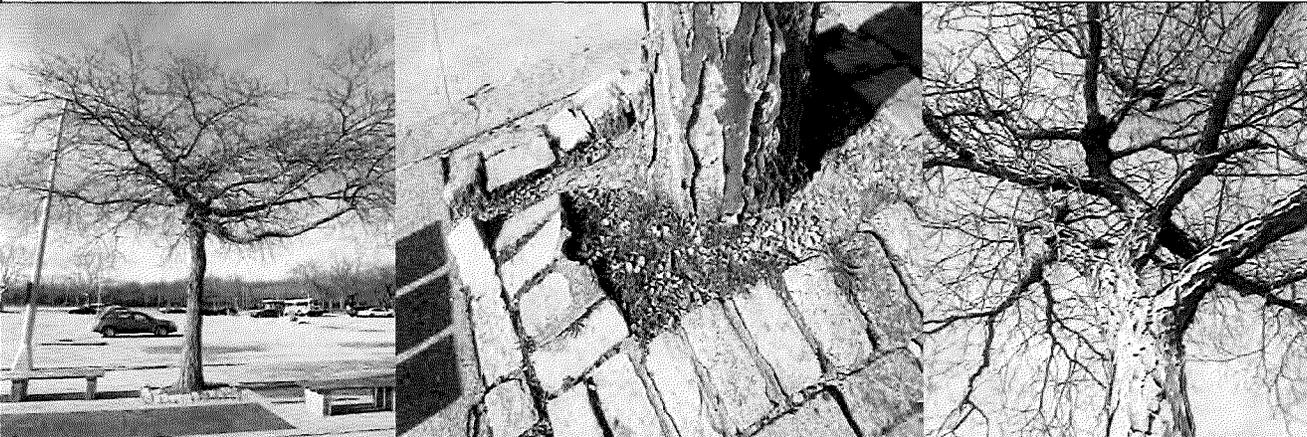
Trunk Condition and Main Scaffold Branches		Moss and lichen growth on trunk and scaffold branches.							
Crown/Structure, Branches & Leaves		Very thin crown from pruning, tree was not assessed during full leaf.							
Pest / Disease		Moss and lichen growth on trunk.							
Setting		Along beach promenade in tree pits, exposed to high winds.							
Character		Y		Does the tree make an important contribution to the character or amenity of the area?					
		Indigenous		Is the tree indigenous, rare, endangered, invasive or exotic?					
Habitat		N		Does the tree represent important habitat for native fauna?					
		N		Is the tree part of a wildlife Corridor, Buffer, etc?					
Notes: Mortared granite block pavers in tree pit, benches directly below tree crown, evidence of pruning to scaffold branches.									
Recommendations: It is recommended to implement a program that continues to monitor this tree by an ISA Arborist. For recommended treatment, remove the sand within the tree pit using pneumatic methods if possible and replace it with mulch that will provide additional benefits to the tree. The Town should implement a comprehensive program of tree management including soil testing.								Level of Urgency

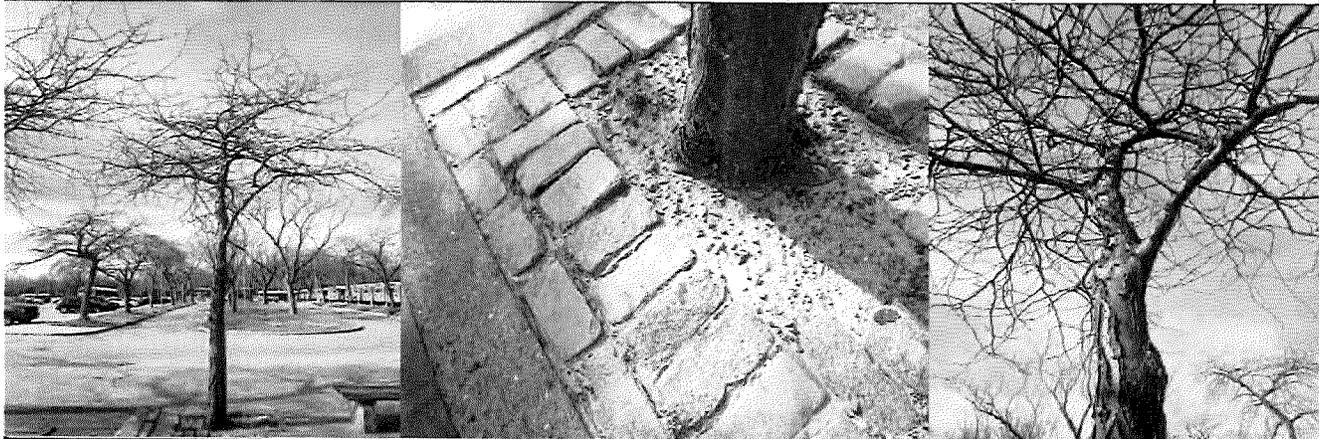
Crown/Structure, Branches & Leaves	Very thin crown from pruning, tree was not assessed during full leaf.		
Pest / Disease	Moss and lichen growth on trunk.		
Setting	Along beach promenade in tree pits, exposed to high winds.		
Character	Y	Does the tree make an important contribution to the character or amenity of the area?	
	Indigenous	Is the tree indigenous, rare, endangered, invasive or exotic?	
Habitat	N	Does the tree represent important habitat for native fauna?	
	N	Is the tree part of a wildlife Corridor, Buffer, etc?	
Notes: Mortared granite block pavers in tree pit, benches directly below tree crown.			
Recommendations: It is recommended to implement a program that continues to monitor this tree by an ISA Arborist. It is recommended to form a mulch collar around the base of the tree. Vertical mulching is recommended for mitigation, this is a technique that benefits stressed trees by improving the movement of water, air, and nutrients in the root zone and should be performed by a qualified tree care professional. The Town should implement a comprehensive program of tree management including soil testing.			Level of Urgency

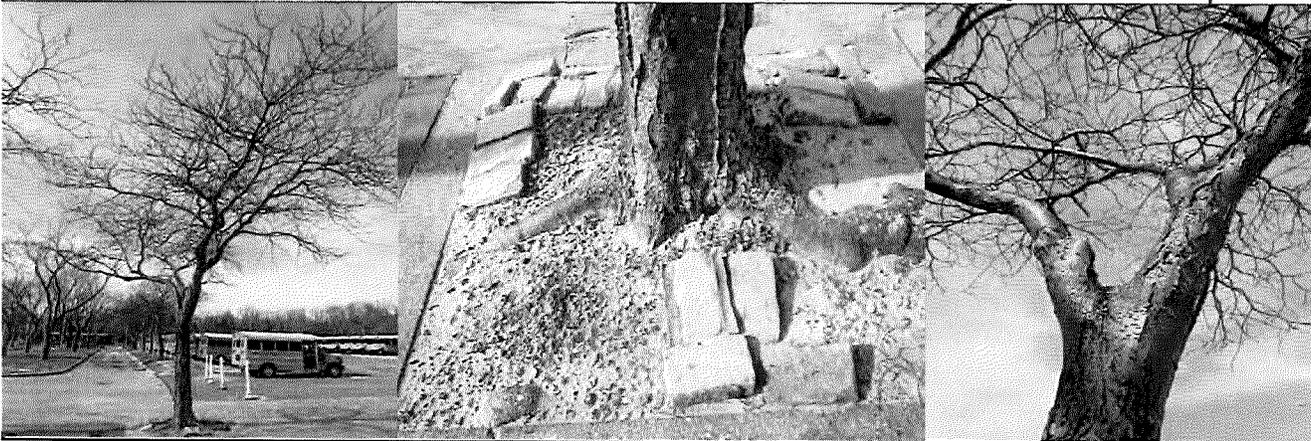
Trunk Condition and Main Scaffold Branches		Codominant leaders, included bark at trunk union, moss and lichen growth on trunk and scaffold branches, minor vertical cracking on trunk, trunk scars from removed scaffold branches have not entirely healed.							
Crown/Structure , Branches & Leaves		Very thin crown from pruning, tree was not assessed during full leaf.							
Pest / Disease		Moss and lichen growth on trunk.							
Setting		Along beach promenade in tree pits, exposed to high winds.							
Character		Y		Does the tree make an important contribution to the character or amenity of the area?					
Habitat		Indigenous		Is the tree indigenous, rare, endangered, invasive or exotic?					
		N		Does the tree represent important habitat for native fauna?					
		N		Is the tree part of a wildlife Corridor, Buffer, etc?					
Notes: Mortared granite block pavers in tree pit, benches directly below tree crown, evidence of pruning to trunk and scaffold branches.

Recommendations: It is recommended to implement a program that continues to monitor this tree by an ISA Arborist. For recommended treatment, proper corrective pruning that follows ANSI A300 standards should be performed to remove dead and damaged branches, specifically scaffold branches above the roadway. Additionally, it is recommended to form a mulch collar around the base of the tree that will prevent any future damage caused by landscape maintenance and provide additional benefits to the tree. Vertical mulching is recommended for mitigation, this is a technique that benefits stressed trees by improving the movement of water, air, and nutrients in the root zone and should be performed by a qualified tree care professional. The Town should implement a comprehensive program of tree management including soil testing.								Level of Urgency	
								2	
Urgency Level: 1 - Requires Immediate Attention 2 - Within (1) Month 3 - Within (6) Months 4 - Within the year 5 - None

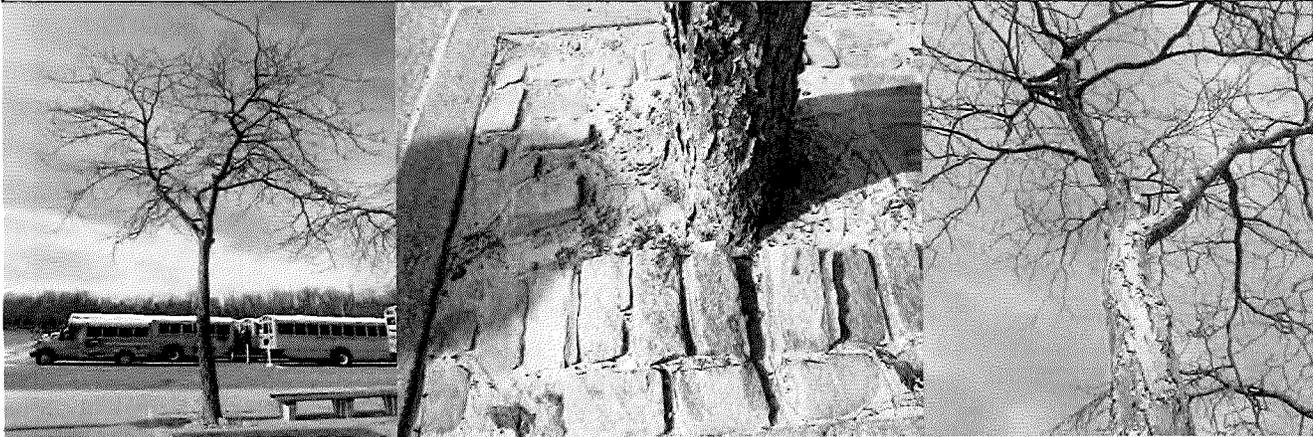
Trunk Condition and Main Scaffold Branches	Codominant leaders, included bark at trunk union, major moss and lichen growth on trunk and scaffold branches, minor vertical cracking on trunk, trunk wounds from removed scaffold branches have not entirely healed.					
Crown/Structure, Branches & Leaves	Very thin crown from pruning, tree was not assessed during full leaf.					
Pest / Disease	Moss and lichen growth on trunk.					
Setting	Along beach promenade in tree pits, exposed to high winds.					
Character	Y	Does the tree make an important contribution to the character or amenity of the area?				
	Indigenous	Is the tree indigenous, rare, endangered, invasive or exotic?				
Habitat	N	Does the tree represent important habitat for native fauna?				
	N	Is the tree part of a wildlife Corridor, Buffer, etc?				
Notes: Mortared granite block pavers in tree pit, benches directly below tree crown, evidence of major scaffold branch removal and pruning to smaller branches. Due to the amount of pruning that has occurred and the branch die-back that is present, it is anticipated the condition of this tree will continue to decline.

Recommendations: Remove tree due to current condition and anticipated decline. For tree replacement it is recommended to use XXX. Replacements should be planted immediately following removals and it is recommended to form a mulch collar around the base of the tree that will prevent any future damage caused by landscape maintenance and provide additional benefits to the tree. The Town should implement a comprehensive program of tree management including soil testing.						Level of Urgency
						1
Urgency Level: 1 - Requires Immediate Attention 2 - Within (1) Month 3 - Within (6) Months 4 - Within the year 5 - None

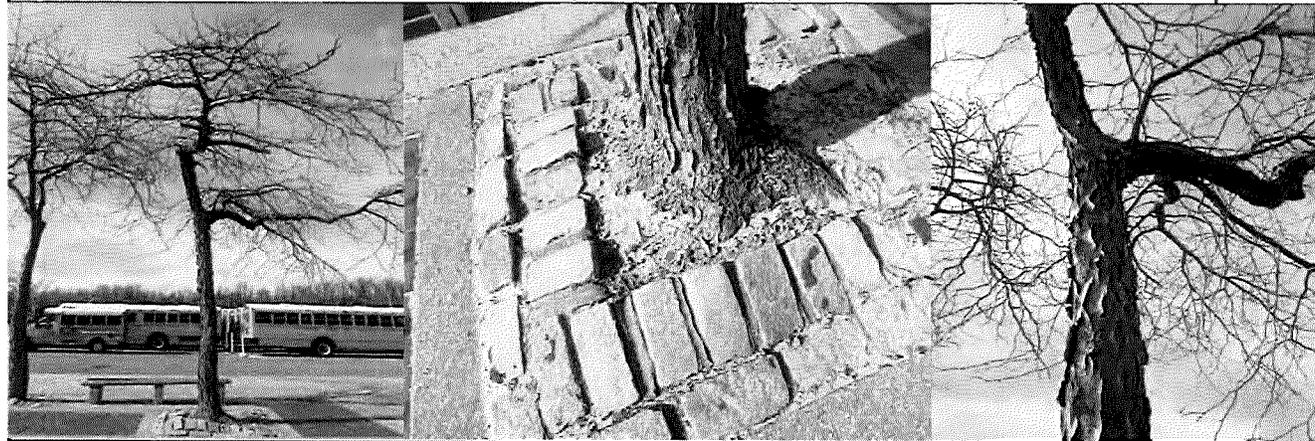
Trunk Condition and Main Scaffold Branches	Codominant leaders, included bark at trunk union, major moss and lichen growth on trunk and scaffold branches, scaffold wounds from removed branches have not entirely healed, major scaffold branch has damage that is causing major die-back.
--	---

Notes:
 Mortared granite block pavers in tree pit, benches directly below tree crown, evidence of scaffold branch removal and pruning to smaller branches. Due to the amount of pruning that has occurred and the branch die-back that is present, it is anticipated the condition of this tree will continue to decline.

Recommendations: Remove tree due to current condition and anticipated decline. For tree replacement it is recommended to use XXX. Replacements should be planted immediately following removals and it is recommended to form a mulch collar around the base of the tree that will prevent any future damage caused by landscape maintenance and provide additional benefits to the tree. The Town should implement a comprehensive program of tree management including soil testing.	Level of Urgency
	1

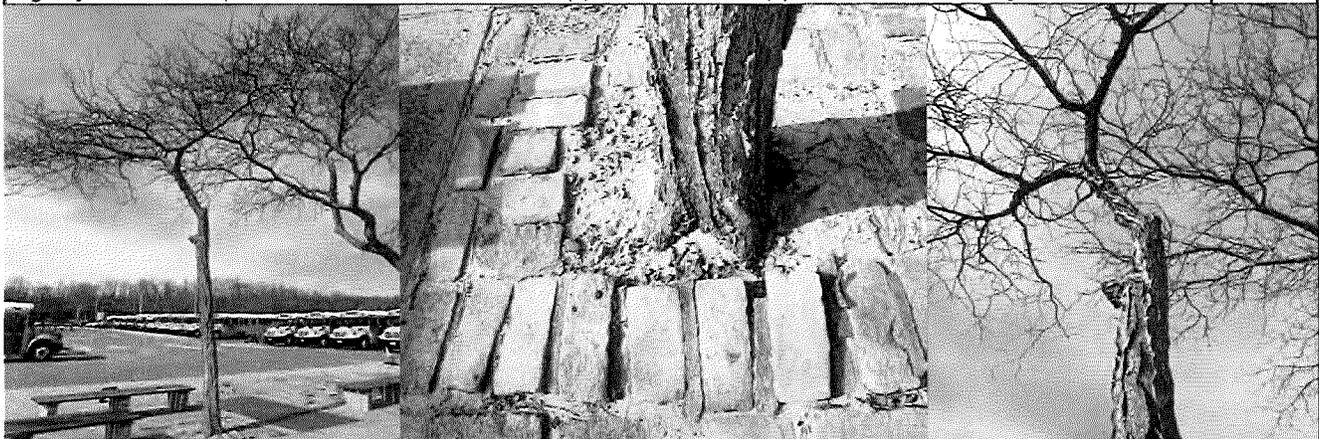
Trunk Condition and Main Scaffold Branches		Major moss and lichen growth on trunk and scaffold branches, trunk wounds from removed scaffold branches have not entirely healed,							
Crown/Structure , Branches & Leaves		Very thin crown from pruning, tree was not assessed during full leaf.							
Pest / Disease		Moss and lichen growth on trunk.							
Setting		Along beach promenade in tree pits, exposed to high winds.							
Character		Y		Does the tree make an important contribution to the character or amenity of the area?					
Habitat		Indigenous		Is the tree indigenous, rare, endangered, invasive or exotic?					
Habitat		N		Does the tree represent important habitat for native fauna?					
Habitat		N		Is the tree part of a wildlife Corridor, Buffer, etc?					
Notes: Mortared granite block pavers in tree pit, benches directly below tree crown, evidence of major scaffold branch removal and pruning to smaller branches. Due to the amount of pruning that has occurred, it is anticipated the condition of this tree will continue to decline.

Recommendations: Remove tree due to current condition and anticipated decline. For tree replacement it is recommended to use XXX. Replacements should be planted immediately following removals and it is recommended to form a mulch collar around the base of the tree that will prevent any future damage caused by landscape maintenance and provide additional benefits to the tree. The Town should implement a comprehensive program of tree management including soil testing.								Level of Urgency	
								1	
Urgency Level: 1 - Requires Immediate Attention 2 - Within (1) Month 3 - Within (6) Months 4 - Within the year 5 - None

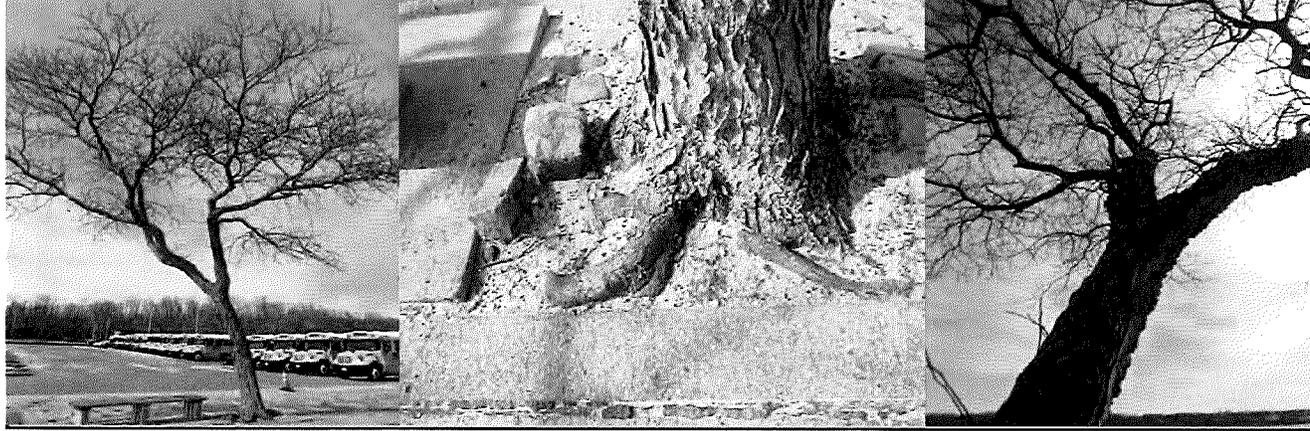
Trunk Condition and Main Scaffold Branches	Codominant leaders, major trunk lean to the south, major moss and lichen growth on trunk and scaffold branches, water sprouting on trunk and scaffold branches, major scaffold branch removal.
---	--

Notes:
 Mortared granite block pavers in tree pit, benches directly below tree crown and leaning trunk. Recommended to assess this tree after bud break.

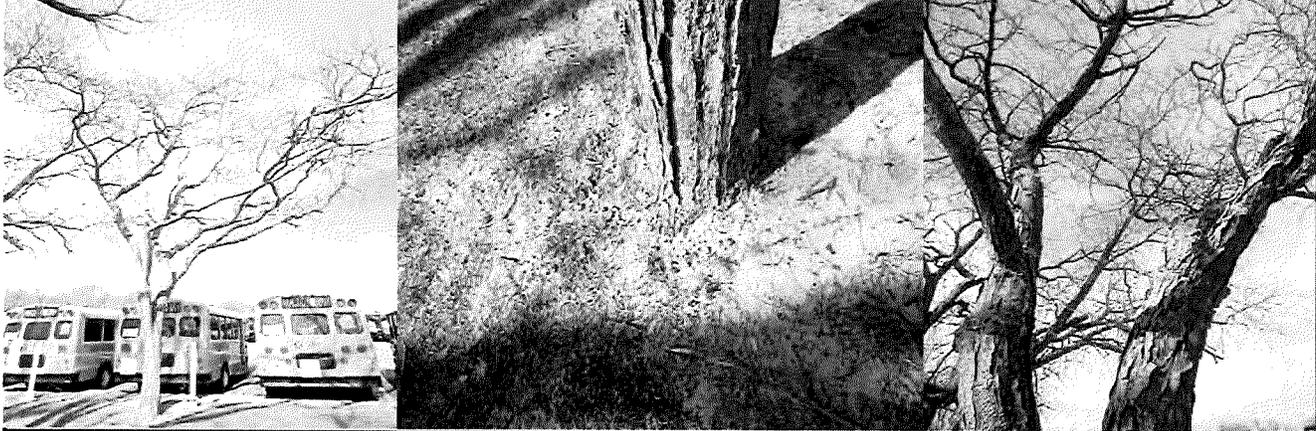
Tree/Root Base/Pit	Growing in a grass area, minor mechanical damage at base from landscape maintenance.
---------------------------	--
