# DRAFT REPORT

100 Crossways Park Drive West, Ste. 104 Woodbury, New York 11797		T 516 364 0660 F 516 364 0668		www.dthayerassociates.com		Assignment: <b>2</b>	Tree No.: <b>183</b>
<b>Arborist Assessment Report</b>			Location: North Hempstead Beach Park - Port Washington, NY		Date: 3/3/2016		
Inspector: Dan Maher		Weather: Partly Sunny		Lat/Long: N 40° 50' 1.39" W 73° 39' 38.22"		Time: 16:29	
<b>Specimen:</b>	<b>Common Name:</b> HONEYLOCUST		<b>Scientific name:</b> Gleditsia triacanthos				
<b>Descriptor</b>	<b>Value</b>	<b>Range</b>					
<b>Girth</b>	12"	<i>Trunk Diameter Measured at Breast Height (DBH)</i>					
<b>Approx. Height</b>	20'-25'	<i>Approximate Height to top of Canopy</i>					
<b>Canopy</b>	N 10',S 13',E 6',W 10'	<i>Canopy Radius in Feet - North South East West</i>					
<b>Condition</b>	3	<i>Health of Specimen - 1 Dead - 2 Declining - 3 Moderate - 4 Good - 5 Excellent</i>					
<b>Approx. Age</b>	M	<i>NP=Newly Planted Within 5yrs M=Moderate 10-20 yrs old E=Existing before development</i>

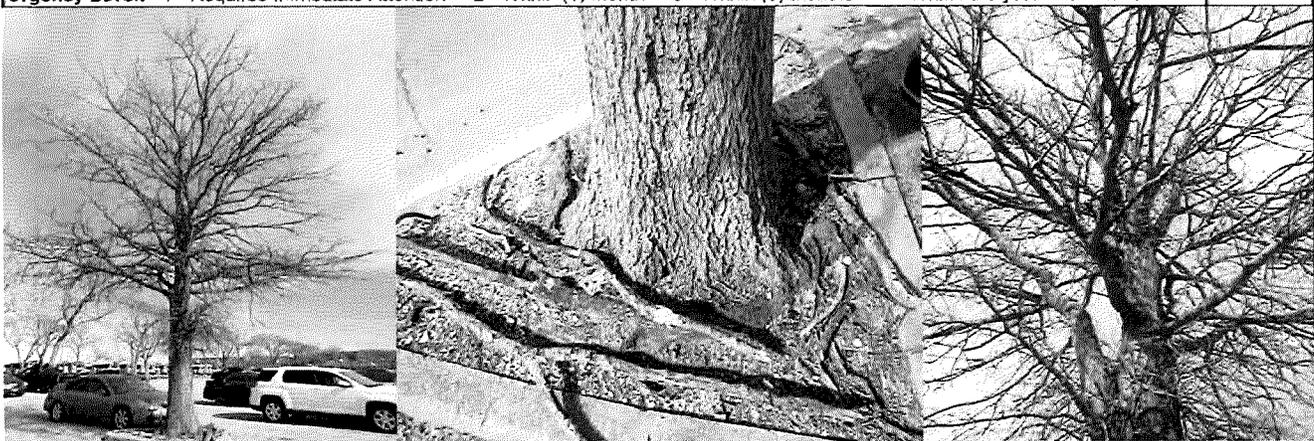
Trunk Condition and Main Scaffold Branches		Moss and lichen growth on trunk, top of central leader is dead, major water sprouting on scaffold branches.							
Crown/Structure, Branches & Leaves		major branch die-back at top of crown, major dead branches, tree was not assessed during full leaf.							
Pest / Disease		Moss and lichen growth on trunk.							
Setting		North end of park in open parking lot, exposed to high winds.							
Character		Y		Does the tree make an important contribution to the character or amenity of the area?					
		Indigenous		Is the tree indigenous, rare, endangered, invasive or exotic?					
Habitat		N		Does the tree represent important habitat for native fauna?					
		N		Is the tree part of a wildlife Corridor, Buffer, etc?					
Notes: Due to the dead central leader and crown die-back, it is anticipated the condition of this tree will continue to decline.									
Recommendations: Remove tree due to current condition and anticipated decline. For tree replacement it is recommended to use XXX. Replacements should be planted immediately following removals and it is recommended to form a mulch collar around the base of the tree that will prevent any future damage caused by landscape maintenance and provide additional benefits to the tree. The Town should implement a comprehensive program of tree management including soil testing.								Level of Urgency

1	
Urgency Level: 1 - Requires Immediate Attention 2 - Within (1) Month 3 - Within (6) Months 4 - Within the year 5 - None

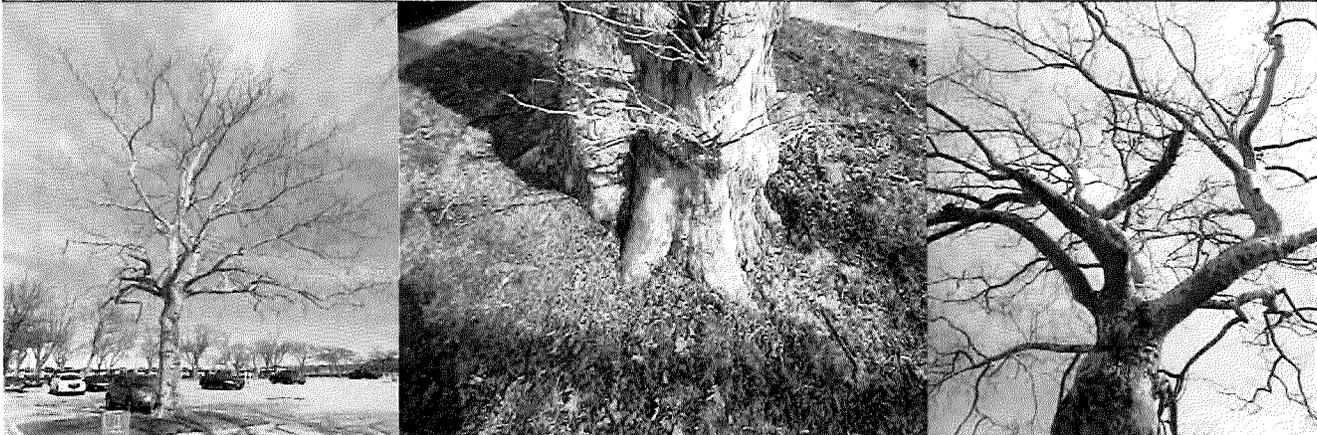
<b>Tree/Root Base/Pit</b>						
Growing in a parking lot island surrounded by grass, minor girdling roots.						
<b>Trunk Condition and Main Scaffold Branches</b>						
Minor moss and lichen growth on trunk, vertical cracking on trunk, water sprouting on trunk and scaffold branches.						
<b>Crown/Structure, Branches &amp; Leaves</b>						
Good crown structure, dead branches, broken branches hanging in crown, moderate fruiting, tree was not assessed during full leaf.						
<b>Pest / Disease</b>						
Moss and lichen growth on trunk.						
<b>Setting</b>						
North end of park in open parking lot, exposed to high winds.						
<b>Character</b>						
Y <i>Does the tree make an important contribution to the character or amenity of the area?</i>						
Indigenous <i>Is the tree indigenous, rare, endangered, invasive or exotic?</i>						
<b>Habitat</b>						
N <i>Does the tree represent important habitat for native fauna?</i>

N <i>Is the tree part of a wildlife Corridor, Buffer, etc?</i>						
<b>Notes:</b> Evidence of pruning to scaffold branches, water sprouting occurring at site on pruning cuts.						
<b>Recommendations:</b> It is recommended to implement a program that continues to monitor this tree by an ISA Arborist and if condition continues to decline, consider removal. For recommended treatment, proper corrective pruning that follows ANSI A300 standards should be performed to remove dead and damaged branches. Additionally, it is recommended to form a mulch collar around the base of the tree that will prevent any future damage caused by landscape maintenance and provide additional benefits to the tree. Vertical mulching is recommended for mitigation, this is a technique that benefits stressed trees by improving the movement of water, air, and nutrients in the root zone and should be performed by a qualified tree care professional. The Town should implement a comprehensive program of tree management including soil testing.						Level of Urgency

Urgency Level: 1 - Requires Immediate Attention 2 - Within (1) Month 3 - Within (6) Months 4 - Within the year 5 - None						<b>2</b>

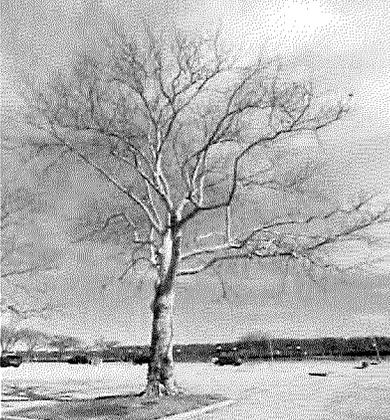
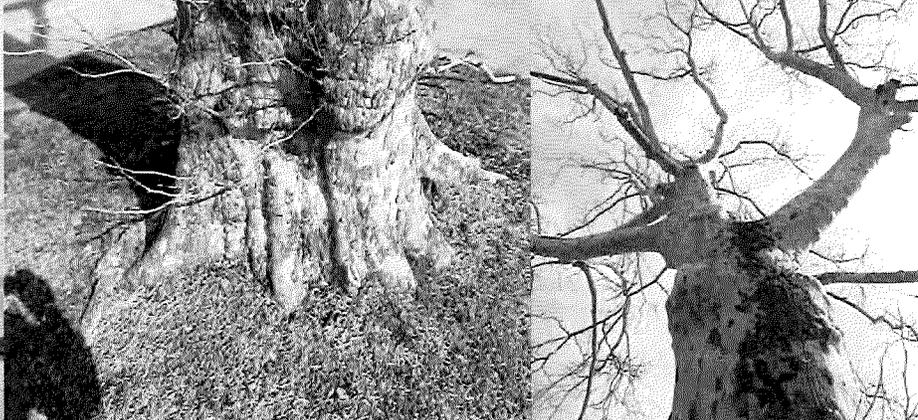
<b>Approx. Age</b>		E		<i>NP=Newly Planted Within 5yrs M=Moderate 10-20 yrs old E=Existing before development</i>			
<b>Tree/Root Base/Pit</b>		Growing in a parking lot island surrounded by grass, mechanical damage at base from landscape maintenance, minor girdling roots.					
<b>Trunk Condition and Main Scaffold Branches</b>		Minor moss and lichen growth on trunk, water sprouting on trunk and scaffold branches, trunk and scaffold wounds from removed branches that have not entirely healed.					
<b>Crown/Structure , Branches &amp; Leaves</b>		Good crown structure, minor dead branches, broken branches hanging in crown, moderate fruiting, tree was not assessed during full leaf.					
<b>Pest / Disease</b>		Moss and lichen growth on trunk.					
<b>Setting</b>		North end of park in open parking lot, exposed to high winds.					
<b>Character</b>		Y		<i>Does the tree make an important contribution to the character or amenity of the area?</i>

<b>Habitat</b>		Indigenous		<i>Is the tree indigenous, rare, endangered, invasive or exotic?</i>			
<b>Character</b>		N		<i>Does the tree represent important habitat for native fauna?</i>			
<b>Habitat</b>		N		<i>Is the tree part of a wildlife Corridor, Buffer, etc?</i>			
<b>Notes:</b> Evidence of pruning to scaffold branches, water sprouting occurring at site on pruning cuts.							
<b>Recommendations:</b> It is recommended to implement a program that continues to monitor this tree by an ISA Arborist and if condition continues to decline, consider removal. For recommended treatment, proper corrective pruning that follows ANSI A300 standards should be performed to remove dead and damaged branches. Additionally, it is recommended to form a mulch collar around the base of the tree that will prevent any future damage caused by landscape maintenance and provide additional benefits to the tree. Vertical mulching is recommended for mitigation, this is a technique that benefits stressed trees by improving the movement of water, air, and nutrients in the root zone and should be performed by a qualified tree care professional. The Town should implement a comprehensive program of tree management including soil testing.							<b>Level of Urgency</b>  2

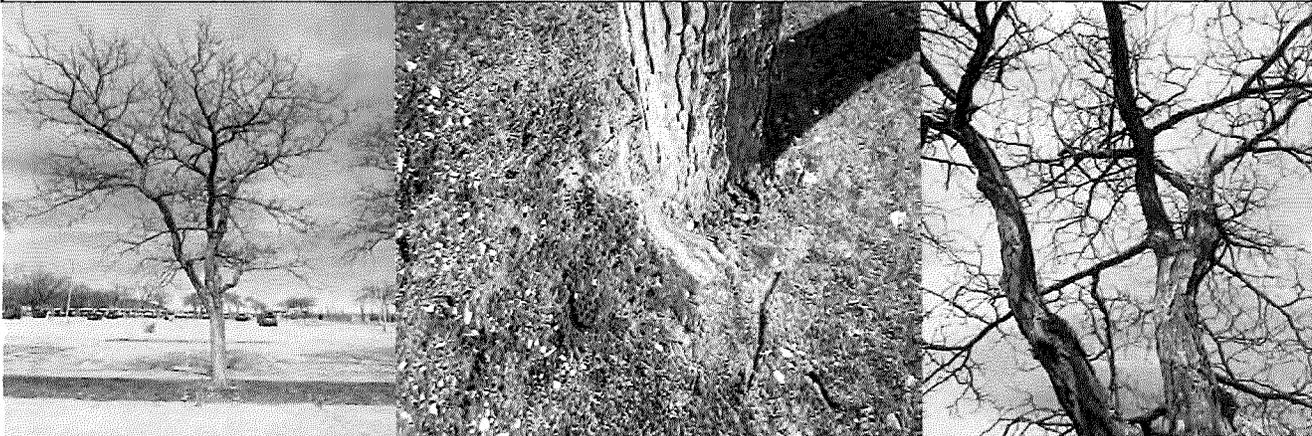
<b>Tree/Root Base/Pit</b>	Growing in a 6' wide grass strip in a dividing island, girdling roots.		
<b>Trunk Condition and Main Scaffold Branches</b>	Codominant leaders, included bark at trunk unions, moss and lichen growth on trunk and scaffold branches, water sprouting on scaffold branches, minor scaffold wounds from removed branches that have not entirely healed.		
<b>Crown/Structure, Branches &amp; Leaves</b>	Good crown structure, minor dead branches, tree was not assessed during full leaf.		
<b>Pest / Disease</b>	Moss and lichen growth on trunk.		
<b>Setting</b>	North end of park in open parking lot, exposed to high winds.		
<b>Character</b>	Y	<i>Does the tree make an important contribution to the character or amenity of the area?</i>	
	Indigenous	<i>Is the tree indigenous, rare, endangered, invasive or exotic?</i>	
<b>Habitat</b>	N	<i>Does the tree represent important habitat for native fauna?</i>

N	<i>Is the tree part of a wildlife Corridor, Buffer, etc?</i>	
<b>Notes:</b> Evidence of pruning to scaffold branches.			
<b>Recommendations:</b> It is recommended to implement a program that continues to monitor this tree by an ISA Arborist. For recommended treatment, proper corrective pruning that follows ANSI A300 standards should be performed to remove dead and damaged branches. Additionally, it is recommended to form a mulch collar around the base of the tree that will prevent any future damage caused by landscape maintenance and provide additional benefits to the tree. Vertical mulching is recommended for mitigation, this is a technique that benefits stressed trees by improving the movement of water, air, and nutrients in the root zone and should be performed by a qualified tree care professional. The Town should implement a comprehensive program of tree management including soil testing.			<b>Level of Urgency</b>  2

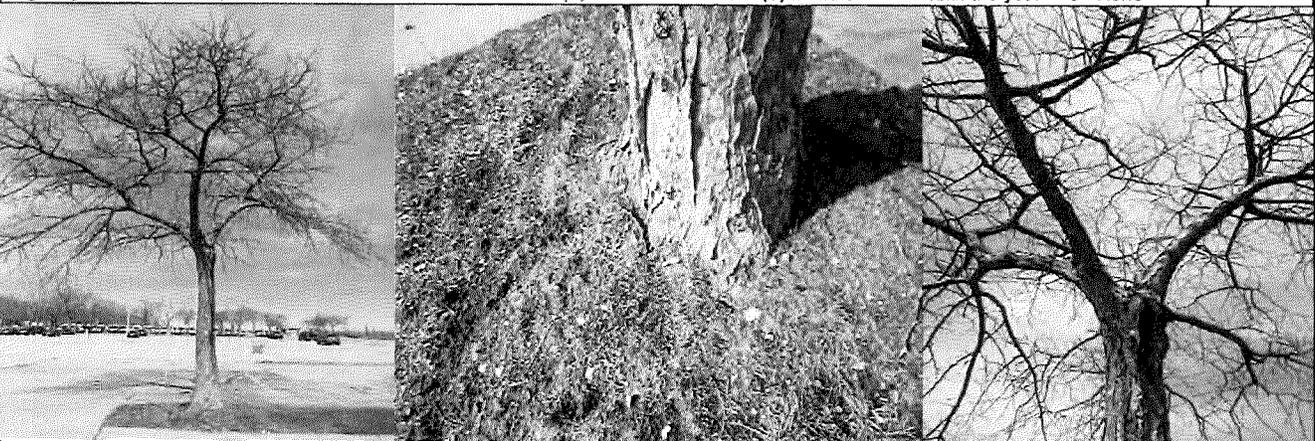
Trunk Condition and Main Scaffold Branches		Codominant leaders, included bark at trunk union, major moss and lichen growth on trunk and scaffold branches, trunk wound from removed branch has not entirely healed and shows signs of canker rot with stains, dead scaffold branches.							
Crown/Structure, Branches & Leaves		Good crown structure, dead branches, broken branches from vehicle damage on north side of tree, tree was not assessed during full leaf.							
Pest / Disease		Moss and lichen growth on trunk.							
Setting		North end of park in open parking lot, exposed to high winds.							
Character		Y		Does the tree make an important contribution to the character or amenity of the area?					
		Indigenous		Is the tree indigenous, rare, endangered, invasive or exotic?					
Habitat		N		Does the tree represent important habitat for native fauna?					
		N		Is the tree part of a wildlife Corridor, Buffer, etc.?

Notes: Evidence of pruning to scaffold branches.									
Recommendations: It is recommended to implement a program that continues to monitor this tree by an ISA Arborist and if condition continues to decline, consider removal. For recommended treatment, proper corrective pruning that follows ANSI A300 standards should be performed to remove dead and damaged branches. Additionally, it is recommended to form a mulch collar around the base of the tree that will prevent any future damage caused by landscape maintenance and provide additional benefits to the tree. Vertical mulching is recommended for mitigation, this is a technique that benefits stressed trees by improving the movement of water, air, and nutrients in the root zone and should be performed by a qualified tree care professional. The Town should implement a comprehensive program of tree management including soil testing.								Level of Urgency

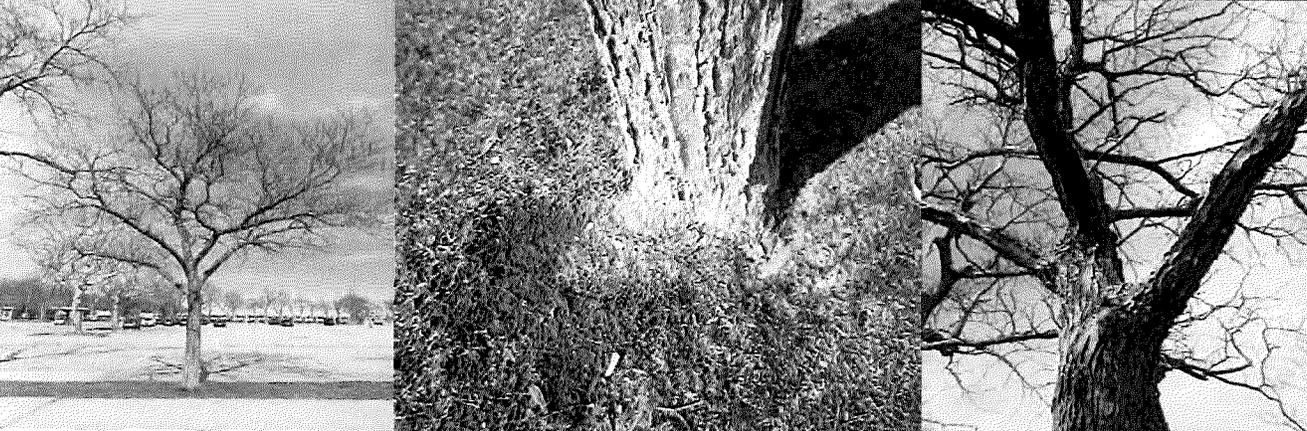
Trunk Condition and Main Scaffold Branches		Codominant leaders, moss and lichen growth on trunk and scaffold branches, vertical cracking on trunk, water sprouting on scaffold branches, minor dead scaffold branches.							
Crown/Structure, Branches & Leaves		Good crown structure, dead branches, die-back on small outer branches, broken branches hanging in crown, tree was not assessed during full leaf.							
Pest / Disease		Moss and lichen growth on trunk.							
Setting		North end of park in open parking lot, exposed to high winds.							
Character		Y		Does the tree make an important contribution to the character or amenity of the area?					
		Indigenous		Is the tree indigenous, rare, endangered, invasive or exotic?					
Habitat		N		Does the tree represent important habitat for native fauna?					
		N		Is the tree part of a wildlife Corridor, Buffer, etc?					
Notes: Dead scaffold branches directly above sidewalk.

Recommendations: It is recommended to implement a program that continues to monitor this tree by an ISA Arborist and if condition continues to decline, consider removal. For recommended treatment, proper corrective pruning that follows ANSI A300 standards should be performed to remove dead and damaged branches. Additionally, it is recommended to form a mulch collar around the base of the tree that will prevent any future damage caused by landscape maintenance and provide additional benefits to the tree. Vertical mulching is recommended for mitigation, this is a technique that benefits stressed trees by improving the movement of water, air, and nutrients in the root zone and should be performed by a qualified tree care professional. The Town should implement a comprehensive program of tree management including soil testing.								Level of Urgency	
								1	
Urgency Level: 1 - Requires Immediate Attention 2 - Within (1) Month 3 - Within (6) Months 4 - Within the year 5 - None

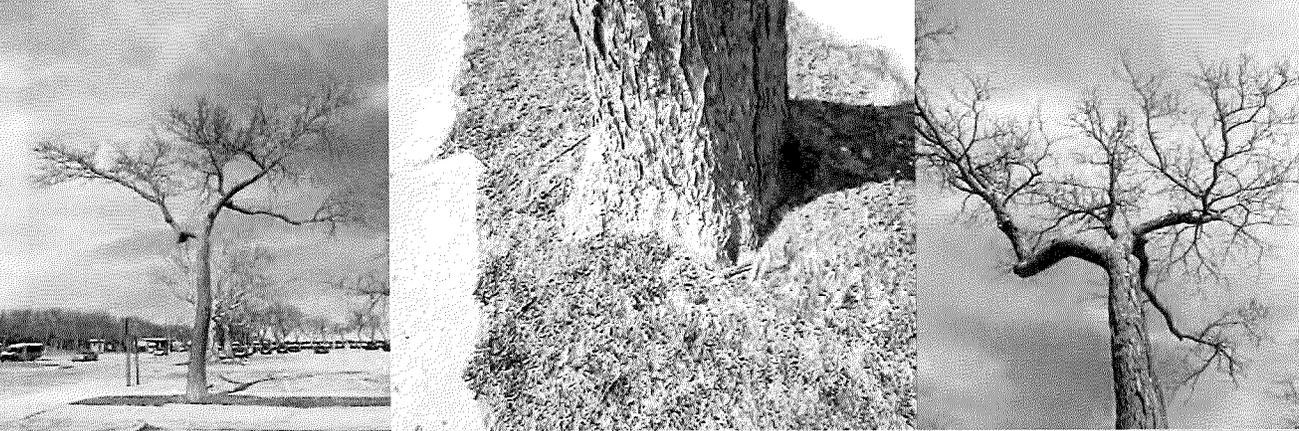
<b>Tree/Root Base/Pit</b>		Growing in a 6' wide grass strip in a dividing island, major heaving of concrete sidewalk on south side from roots, girdling roots.							
<b>Trunk Condition and Main Scaffold Branches</b>		Codominant leaders, moss and lichen growth on trunk and scaffold branches, evidence of insect activity underneath bark, new vertical cracking on trunk causing wood rot, minor water sprouting on scaffold branches, major pruning of scaffold branches created							
<b>Crown/Structure, Branches &amp; Leaves</b>		Thin crown, lower scaffold branches have been removed or have fallen causing lions tailing, dead branches, tree was not assessed during full leaf.							
<b>Pest / Disease</b>		Moss and lichen growth on trunk, evidence of insect activity.							
<b>Setting</b>		North end of park in open parking lot, exposed to high winds.							
<b>Character</b>		Y		Does the tree make an important contribution to the character or amenity of the area?

Indigenous		Is the tree indigenous, rare, endangered, invasive or exotic?					
<b>Habitat</b>		N		Does the tree represent important habitat for native fauna?					
		N		Is the tree part of a wildlife Corridor, Buffer, etc?					
<b>Notes:</b> New concrete sidewalk has been installed on the north side of tree, evidence suggests that major root pruning has occurred during construction. Evidence of recent major pruning to scaffold branches. Tree exhibits heavy pruning of a large number of lower branches and inner branches resulting in "Lion's-tailing" appearance which increases the risk of branch failure by weakening tree roots and decreasing the dampening effect that interior limbs provide during storms.									
<b>Recommendations:</b> Remove tree due to current condition and anticipated decline. For tree replacement it is recommended to use XXX. Replacements should be planted immediately following removals and it is recommended to form a mulch collar around the base of the tree that will prevent any future damage caused by landscape maintenance and provide additional benefits to the tree. The Town should implement a comprehensive program of tree management including soil testing.								Level of Urgency

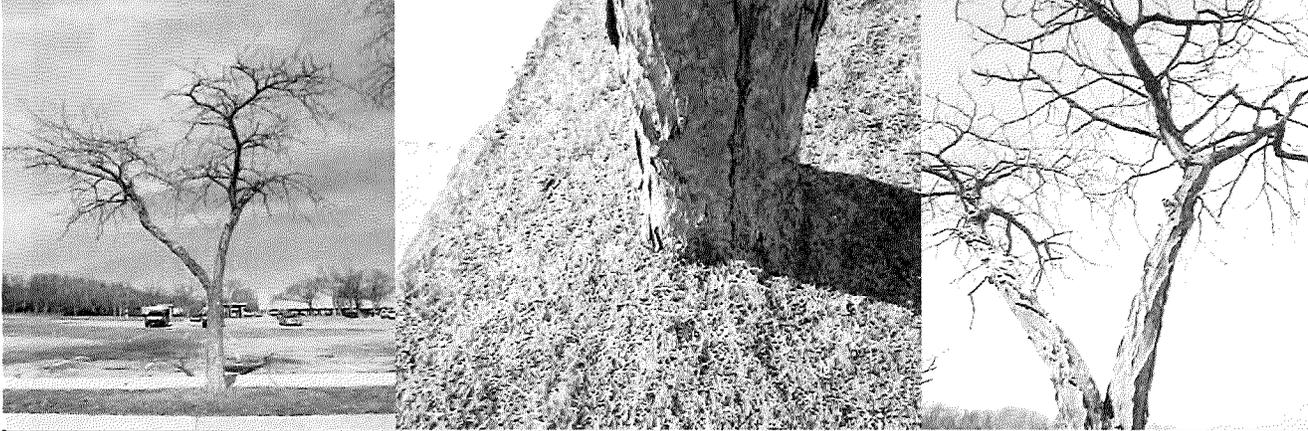
Trunk Condition and Main Scaffold Branches		Codominant leaders, included bark at trunk union, moss and lichen growth on trunk and scaffold branches, major trunk damage, water sprouting on scaffold branches, major dead scaffold branches.							
Crown/Structure, Branches & Leaves		Major die-back on most branches, broken branches hanging in crown, tree was not assessed during full leaf.							
Pest / Disease		Moss and lichen growth on trunk.							
Setting		North end of park in open parking lot, exposed to high winds.							
Character		Y		Does the tree make an important contribution to the character or amenity of the area?					
		Indigenous		Is the tree indigenous, rare, endangered, invasive or exotic?					
Habitat		N		Does the tree represent important habitat for native fauna?					
		N		Is the tree part of a wildlife Corridor, Buffer, etc?					
Notes: New concrete sidewalk has been installed on the north and south side of tree, it is anticipated that major root pruning has occurred during construction.

Recommendations: Remove tree due to current condition and anticipated decline. For tree replacement it is recommended to use XXX. Replacements should be planted immediately following removals and it is recommended to form a mulch collar around the base of the tree that will prevent any future damage caused by landscape maintenance and provide additional benefits to the tree. The Town should implement a comprehensive program of tree management including soil testing.								Level of Urgency	
								1	
Urgency Level: 1 - Requires Immediate Attention 2 - Within (1) Month 3 - Within (6) Months 4 - Within the year 5 - None

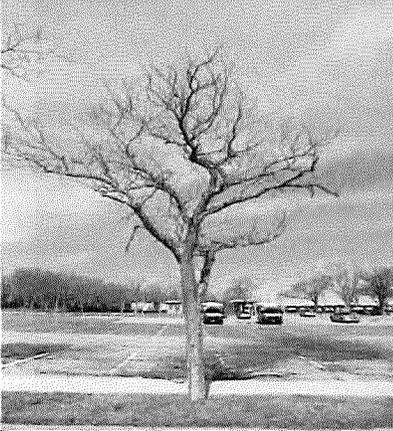
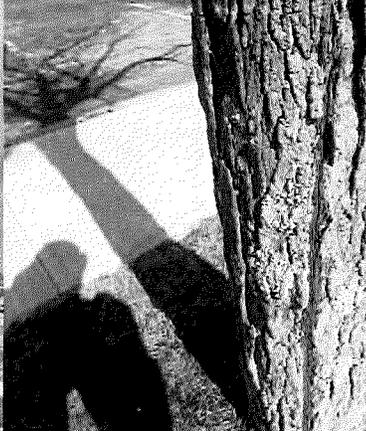
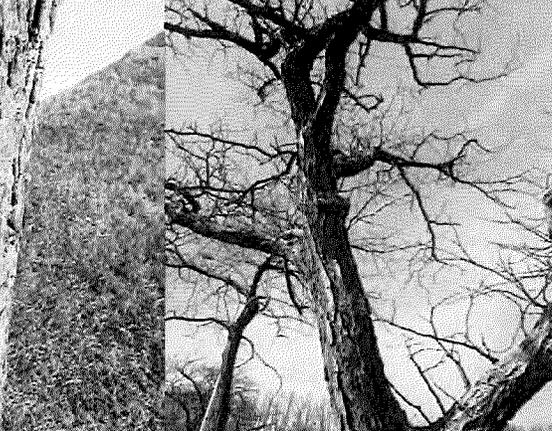
<b>Approx. Age</b>		M		<i>NP=Newly Planted Within 5yrs M=Moderate 10-20 yrs old E=Existing before development</i>			
<b>Tree/Root Base/Pit</b>		Growing in a 6' wide grass strip in a dividing island, buried root collar.					
<b>Trunk Condition and Main Scaffold Branches</b>		Codominant leaders, included bark at trunk union, moss and lichen growth on trunk and scaffold branches, vertical cracking on opposite sides of trunk, water sprouting on scaffold branches, major dead scaffold branches.					
<b>Crown/Structure, Branches &amp; Leaves</b>		Major die-back on most branches, broken branches hanging in crown, tree was not assessed during full leaf.					
<b>Pest / Disease</b>		Moss and lichen growth on trunk.					
<b>Setting</b>		North end of park in open parking lot, exposed to high winds.					
<b>Character</b>		Y		<i>Does the tree make an important contribution to the character or amenity of the area?</i>

<b>Habitat</b>		Indigenous		<i>Is the tree indigenous, rare, endangered, invasive or exotic?</i>			
<b>Habitat</b>		N		<i>Does the tree represent important habitat for native fauna?</i>			
<b>Habitat</b>		N		<i>Is the tree part of a wildlife Corridor, Buffer, etc?</i>			
<b>Notes:</b> New concrete sidewalk has been installed on the north side of tree, it is anticipated that major root pruning has occurred during construction. More than 2/3 of tree crown is dead.							
<b>Recommendations:</b> Remove tree due to current condition and anticipated decline. For tree replacement it is recommended to use XXX. Replacements should be planted immediately following removals and it is recommended to form a mulch collar around the base of the tree that will prevent any future damage caused by landscape maintenance and provide additional benefits to the tree. The Town should implement a comprehensive program of tree management including soil testing.							<b>Level of Urgency</b>

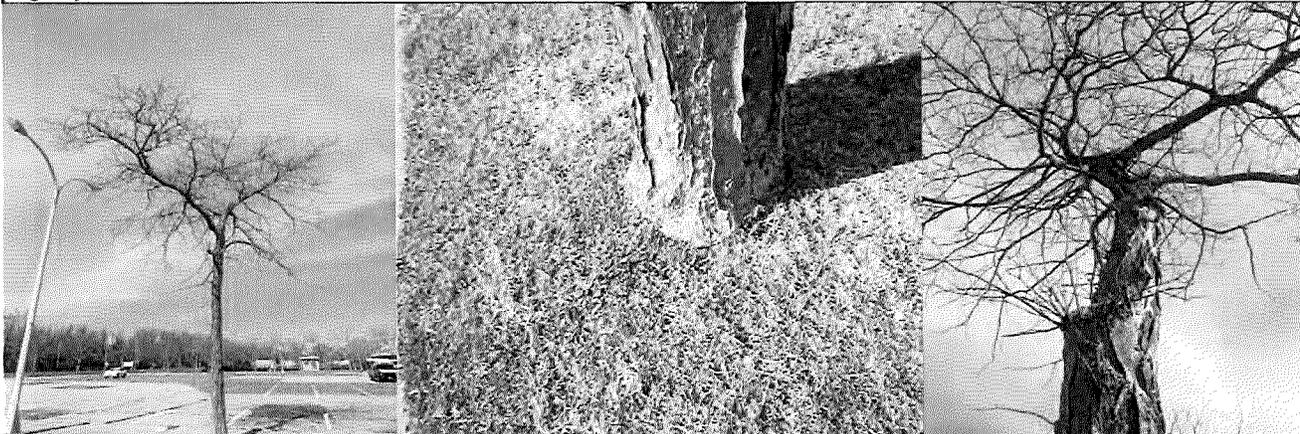
<b>Canopy</b>		N 9',S 10',E 5',W 5'		<i>Canopy Radius in Feet - North South East West</i>					
<b>Condition</b>		2		<i>Health of Specimen - 1 Dead - 2 Declining - 3 Moderate - 4 Good - 5 Excellent</i>					
<b>Approx. Age</b>		M		<i>NP=Newly Planted Within 5yrs M=Moderate 10-20 yrs old E=Existing before development</i>					
<b>Tree/Root Base/Pit</b>		Growing in a 6' wide grass strip in a dividing island, mechanical damage at base from landscape maintenance.							
<b>Trunk Condition and Main Scaffold Branches</b>		Codominant leaders, moss and lichen growth on trunk and scaffold branches, vertical cracking on trunk, evidence of insect activity underneath bark, water sprouting on trunk and scaffold branches, dead scaffold branches, die-back on central leader.							
<b>Crown/Structure, Branches &amp; Leaves</b>		Thin crown, lower scaffold branches have been removed or have fallen causing lions tailing, dead branches, broken branches hanging in crown, tree was not assessed during full leaf.

<b>Pest / Disease</b>		Moss and lichen growth on trunk, evidence of insect activity.							
<b>Setting</b>		North end of park in open parking lot, exposed to high winds.							
<b>Character</b>		Y		<i>Does the tree make an important contribution to the character or amenity of the area?</i>					
<b>Habitat</b>		Indigenous		<i>Is the tree indigenous, rare, endangered, invasive or exotic?</i>					
<b>Habitat</b>		N		<i>Does the tree represent important habitat for native fauna?</i>					
<b>Habitat</b>		N		<i>Is the tree part of a wildlife Corridor, Buffer, etc?</i>					
<b>Notes:</b> Evidence of recently fallen scaffold branches. Dead scaffold branches directly above sidewalk.									
<b>Recommendations:</b> Remove tree due to current condition and anticipated decline. For tree replacement it is recommended to use XXX. Replacements should be planted immediately following removals and it is recommended to form a mulch collar around the base of the tree that will prevent any future damage caused by landscape maintenance and provide additional benefits to the tree. The Town should implement a comprehensive program of tree management including soil testing.								<b>Level of Urgency</b>

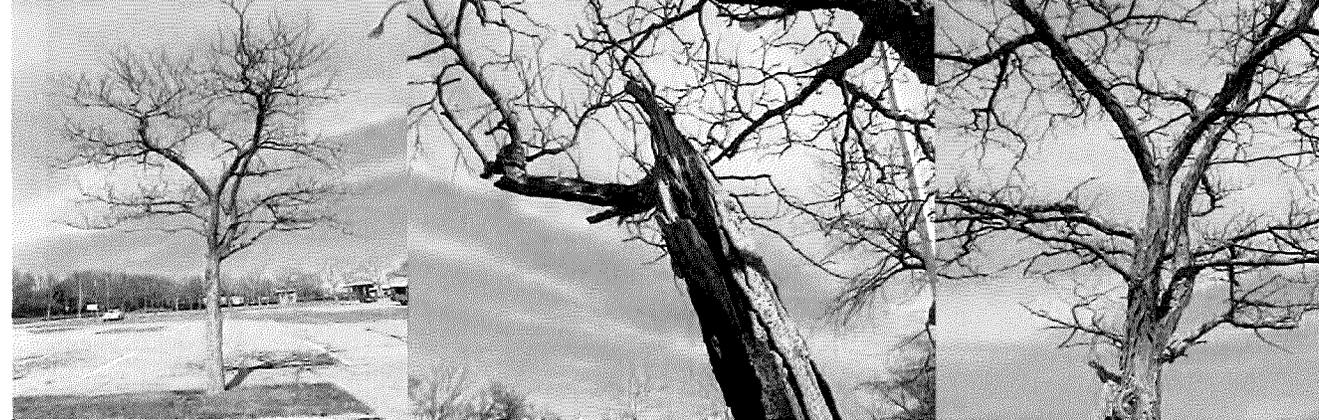
<b>Tree/Root Base/Pit</b>	Growing in a 6' wide grass strip in a dividing island, mechanical damage at base from landscape maintenance, buried root collar.
<b>Trunk Condition and Main Scaffold Branches</b>	Codominant leaders, included bark at trunk union, minor moss and lichen growth on trunk and scaffold branches, minor vertical cracking on trunk, water sprouting on scaffold branches, major damage on large scaffold branch, major dead scaffold branches.
<b>Crown/Structure , Branches &amp; Leaves</b>	Majority of branches are dead on dmahed scaffold branch, dead branches, broken branches hanging in crown, tree was not assessed during full leaf.
<b>Pest / Disease</b>	Moss and lichen growth on trunk.
<b>Setting</b>	North end of park in open parking lot, exposed to high winds.

<b>Recommendations:</b> It is recommended to implement a program that continues to monitor this tree by an ISA Arborist and If condition continues to decline, consider removal. For recommended treatment, proper corrective pruning that follows ANSI A300 standards should be performed to remove dead and damaged branches, specifically scaffold branches directly above the sidewalk. Additionally, it is recommended to form a mulch collar around the base of the tree that will prevent any future damage caused by landscape maintenance and provide additional benefits to the tree. Vertical mulching is recommended for mitigation, this is a technique that benefits stressed trees by improving the movement of water, air, and nutrients in the root zone and should be performed by a qualified tree care professional. The Town should implement a comprehensive program of tree management including soil testing.	<b>Level of Urgency</b>  <b>1</b>

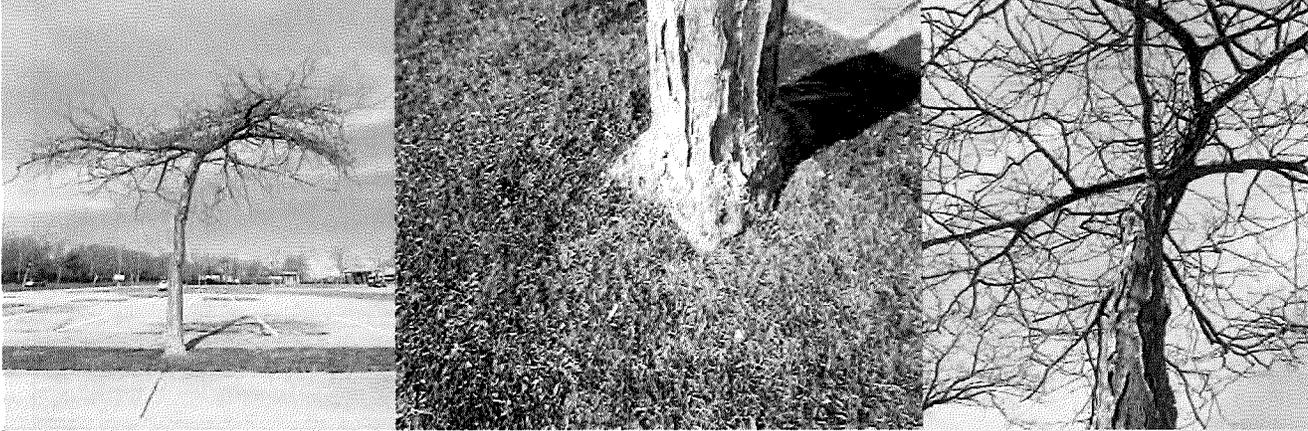
Growing in a 6' wide grass strip in a dividing island, mechanical damage at base from landscape maintenance, girdling roots.						
<b>Trunk Condition and Main Scaffold Branches</b>						
Moss and lichen growth on trunk and scaffold branches, trunk wounds from removed scaffold branches have not entirely healed, dead scaffold branches, splitting scaffold branch at branch union.						
<b>Crown/Structure, Branches &amp; Leaves</b>						
Poor crown structure, dead branches, broken branches hanging in crown, tree was not assessed during full leaf.						
<b>Pest / Disease</b>						
Moss and lichen growth on trunk.						
<b>Setting</b>						
North end of park in open parking lot, exposed to high winds.						
<b>Character</b>						
	Y	Does the tree make an important contribution to the character or amenity of the area?				
	Indigenous	Is the tree indigenous, rare, endangered, invasive or exotic?				
<b>Habitat</b>

N	Does the tree represent important habitat for native fauna?				
	N	Is the tree part of a wildlife Corridor, Buffer, etc?				
<b>Notes:</b>						
Evidence of recently fallen scaffold branches. Dead scaffold branches directly above sidewalk. Recommended to reassess this tree after bud break to evaluate the full condition of tree.						
<b>Recommendations:</b>						<b>Level of Urgency</b>
It is recommended to implement a program that continues to monitor this tree by an ISA Arborist and if condition continues to decline, consider removal. For recommended treatment, proper corrective pruning that follows ANSI A300 standards should be performed to remove dead and damaged branches, specifically scaffold branches directly above the sidewalk. Additionally, it is recommended to form a mulch collar around the base of the tree that will prevent any future damage caused by landscape maintenance and provide additional benefits to the tree. Vertical mulching is recommended for mitigation, this is a technique that benefits stressed trees by improving the movement of water, air, and nutrients in the root zone and should be performed by a qualified tree care professional. The Town should implement a comprehensive program of tree management including soil testing. Recommended to reassess this tree after bud break to evaluate the full condition of tree.						1

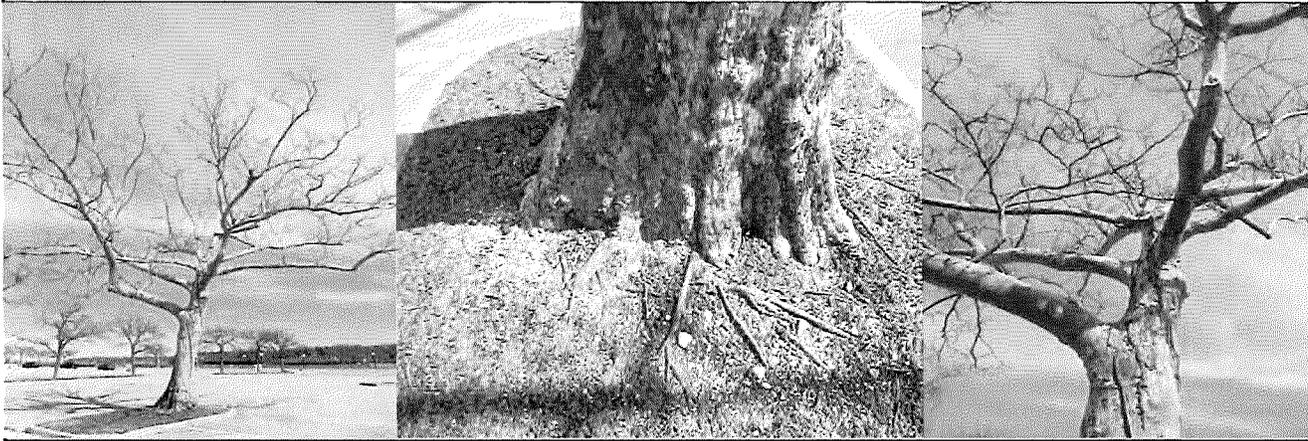
<b>Approx. Age</b>		E		<i>NP=Newly Planted Within 5yrs M=Moderate 10-20 yrs old E=Existing before development</i>					
<b>Tree/Root Base/Pit</b>		Growing in a parking lot island surrounded by grass, mechanical damage at base from landscape maintenance, minor girdling roots.							
<b>Trunk Condition and Main Scaffold Branches</b>		Major vertical cracking on trunk, minor trunk lean to the south, minor water sprouting on trunk and scaffold branches, trunk and scaffold wounds from removed branches have not entirely healed, major dead scaffold branches.							
<b>Crown/Structure, Branches &amp; Leaves</b>		Thin crown, poor small branch structure, major die-back at top of crown, major dead branches, broken branches hanging in crown, poor fruiting, tree was not assessed during full leaf.							
<b>Pest / Disease</b>		No noticeable signs.							
<b>Setting</b>		North end of park in open parking lot, exposed to high winds.

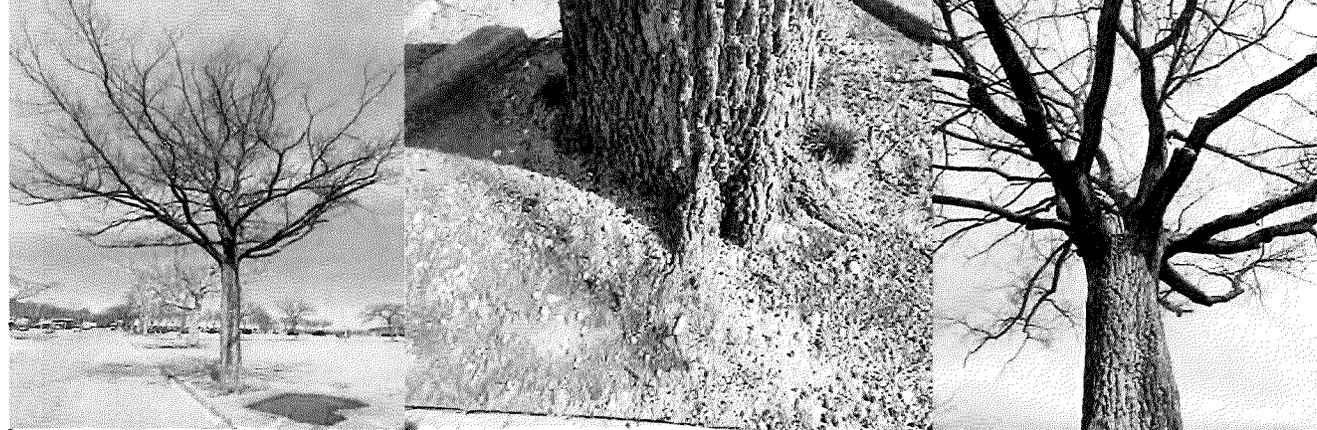
<b>Tree/Root Base/Pit</b>	Growing in a small parking lot island, major cracking and heaving of concrete curb and asphalt pavement surrounding base, major girdling roots.
<b>Trunk Condition and Main Scaffold Branches</b>	Codominant leaders, major moss and lichen growth on trunk, the top of multiple main leaders are dead and have major die-back of small branches, dead scaffold branches.
<b>Crown/Structure , Branches &amp; Leaves</b>	Major branch die-back at top of crown and outer branches, tree was not assessed during full leaf.
<b>Pest / Disease</b>	Moss and lichen growth on trunk.
<b>Setting</b>	North end of park in open parking lot, exposed to high winds.

**Notes:**  
Multiple main leaders have major die-back at the top of the tree crown, it is anticipated the condition of this tree will continue to decline. Recommended to reassess this tree after bud break to evaluate the full condition of tree.

<b>Recommendations:</b> Remove tree due to current condition and anticipated decline. For tree replacement it is recommended to use XXX. Replacements should be planted immediately following removals and it is recommended to form a mulch collar around the base of the tree that will prevent any future damage caused by landscape maintenance and provide additional benefits to the tree. The Town should implement a comprehensive program of tree management including soil testing.	<b>Level of Urgency</b>
	<b>1</b>

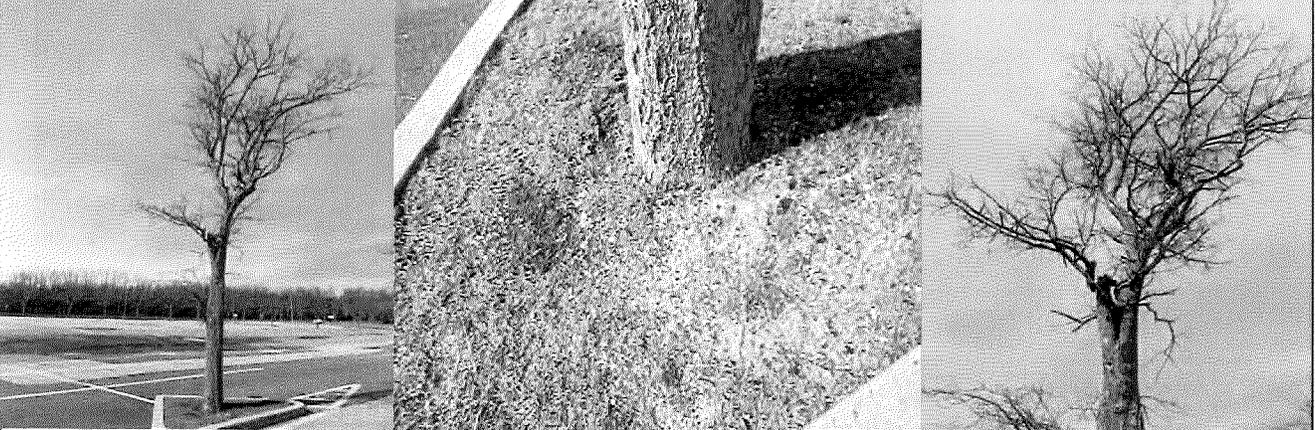
Trunk Condition and Main Scaffold Branches		Moss and lichen growth on trunk, major die-back at the top of tree crown, major dead and broken scaffold branches.							
Crown/Structure, Branches & Leaves		Very thin crown, branch die-back at top of crown, major dead branches, broken branches hanging in crown, tree was not assessed during full leaf.							
Pest / Disease		Moss and lichen growth on trunk.							
Setting		North end of park in open parking lot, exposed to high winds.							
Character		Y		Does the tree make an important contribution to the character or amenity of the area?					
		Indigenous		Is the tree indigenous, rare, endangered, invasive or exotic?					
Habitat		N		Does the tree represent important habitat for native fauna?					
		N		Is the tree part of a wildlife Corridor, Buffer, etc?					
Notes: New asphalt has been installed around the tree, it is expected that major root pruning has occurred during construction. More than 2/3 of tree crown is dead.

Recommendations: Remove tree due to current condition and anticipated decline. For tree replacement it is recommended to use XXX. Replacements should be planted immediately following removals and it is recommended to form a mulch collar around the base of the tree that will prevent any future damage caused by landscape maintenance and provide additional benefits to the tree. The Town should implement a comprehensive program of tree management including soil testing.								Level of Urgency	
								1	
Urgency Level: 1 - Requires Immediate Attention 2 - Within (1) Month 3 - Within (6) Months 4 - Within the year 5 - None

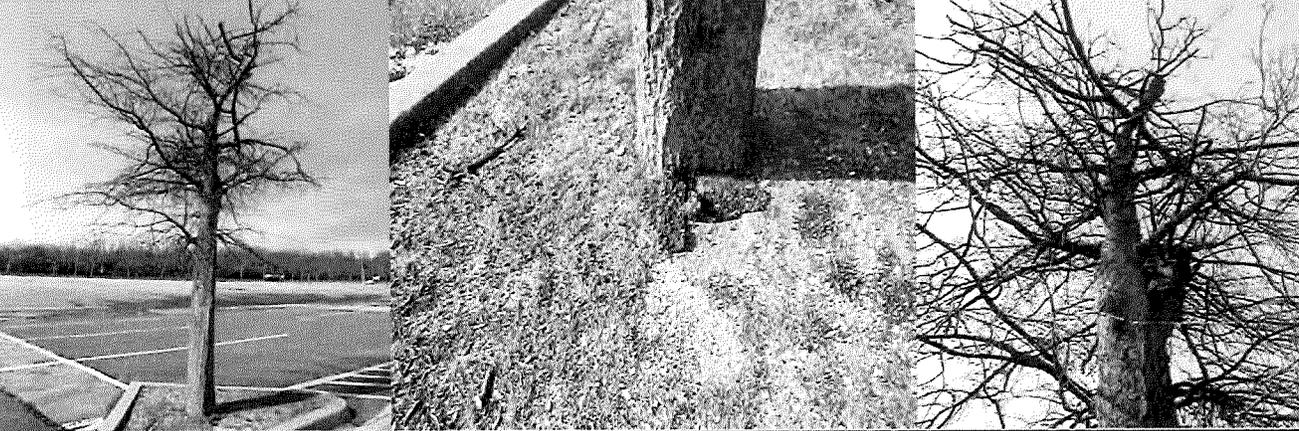
<b>Approx. Age</b>		M		<i>NP=Newly Planted Within 5yrs M=Moderate 10-20 yrs old E=Existing before development</i>					
<b>Tree/Root Base/Pit</b>		Growing in a small parking lot island, buried root collar.							
<b>Trunk Condition and Main Scaffold Branches</b>		Moss and lichen growth on trunk, dead central leader, major die-back around entire tree crown, major dead and broken scaffold branches.							
<b>Crown/Structure, Branches &amp; Leaves</b>		Very poor crown structure, branch die-back at top of crown, major dead branches, broken branches hanging in crown, tree was not assessed during full leaf.							
<b>Pest / Disease</b>		Moss and lichen growth on trunk.							
<b>Setting</b>		North end of park in open parking lot, exposed to high winds.							
<b>Character</b>		Y		<i>Does the tree make an important contribution to the character or amenity of the area?</i>					
<b>Habitat</b>		Indigenous		<i>Is the tree indigenous, rare, endangered, invasive or exotic?</i>

<b>Habitat</b>		N		<i>Does the tree represent important habitat for native fauna?</i>					
<b>Habitat</b>		N		<i>Is the tree part of a wildlife Corridor, Buffer, etc?</i>					
<b>Notes:</b> New asphalt has been installed around the tree, it is expected that major root pruning has occurred during construction. More than 2/3 of tree crown is dead.									
<b>Recommendations:</b> Remove tree due to current condition and anticipated decline. For tree replacement it is recommended to use XXX. Replacements should be planted immediately following removals and it is recommended to form a mulch collar around the base of the tree that will prevent any future damage caused by landscape maintenance and provide additional benefits to the tree. The Town should implement a comprehensive program of tree management including soil testing.								<b>Level of Urgency</b>	
								1	
<b>Urgency Level:</b> 1 - Requires Immediate Attention 2 - Within (1) Month 3 - Within (6) Months 4 - Within the year 5 - None

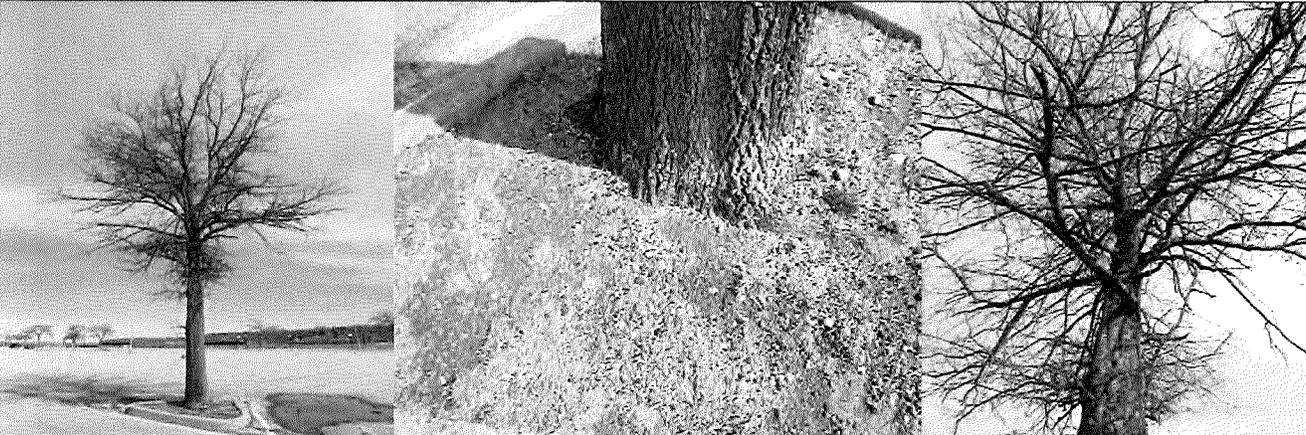
<b>Tree/Root Base/Pit</b>						
Growing in a small parking lot island, major cracking and heaving of concrete curb and asphalt pavement surrounding the tree island.						
<b>Trunk Condition and Main Scaffold Branches</b>						
Moss and lichen growth on trunk, water sprouting on scaffold branches, dead scaffold branches.						
<b>Crown/Structure , Branches &amp; Leaves</b>						
Branch die-back on outer branches of crown, tree was not assessed during full leaf.						
<b>Pest / Disease</b>						
Moss and lichen growth on trunk.						
<b>Setting</b>						
North end of park in open parking lot, exposed to high winds.						
<b>Character</b>						
Y Does the tree make an important contribution to the character or amenity of the area?						
Indigenous Is the tree indigenous, rare, endangered, invasive or exotic?						
<b>Habitat</b>						
N Does the tree represent important habitat for native fauna?						
N Is the tree part of a wildlife Corridor, Buffer, etc?

<b>Notes:</b>						
Major die-back at the top of the tree crown is evident but unclear how far the damage has reached. Recommended to reassess this tree after bud break to evaluate the full condition of tree.						
<b>Recommendations:</b>						Level of Urgency  <b>1</b>
It is recommended to implement a program that continues to monitor this tree by an ISA Arborist and if condition continues to decline, consider removal. For recommended treatment, proper corrective pruning that follows ANSI A300 standards should be performed to remove dead and damaged branches. Additionally, it is recommended to form a mulch collar around the base of the tree that will prevent any future damage caused by landscape maintenance and provide additional benefits to the tree. Vertical mulching is recommended for mitigation, this is a technique that benefits stressed trees by improving the movement of water, air, and nutrients in the root zone and should be performed by a qualified tree care professional. The Town should implement a comprehensive program of tree management including soil testing. Recommended to reassess this tree after bud break to evaluate the full condition of tree.

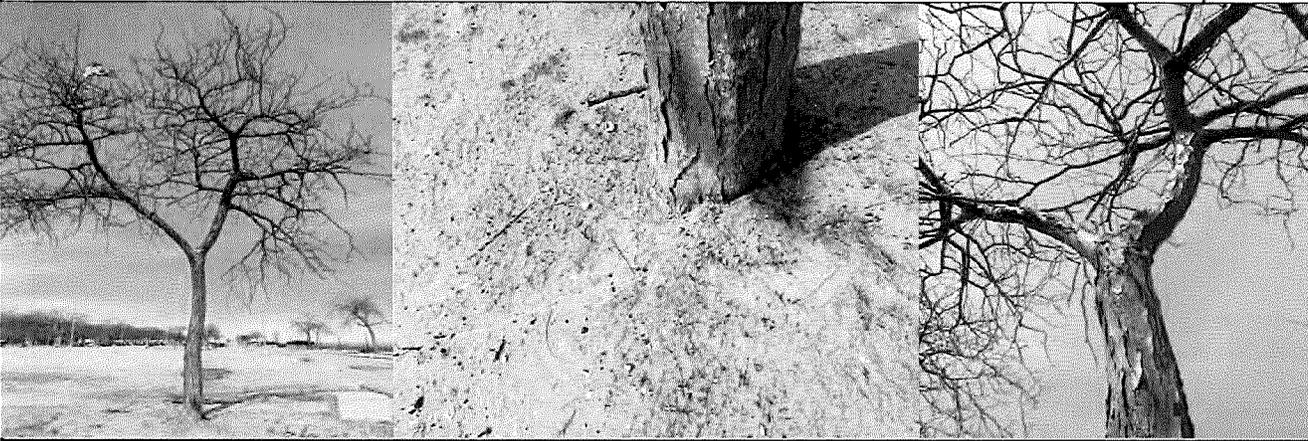
N	Is the tree part of a wildlife Corridor, Buffer, etc?						
<b>Notes:</b> Previous tag #425 nailed to trunk. Evidence of pruning to scaffold branches. Numerous dead scaffold and smaller branches that will require a major pruning effort and leave the tree crown even thinner than it currently is.									
<b>Recommendations:</b> Remove tree due to current condition and anticipated decline. For tree replacement it is recommended to use XXX. Replacements should be planted immediately following removals and it is recommended to form a mulch collar around the base of the tree that will prevent any future damage caused by landscape maintenance and provide additional benefits to the tree. The Town should implement a comprehensive program of tree management including soil testing.								Level of Urgency	
								<b>1</b>	
<b>Urgency Level:</b> 1 - Requires Immediate Attention 2 - Within (1) Month 3 - Within (6) Months 4 - Within the year 5 - None

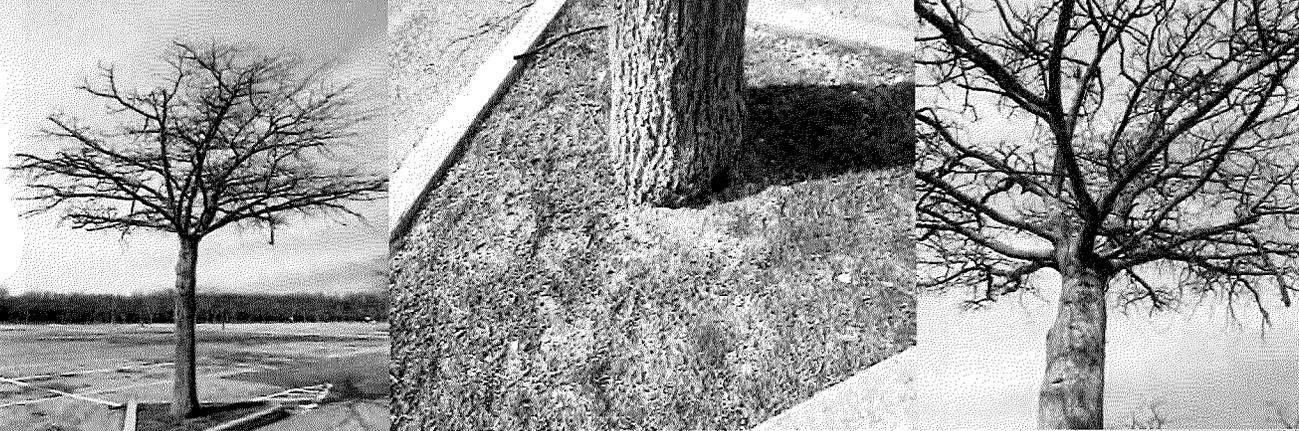
<hr/>						
<b>Notes:</b> Previous tag #428 nailed to trunk. Evidence of major broken branches, dead and broken branches are directly above parking spaces.						
<b>Recommendations:</b> Remove tree due to current condition and anticipated decline. For tree replacement it is recommended to use XXX. Replacements should be planted immediately following removals and it is recommended to form a mulch collar around the base of the tree that will prevent any future damage caused by landscape maintenance and provide additional benefits to the tree. The Town should implement a comprehensive program of tree management including soil testing.						Level of Urgency
						1
<b>Urgency Level:</b> 1 - Requires Immediate Attention 2 - Within (1) Month 3 - Within (6) Months 4 - Within the year 5 - None
