THE TOWN OF NORTH HEMPSTEAD

ARBORIST TREE ASSESSMENT REPORT FOR MANORHAVEN BEACH PARK

DECEMBER 2015

B. THAYER ASSOCIATES

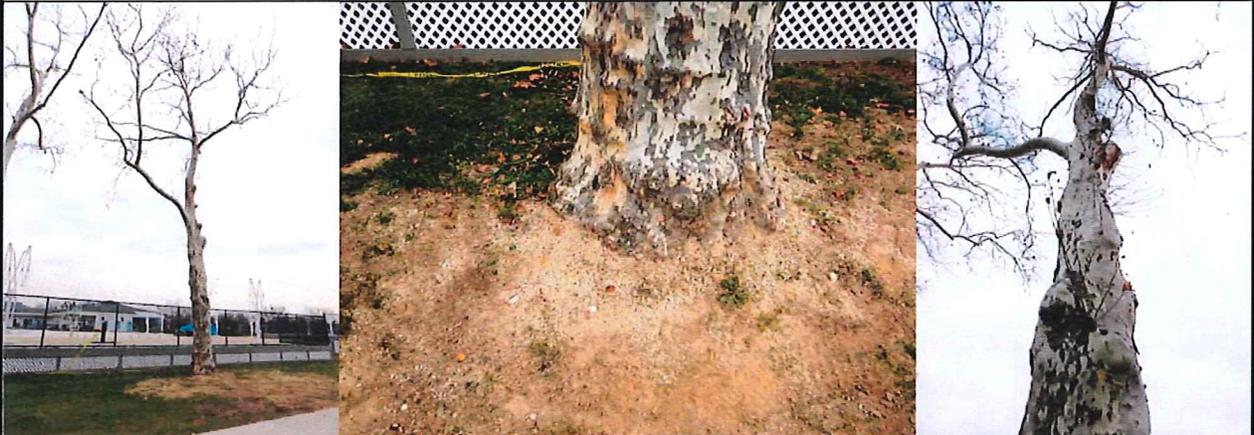
Assignment:	Tree No.:
1	1

Tree/Root Base/Pit	Recent utility line installed in close proximity to trunk, major impacts to roots is likely to have occurred; minor mechanical damage at base from landscape maintenance.
Trunk Condition and Main Scaffold Branches	Major sprouting on trunk and scaffold branches; bark discoloration and defoliation around recent scaffold removal.
Crown/Structure , Branches & Leaves	Thin crown; minimal fruiting on small branches; poor small branch structure; minor dead branches; tree was not assessed during full leaf.
Pest / Disease	Evidence of bird or insect activity.
Setting	Along entrance path to park from Manorhaven Blvd., adjacent to pool area.

Notes: Evidence of pruning to major scaffold branches and smaller branches, water sprouting around old pruning cuts. Lawn area at base of tree shows signs of utility excavation. Tree exhibits heavy pruning of a large number of lower branches and inner branches resulting in "Lion's-tailing" appearance which increases the risk of branch failure by weakening tree roots and decreasing the dampening effect that interior limbs provide during storms. Damage caused by root cutting due to utility excavation can further reduce tree structure.

<p>Recommendations: This tree should be removed prior to reopening of the pool area. For tree replacement it is recommended to use <i>Platanus x acerifolia</i> 'Liberty'. Replacements should be planted immediately following removals and it is recommended to form a mulch collar around the base of the tree that will prevent any future damage caused by landscape maintenance and provide additional benefits to the tree. Implement a comprehensive program of tree management including soil testing.</p>	Level of Urgency
	2

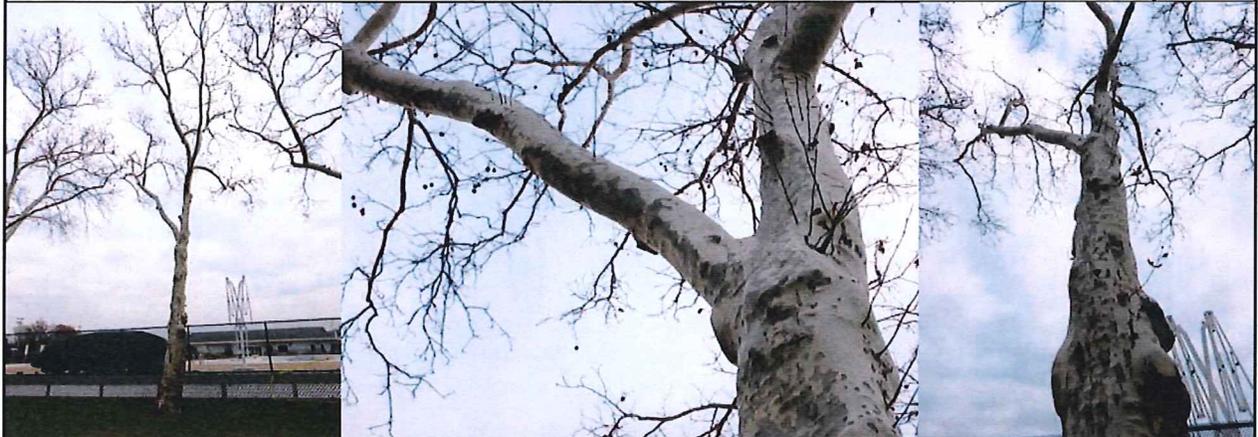
Assignment:	Tree No.:
1	2

Arborist Assessment Report		Location: Manorhaven Beach Park - Port Washington, NY	Date: 12/08/2015
Inspector: Dan Maher	Weather: Overcast	Lat/Long: N 40° 50' 22.2" W 73° 42' 55.44"	Time: 12:46
Specimen:	Common Name: LONDON PLANETREE	Scientific name: <i>Platanus x acerifolia</i>	
Descriptor	Value	Range	
Girth	24"	Trunk Diameter Measured at Breast Height (DBH)	
Approx. Height	55-60'	Approximate Height to top of Canopy	
Canopy	N 15' ,S 13' ,E 18' ,W 14'	Canopy Radius in Feet - North South East West	
Condition	3	Health of Specimen - 1 Dead - 2 Declining - 3 Moderate - 4 Good - 5 Excellent	
Approx. Age	E	NP=Newly Planted Within 5yrs M=Moderate 10-20 yrs old E=Existing before development	
Tree/Root Base/Pit	Minor mechanical damage at base from landscape maintenance.		
Trunk Condition and Main Scaffold Branches	Large vertical cracks on trunk; old pruning cuts not completely healing; minor lean towards pool area, water sprouting on trunk and scaffold branches.

Crown/Structure , Branches & Leaves	Thin crown; minimal fruiting on small branches; minor dead branches; tree was not assessed during full leaf.		
Pest / Disease	No noticeable signs.		
Setting	Along entrance path to park from Manorhaven Blvd., adjacent to pool area.		
Character	Y	Does the tree make an important contribution to the character or amenity of the area?	
	Indigenous	Is the tree indigenous, rare, endangered, invasive or exotic?	
Habitat	N	Does the tree represent important habitat for native fauna?	
	N	Is the tree part of a wildlife Corridor, Buffer, etc?	
<p>Notes: Branches hanging over adjacent pool area, evidence of removal of major scaffold branches over pool area, and recent pruning on most of remaining scaffold branches. Tree exhibits heavy pruning of a large number of lower branches and inner branches resulting in "Lion's-tailing" appearance which increases the risk of branch failure by weakening tree roots and decreasing the dampening effect that interior limbs provide during storms.</p>

<p>Recommendations: It is recommended to implement a program that continues to monitor this tree by an ISA Arborist and If condition continues to decline, consider removal. For recommended treatment, proper corrective pruning that follows ANSI A300 standards should be performed to remove dead branches over the pool area before it reopens. Additionally, it is recommended to form a mulch collar around the base of the tree that will prevent any future damage caused by landscape maintenance and provide additional benefits to the tree. Vertical mulching is recommended for mitigation, this is a technique that benefits stressed trees by improving the movement of water, air, and nutrients in the root zone and should be performed by a qualified tree care professional. The Town should implement a comprehensive program of tree management including soil testing.</p>			Level of Urgency
<p>Urgency Level: 1 - Requires Immediate Attention 2 - Within (1) Month 3 - Within (6) Months 4 - Within the year 5 - None</p>			2

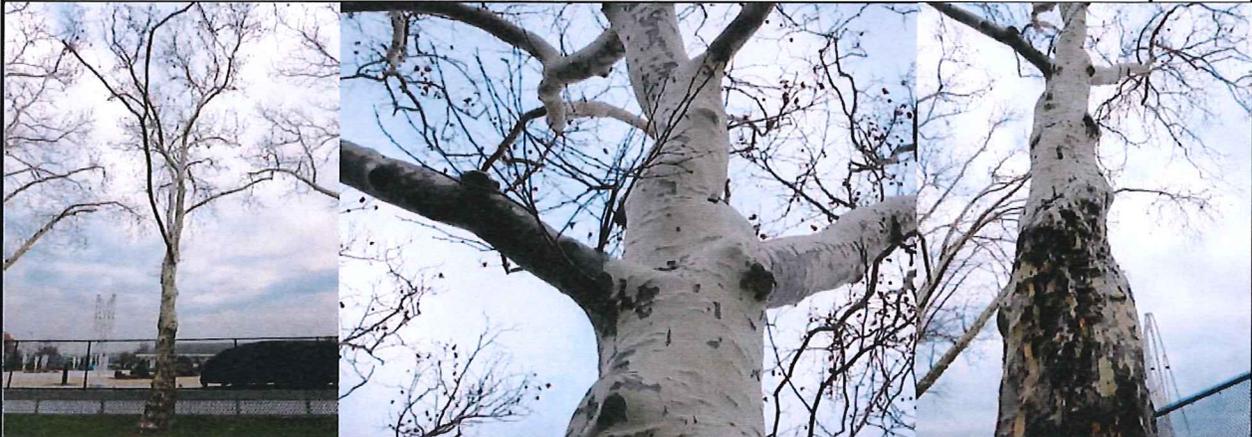
Arborist Assessment Report		Location: Manorhaven Beach Park - Port Washington, NY	Date: 12/08/2015
Inspector: Dan Maher		Weather: Overcast	La/Long: N 40° 50' 22.47" W 73° 42' 55.52" Time: 12:59
Specimen:	Common Name: LONDON PLANETREE	Scientific name: <i>Platanus x acerifolia</i>	
Descriptor	Value	Range	
Girth	26"	Trunk Diameter Measured at Breast Height (DBH)	
Approx. Height	55-60'	Approximate Height to top of Canopy	
Canopy	N 14' ,S 23' ,E 21' ,W 21'	Canopy Radius in Feet - North South East West	
Condition	3	Health of Specimen - 1 Dead - 2 Declining - 3 Moderate - 4 Good - 5 Excellent	
Approx. Age	E	NP=Newly Planted Within 5yrs M=Moderate 10-20 yrs old E=Existing before development	
Tree/Root Base/Pit	Mechanical damage at base from landscape maintenance.		
Trunk Condition and Main Scaffold Branches	Vertical cracks on trunk; water sprouting on trunk and scaffold branches; partially dead scaffold branches.

Notes: Branches hanging over adjacent pool area. Tree exhibits heavy pruning of a large number of lower branches and inner branches resulting in "Lion's-tailing" appearance which increases the risk of branch failure by weakening tree roots and decreasing the dampening effect that interior limbs provide during storms.

Recommendations: It is recommended to implement a program that continues to monitor this tree by an ISA Arborist and If condition continues to decline, consider removal. For recommended treatment, proper corrective pruning that follows ANSI A300 standards should be performed to remove dead branches over the pool area before it reopens. Additionally, it is recommended to form a mulch collar around the base of the tree that will prevent any future damage caused by landscape maintenance and provide additional benefits to the tree. Vertical mulching is recommended for mitigation, this is a technique that benefits stressed trees by improving the movement of water, air, and nutrients in the root zone and should be performed by a qualified tree care professional. The Town should implement a comprehensive program of tree management including soil testing.

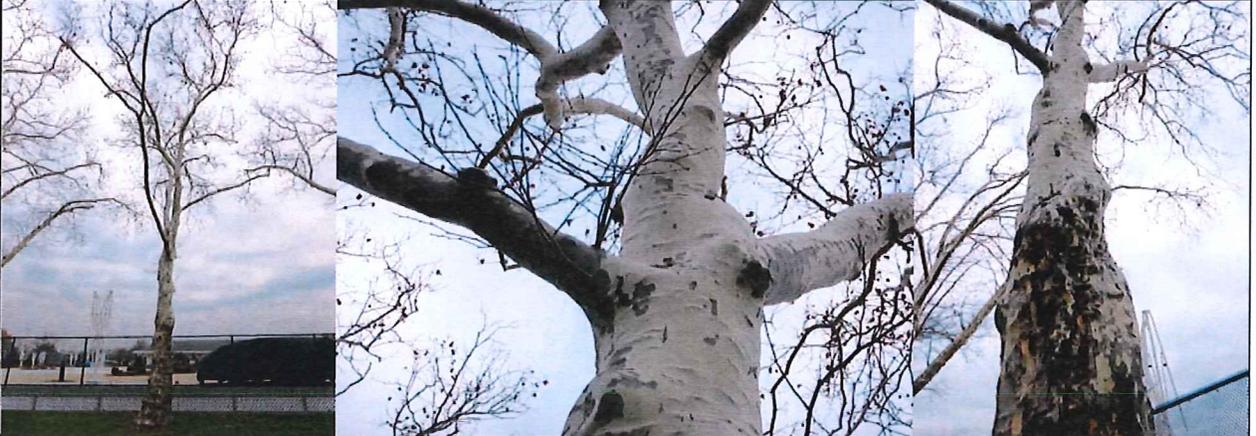
100 Crossways Park Drive West, Ste 104 Woodbury, New York 11797		t: 516.364.0660 f: 516.364.0668		www.bthayerassociates.com		Assignment:	Tree No.:
								1	4
Arborist Assessment Report				Location: Manorhaven Beach Park - Port Washington, NY				Date: 12/08/2015	
Inspector: Dan Maher				Weather: Overcast		Lat/Long: N 40° 50' 22.74" W 73° 42' 55.59"		Time: 1:15	
Specimen:		Common Name: LONDON PLANETREE		Scientific name: <i>Platanus x acerifolia</i>					
Descriptor		Value		Range					
Girth		27"		Trunk Diameter Measured at Breast Height (DBH)					
Approx. Height		60-65'		Approximate Height to top of Canopy					
Canopy		N 26' ,S 21' ,E 22' ,W 17'		Canopy Radius in Feet - North South East West					
Condition		3		Health of Specimen - 1 Dead - 2 Declining - 3 Moderate - 4 Good - 5 Excellent					
Approx. Age		E		NP=Newly Planted Within 5yrs M=Moderate 10-20 yrs old E=Existing before development					
Tree/Root Base/Pit		Mechanical damage at base from landscape maintenance.

Trunk Condition and Main Scaffold Branches		Major water sprouting on scaffold branches; die-back on major scaffold branch hanging over pool deck; old pruning cuts on scaffold branches not completely healed.							
Crown/Structure , Branches & Leaves		Thin crown; minimal fruiting on branches; dead smaller branches off scaffold branch mentioned above; tree was not assessed during full leaf.							
Pest / Disease		No noticeable signs.							
Setting		Along entrance path to park from Manorhaven Blvd., adjacent to pool area.							
Character		Y		Does the tree make an important contribution to the character or amenity of the area?					
		Indigenous		Is the tree indigenous, rare, endangered, invasive or exotic?					
Habitat		N		Does the tree represent important habitat for native fauna?					
		N		Is the tree part of a wildlife Corridor, Buffer, etc?					
Notes: Branches hanging over pool area, evidence of removal of major scaffold branches. Tree exhibits heavy pruning of a large number of lower branches and inner branches resulting in "Lion's-tailing" appearance which increases the risk of branch failure by weakening tree roots and decreasing the dampening effect that interior limbs provide during storms.

Recommendations: It is recommended to implement a program that continues to monitor this tree by an ISA Arborist and If condition continues to decline, consider removal. For recommended treatment, proper corrective pruning that follows ANSI A300 standards should be performed to remove dead branches over the pool area before it reopens. Additionally, it is recommended to form a mulch collar around the base of the tree that will prevent any future damage caused by landscape maintenance and provide additional benefits to the tree. Vertical mulching is recommended for mitigation, this is a technique that benefits stressed trees by improving the movement of water, air, and nutrients in the root zone and should be performed by a qualified tree care professional. The Town should implement a comprehensive program of tree management including soil testing.									Level of Urgency
									2
Urgency Level: 1 - Requires Immediate Attention 2 - Within (1) Month 3 - Within (6) Months 4 - Within the year 5 - None

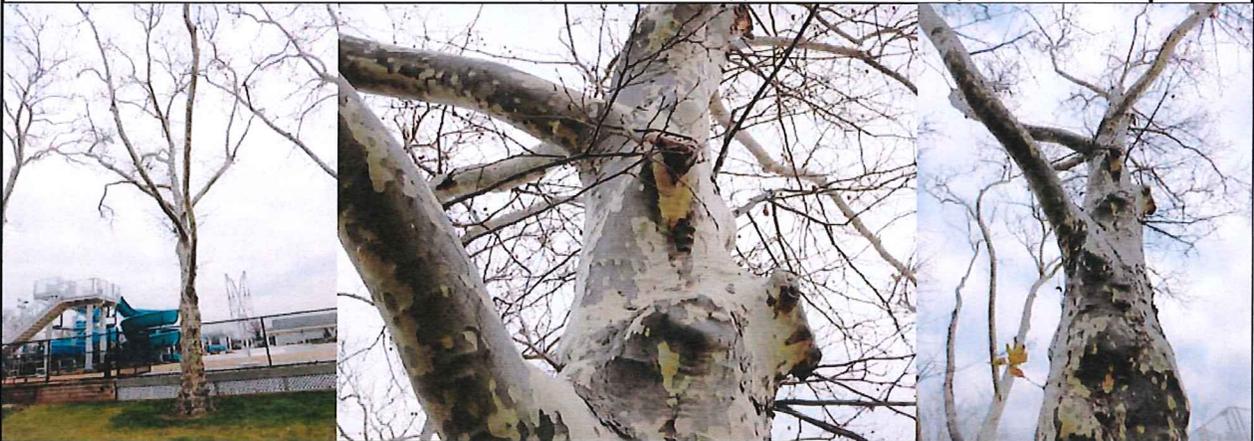
Arborist Assessment Report		Location: Manorhaven Beach Park - Port Washington, NY	Date: 12/08/2015
Inspector: Dan Maher		Weather: Overcast	Lat/Long: N 40° 50' 22.96" W 73° 42' 55.67" Time: 1:28
Specimen:	Common Name: LONDON PLANETREE	Scientific name: <i>Platanus x acerifolia</i>	
Descriptor	Value	Range	
Girth	25"	Trunk Diameter Measured at Breast Height (DBH)	
Approx. Height	55-60'	Approximate Height to top of Canopy	
Canopy	N 20", S 17', E 18', W 21'	Canopy Radius in Feet - North South East West	
Condition	3	Health of Specimen - 1 Dead - 2 Declining - 3 Moderate - 4 Good - 5 Excellent	
Approx. Age	E	NP=Newly Planted Within 5yrs M=Moderate 10-20 yrs old E=Existing before development	
Tree/Root Base/Pit	Mechanical damage at base and exposed root from landscape maintenance.		
Trunk Condition and Main Scaffold Branches	Minor vertical cracks on trunk; water sprouting on trunk and scaffold branches; recent pruning cuts on scaffold branches not completely healed.

Notes: Branches hanging over pool area, evidence of recent pruning to smaller branches, branch die-back over portable shade structure on pool deck. Tree exhibits heavy pruning of a large number of lower branches and inner branches resulting in "Lion's-tailing" appearance which increases the risk of branch failure by weakening tree roots and decreasing the dampening effect that interior limbs provide during storms.

Recommendations: It is recommended to implement a program that continues to monitor this tree by an ISA Arborist and if condition continues to decline, consider removal. For recommended treatment, proper corrective pruning that follows ANSI A300 standards should be performed to remove dead branches before pool area reopens. Additionally, it is recommended to form a mulch collar around the base of the tree that will prevent any future damage caused by landscape maintenance and provide additional benefits to the tree. Vertical mulching is recommended for mitigation, this is a technique that benefits stressed trees by improving the movement of water, air, and nutrients in the root zone and should be performed by a qualified tree care professional. The Town should implement a comprehensive program of tree management including soil testing.

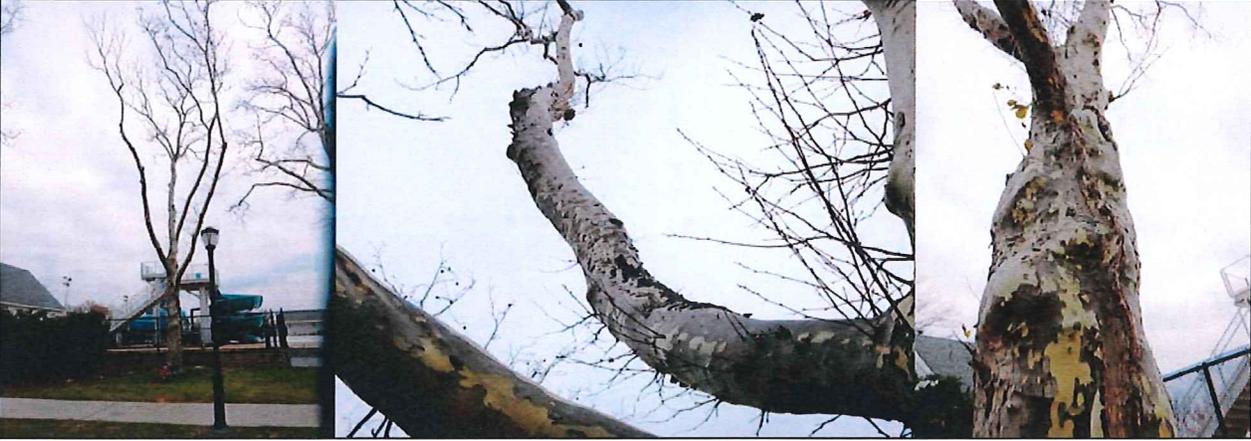
Tree/Root Base/Pit	Mechanical damage at base from landscape maintenance.
Trunk Condition and Main Scaffold Branches	Major vertical cracks on trunk; major water sprouting on trunk and scaffold branches; evidence of recent removal of major scaffold branches; partially dead major scaffold branches are declining.
Crown/Structure , Branches & Leaves	Thin crown; poor branching structure; poor small branch structure; tree was not assessed during full leaf.
Pest / Disease	No noticeable signs.
Setting	Along entrance path to park from Manorhaven Blvd., adjacent to pool area and maintenance building.

Notes: Trunk within 35' of maintenance building and 25' of waterslide staircase on adjacent pool deck, branches hanging over pool area. Tree exhibits heavy pruning of a large number of lower branches and inner branches resulting in "Lion's-tailing" appearance which increases the risk of branch failure by weakening tree roots and decreasing the dampening effect that interior limbs provide during storms.

<p>Recommendations: This tree should be removed prior to reopening of pool area. For tree replacement it is recommended to use <i>Platanus x acerifolia</i> 'Liberty'. Replacements should be planted immediately following removals and it is recommended to form a mulch collar around the base of the tree that will prevent any future damage caused by landscape maintenance and provide additional benefits to the tree. The Town should implement a comprehensive program of tree management including soil testing.</p>	<div style="border: 1px solid black; padding: 5px;">Level of Urgency</div>
--	--

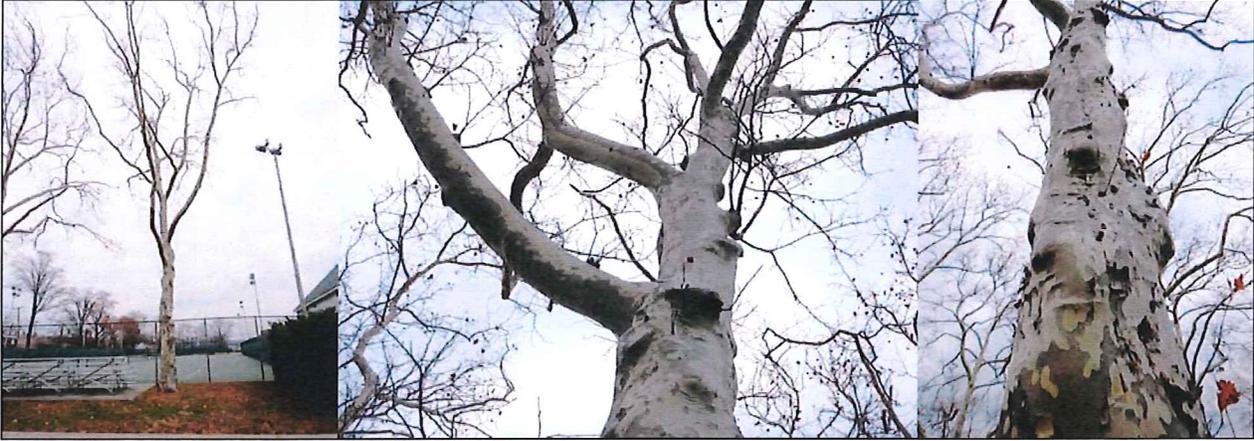
Tree/Root Base/Pit	Minor mechanical damage at base from landscape maintenance.
Trunk Condition and Main Scaffold Branches	Water sprouting on scaffold branches; old pruning cuts on trunk not completely healed.
Crown/Structure , Branches & Leaves	Thin crown; moderate fruiting; minor damage to small branches; minor die-back on small branches; tree was not assessed during full leaf.
Pest / Disease	No noticeable signs.
Setting	Along entrance path to park from Manorhaven Blvd., adjacent to tennis courts.

Notes: Trunk is 8' from tennis courts, branches leaning over courts. Trunk is 1' from concrete slab for bleachers. Tree exhibits heavy pruning of a large number of lower branches and inner branches resulting in "Lion's-tailing" appearance which increases the risk of branch failure by weakening tree roots and decreasing the dampening effect that interior limbs provide during storms.

Recommendations: It is recommended to implement a program that continues to monitor this tree by an ISA Arborist and If condition continues to decline, consider removal. For recommended treatment, proper corrective pruning that follows ANSI A300 standards should be performed to remove dead branches. Additionally, it is recommended to form a mulch collar around the base of the tree that will prevent any future damage caused by landscape maintenance and provide additional benefits to the tree. Vertical mulching is recommended for mitigation, this is a technique that benefits stressed trees by improving the movement of water, air, and nutrients in the root zone and should be performed by a qualified tree care professional. The Town should implement a comprehensive program of tree management including soil testing.

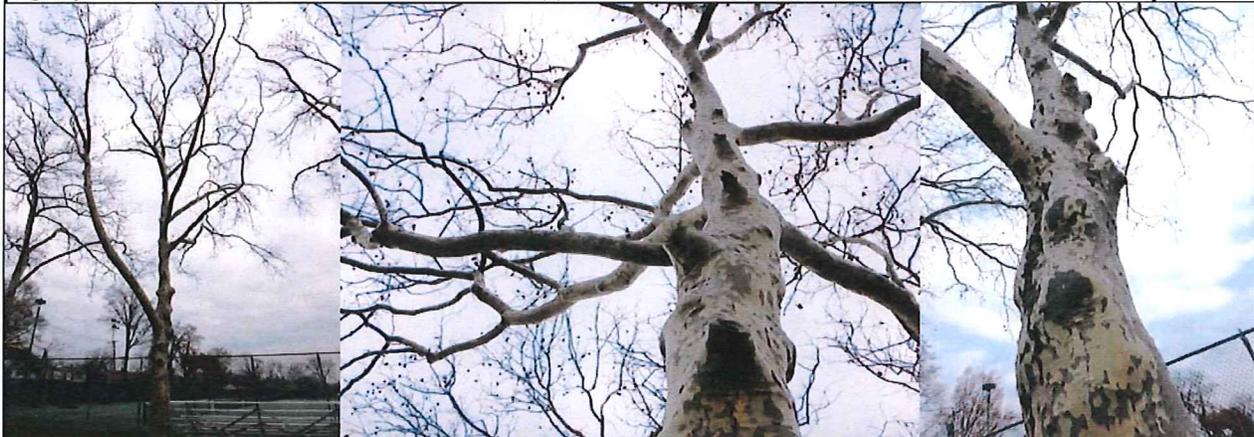
Arborist Assessment Report		Location: Manorhaven Beach Park - Port Washington, NY	Date: 12/08/2015
Inspector: Dan Maher		Weather: Overcast	Lat/Long: N 40° 50' 24.51" W 73° 42' 56.16" Time: 2:16
Specimen:	Common Name: LONDON PLANETREE	Scientific name: <i>Platanus x acerifolia</i>	
Descriptor	Value	Range	
Girth	26"	Trunk Diameter Measured at Breast Height (DBH)	
Approx. Height	55-60'	Approximate Height to top of Canopy	
Canopy	N 20' ,S 17' ,E 22' ,W 20'	Canopy Radius in Feet - North South East West	
Condition	3	Health of Specimen - 1 Dead - 2 Declining - 3 Moderate - 4 Good - 5 Excellent	
Approx. Age	E	NP=Newly Planted Within 5yrs M=Moderate 10-20 yrs old E=Existing before development	
Tree/Root Base/Pit	Minor mechanical damage at base from landscape maintenance.		
Trunk Condition and Main Scaffold Branches	Minor water sprouting on scaffold branches; multiple trunk wounds from fallen branches that have not completely healed.

Notes: Trunk 8' from tennis courts, branches leaning over courts. 1' from concrete slab for bleachers. Evidence of removal of scaffold branches on side of tennis courts. Tree exhibits heavy pruning of a large number of lower branches and inner branches resulting in "Lion's-tailing" appearance which increases the risk of branch failure by weakening tree roots and decreasing the dampening effect that interior limbs provide during storms.

Recommendations: It is recommended to implement a program that continues to monitor this tree by an ISA Arborist and If condition continues to decline, consider removal. It is recommended to form a mulch collar around the base of the tree that will prevent any future damage caused by landscape maintenance and provide additional benefits to the tree. Vertical mulching is recommended for mitigation, this is a technique that benefits stressed trees by improving the movement of water, air, and nutrients in the root zone and should be performed by a qualified tree care professional. The Town should implement a comprehensive program of tree management including soil testing.

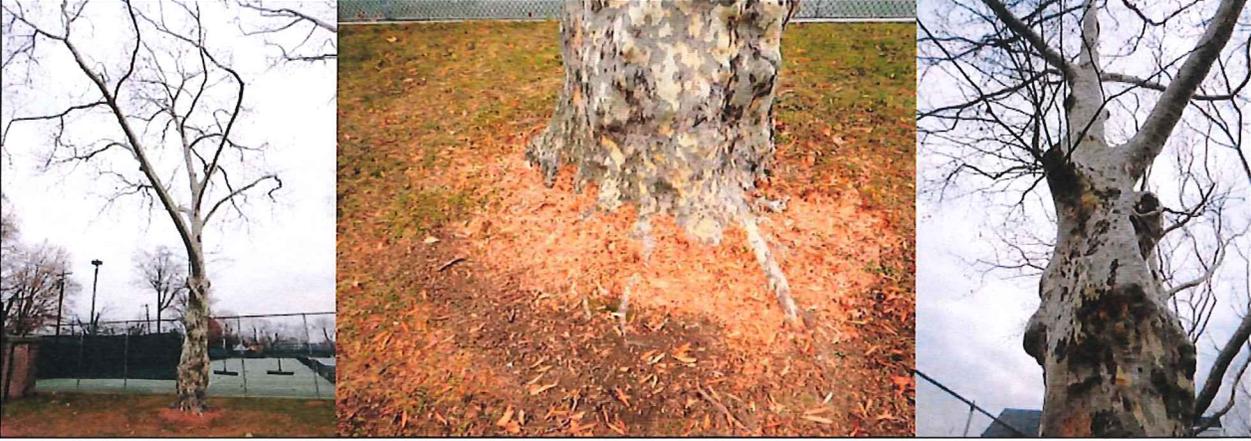
Tree/Root Base/Pit	Mechanical damage at base and exposed root from landscape maintenance.
Trunk Condition and Main Scaffold Branches	Major trunk wounds from old pruning cuts that have not completely healed and appear to have canker rot; water sprouting on trunk and scaffold branches.
Crown/Structure , Branches & Leaves	Moderate fruiting on small branches; damaged branches hanging over tennis courts; relatively full canopy compared to adjacent trees; tree was not assessed during full leaf.
Pest / Disease	No noticeable signs.
Setting	Along entrance path to park from Manorhaven Blvd., adjacent to tennis courts.

Notes: Trunk 6' from tennis courts and closest tree to entrance gate off Manorhaven Blvd. Evidence of recent removal of major scaffold branches. Tree exhibits heavy pruning of a large number of lower branches and inner branches resulting in "Lion's-tailing" appearance which increases the risk of branch failure by weakening tree roots and decreasing the dampening effect that interior limbs provide during storms.

Recommendations: It is recommended to implement a program that continues to monitor this tree by an ISA Arborist and If condition continues to decline, consider removal. For recommended treatment, proper corrective pruning that follows ANSI A300 standards should be performed to remove dead and damaged branches. Additionally, it is recommended to form a mulch collar around the base of the tree that will prevent any future damage caused by landscape maintenance and provide additional benefits to the tree. Vertical mulching is recommended for mitigation, this is a technique that benefits stressed trees by improving the movement of water, air, and nutrients in the root zone and should be performed by a qualified tree care professional. The Town should implement a comprehensive program of tree management including soil testing.

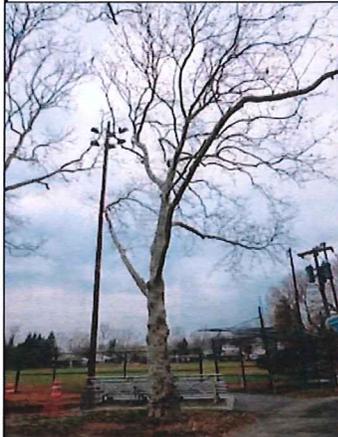
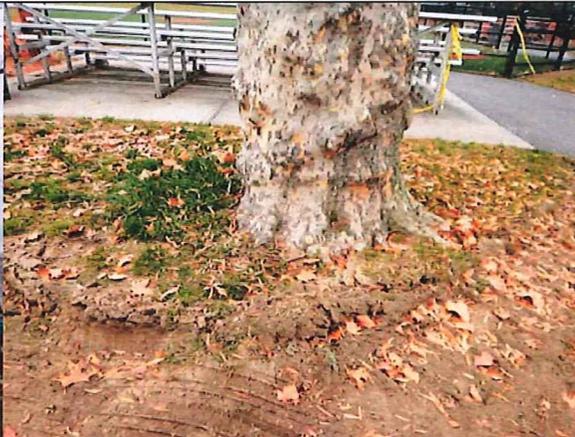
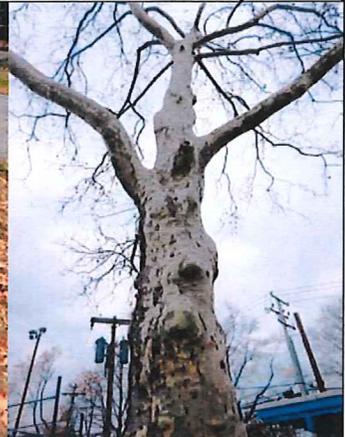
Assignment:	Tree No.:
1	10

Arborist Assessment Report		Location: Manorhaven Beach Park - Port Washington, NY	Date: 12/08/2015		
Inspector: Dan Maher		Weather: Overcast	Lat/Long: N 40° 50' 24.82" W 73° 42' 56.65" Time: 3:00		
Specimen:	Common Name: LONDON PLANETREE	Scientific name: <i>Platanus x acerifolia</i>			
Descriptor	Value	Range			
Girth	33"	Trunk Diameter Measured at Breast Height (DBH)			
Approx. Height	60-65'	Approximate Height to top of Canopy			
Canopy	N 38' ,S 12' ,E 21' ,W 25'	Canopy Radius in Feet - North South East West			
Condition	3	Health of Specimen - 1 Dead - 2 Declining - 3 Moderate - 4 Good - 5 Excellent			
Approx. Age	E	NP=Newly Planted Within 5yrs M=Moderate 10-20 yrs old E=Existing before development			
Tree/Root Base/Pit	Minor mechanical damage at base from landscape maintenance; evidence of root compaction from heavy machinery underneath canopy.				
Trunk Condition and Main Scaffold Branches	Vertical cracks on trunk; water sprouting on scaffold branches; long scaffold branch leaning over entrance to park with major water sprouting; scaffold branch on west side of tree is growing into current light pole.				
Crown/Structure , Branches & Leaves	Uneven canopy; fruiting well on small branches throughout crown; minor damaged branches; tree was not assessed during full leaf.				
Pest / Disease	No noticeable signs.				
Setting	Along entrance path to park from Manorhaven Blvd., adjacent to baseball field.				
Character	Y	Does the tree make an important contribution to the character or amenity of the area?			
	Indigenous	Is the tree indigenous, rare, endangered, invasive or exotic?			
Habitat	N	Does the tree represent important habitat for native fauna?			
	N	Is the tree part of a wildlife Corridor, Buffer, etc?			
<p>Notes: Recent excavation for a 10' x 10' concrete foundation for new light pole 13' away from trunk. New light pole may require pruning of major scaffold branch hanging over bleachers. Deep track marks close to trunk from heavy machinery used for excavation of new light pole foundation. Tree appears to be in moderate to good condition however, recent construction activities may add more stress to a tree that does show signs of impact from salt damages. Tree exhibits heavy pruning of a large number of lower branches and inner branches resulting in "Lion's-tailing" appearance which increases the risk of branch failure by weakening tree roots and decreasing the dampening effect that interior limbs provide during storms.</p>					
<p>Recommendations: It is recommended to implement a program that continues to monitor this tree by an ISA Arborist and if condition continues to decline, consider removal. For recommended treatment, proper corrective pruning that follows ANSI A300 standards should be performed to prune back scaffold branch over park entrance to reduce load on extended limb. Additionally, it is recommended to form a mulch collar around the base of the tree that will prevent any future damage caused by landscape maintenance and provide additional benefits to the tree. Vertical mulching is recommended for mitigation, this is a technique that benefits stressed trees by improving the movement of water, air, and nutrients in the root zone and should be performed by a qualified tree care professional. The Town should implement a comprehensive program of tree management including soil testing.</p>			<table border="1"> <tr> <td>Level of Urgency</td> </tr> <tr> <td>2</td> </tr> </table>	Level of Urgency	2
Level of Urgency					
2					
<p>Urgency Level: 1 - Requires Immediate Attention 2 - Within (1) Month 3 - Within (6) Months 4 - Within the year 5 - None</p>

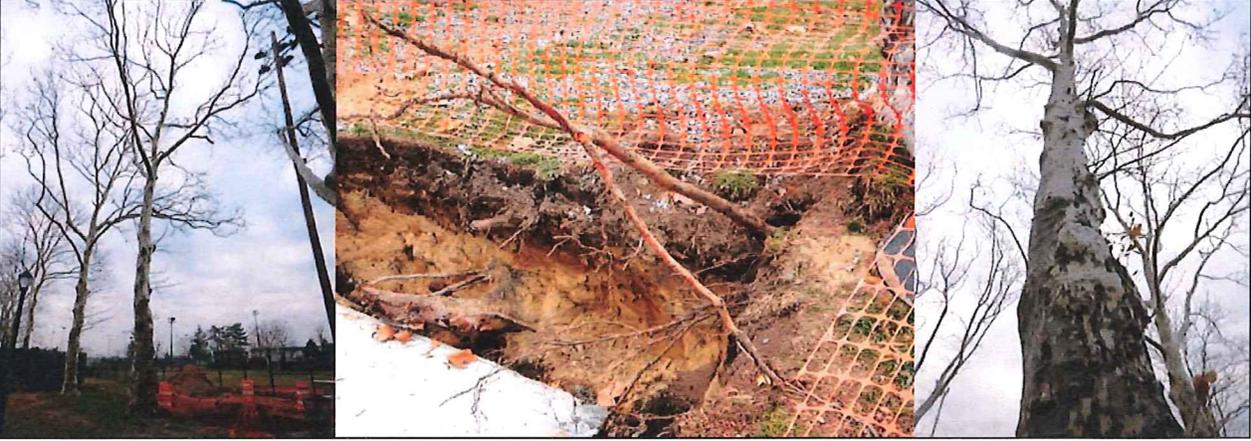
Tree/Root Base/Pit	Major root damage due to excavation for a 10' x 10' concrete foundation for new light pole less than 1' away from trunk.
Trunk Condition and Main Scaffold Branches	Major water sprouting on trunk and scaffold branches; trunk wounds from old pruning cuts have not completely healed and appear to have canker rot; dead scaffold branches.
Crown/Structure , Branches & Leaves	Thin crown; poor fruiting on small branches; dead small branches; tree was not assessed during full leaf.
Pest / Disease	No noticeable signs.
Setting	Along entrance path to park from Manorhaven Blvd., adjacent to baseball field.

Notes: Recent excavation for a 10' x 10' concrete foundation for new light pole less than 1' from trunk has caused major damage to large roots. The location of the new light pole appears to require major pruning to scaffold branches directly above the foundation. Evidence of recent pruning cuts of scaffold branches. Tree exhibits heavy pruning of a large number of lower branches and inner branches resulting in "Lion's-tailing" appearance which increases the risk of branch failure by weakening tree roots and decreasing the dampening effect that interior limbs provide during storms.

Recommendations: Remove tree due to current condition, anticipated decline and recent severe impacts to root system by excavation. For tree replacement it is recommended to use *Platanus x acerifolia* 'Liberty'. Replacements should be planted immediately following removals and it is recommended to form a mulch collar around the base of the tree that will prevent any future damage caused by landscape maintenance and provide additional benefits to the tree. The Town should implement a comprehensive program of tree management including soil testing.

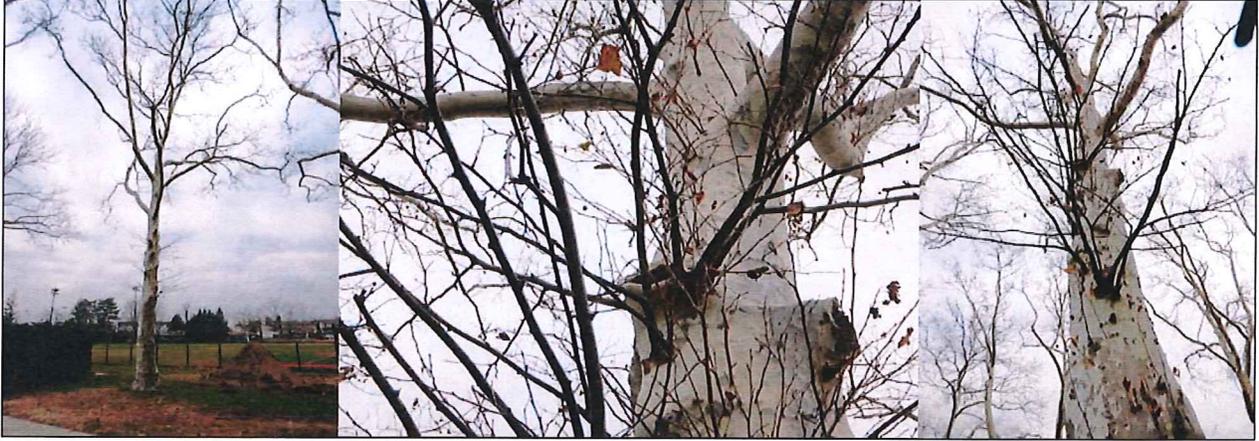
Tree/Root Base/Pit	Minor mechanical damage at base from landscape maintenance; root compaction from heavy machinery underneath canopy.
Trunk Condition and Main Scaffold Branches	Vertical cracks on trunk; major water sprouting on trunk and scaffold branches; trunk wounds from old pruning cuts have not completely healed and appear to have canker rot; major die back on scaffold branch leaning over baseball field.
Crown/Structure , Branches & Leaves	Thin crown; poor fruiting on small branches; small branch die-back; tree was not assessed during full leaf.
Pest / Disease	No noticeable signs.
Setting	Along entrance path to park from Manorhaven Blvd., adjacent to baseball field.

Notes: Multiple major scaffold branches appear to be declining and will need removal. Deep track marks close to trunk from heavy machinery used for excavation of new light pole foundation. Tree exhibits heavy pruning of a large number of lower branches and inner branches resulting in "Lion's-tailing" appearance which increases the risk of branch failure by weakening tree roots and decreasing the dampening effect that interior limbs provide during storms.

Recommendations: Remove tree due to current condition and anticipated decline. For tree replacement it is recommended to use *Platanus x acerifolia* 'Liberty'. Replacements should be planted immediately following removals and it is recommended to form a mulch collar around the base of the tree that will prevent any future damage caused by landscape maintenance and provide additional benefits to the tree. The Town should implement a comprehensive program of tree management including soil testing.

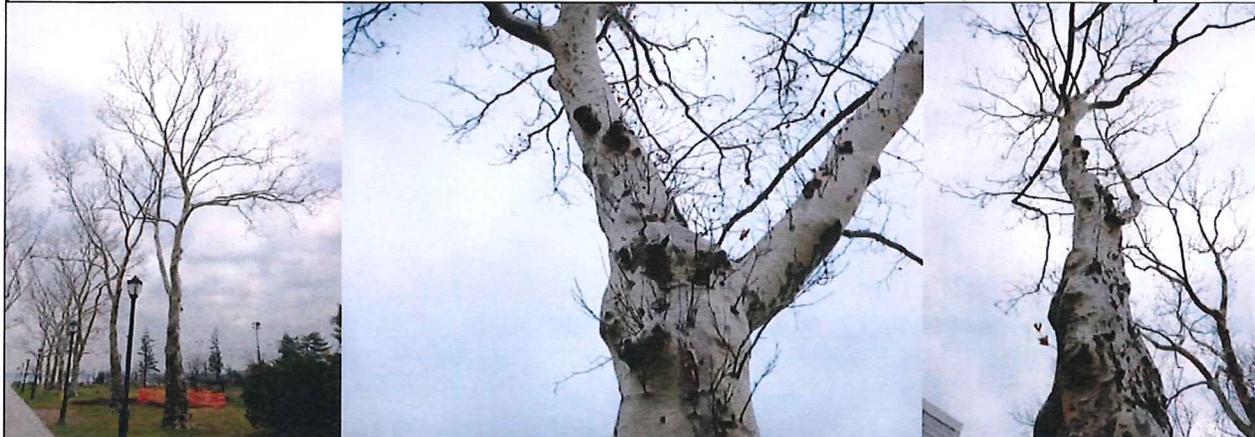
Arborist Assessment Report		Location: Manorhaven Beach Park - Port Washington, NY	Date: 12/08/2015
Inspector: Dan Maher		Weather: Overcast	Lat/Long: N 40° 50' 23.74" W 73° 42' 56.42" Time: 3:50
Specimen:	Common Name: LONDON PLANETREE	Scientific name: <i>Platanus x acerifolia</i>	
Descriptor	Value	Range	
Girth	35"	Trunk Diameter Measured at Breast Height (DBH)	
Approx. Height	60-65'	Approximate Height to top of Canopy	
Canopy	N 18' ,S 15' ,E 15' ,W 22'	Canopy Radius in Feet - North South East West	
Condition	3	Health of Specimen - 1 Dead - 2 Declining - 3 Moderate - 4 Good - 5 Excellent	
Approx. Age	E	NP=Newly Planted Within 5yrs M=Moderate 10-20 yrs old E=Existing before development	
Tree/Root Base/Pit	Minor mechanical damage at base from landscape maintenance; planting bed around base of tree.		
Trunk Condition and Main Scaffold Branches	Water sprouting on trunk and scaffold branches; open trunk wounds from old pruning cuts.

Crown/Structure , Branches & Leaves	Uneven and thin crown; poor fruiting on branches; dead smaller branches; tree was not assessed during full leaf.		
Pest / Disease	No noticeable signs.		
Setting	Along entrance path to park from Manorhaven Blvd., adjacent to baseball field.		
Character	Y	Does the tree make an important contribution to the character or amenity of the area?	
	Indigenous	Is the tree indigenous, rare, endangered, invasive or exotic?	
Habitat	N	Does the tree represent important habitat for native fauna?	
	N	Is the tree part of a wildlife Corridor, Buffer, etc?	
<p>Notes: Trunk is 28' away from pool maintenance building across concrete sidewalk. Evidence of recent removal of major scaffold branches. Remaining scaffold branches with major water sprouting appear to be declining. Tree exhibits heavy pruning of a large number of lower branches and inner branches resulting in "Lion's-tailing" appearance which increases the risk of branch failure by weakening tree roots and decreasing the dampening effect that interior limbs provide during storms.</p>

<p>Recommendations: It is recommended to implement a program that continues to monitor this tree by an ISA Arborist and If condition continues to decline, consider removal. For recommended treatment, proper corrective pruning that follows ANSI A300 standards should be performed to remove dead branches. Vertical mulching is recommended for mitigation, this is a technique that benefits stressed trees by improving the movement of water, air, and nutrients in the root zone and should be performed by a qualified tree care professional. Implement a comprehensive program of tree management including soil testing.</p>			<p>Level of Urgency</p> <p>2</p>
<p>Urgency Level: 1 - Requires Immediate Attention 2 - Within (1) Month 3 - Within (6) Months 4 - Within the year 5 - None</p>

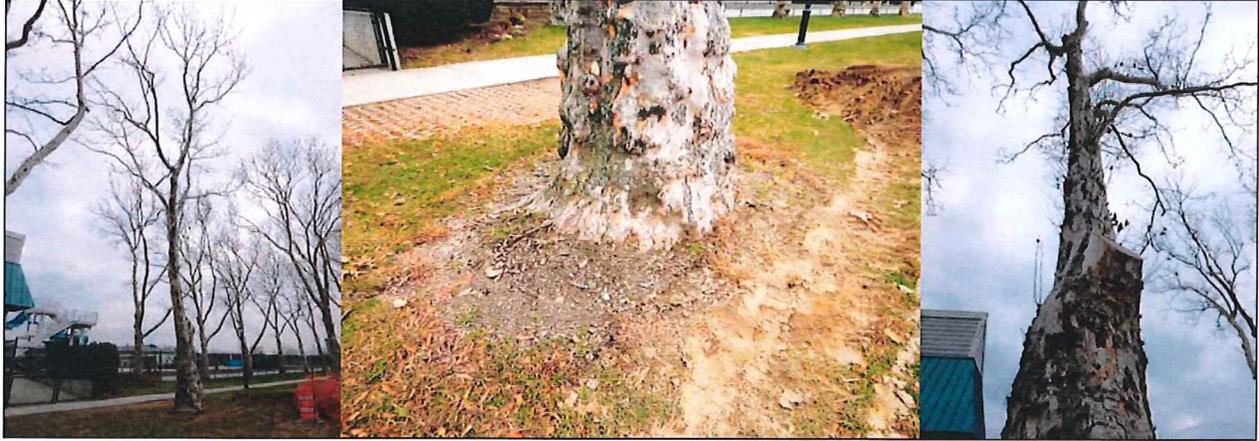
Tree/Root Base/Pit	Minor mechanical damage at base from landscape maintenance; minor girdling roots; planting bed around base of tree; evidence of root compaction from heavy machinery underneath canopy.
Trunk Condition and Main Scaffold Branches	Major codominant leader has recently been removed; minor trunk damage from machinery; major water sprouting on trunk and scaffold branches; discoloration of remaining leader that appears to be declining in condition.
Crown/Structure , Branches & Leaves	Thin crown; poor small branching structure; tree was not assessed during full leaf.
Pest / Disease	No noticeable signs.
Setting	Along entrance path to park from Manorhaven Blvd., adjacent to baseball field and across from a vehicle entrance to the pool area.

Notes: Block pavers have been installed underneath the canopy of this tree across from a maintenance vehicle entrance gate to the pool area. Excavation for new foundation of light pole 15' away from trunk, roots were likely impacted. Deep track marks close to trunk from heavy machinery used for excavation of new light pole foundation. Tree exhibits heavy pruning of a large number of lower branches and inner branches resulting in "Lion's-tailing" appearance which increases the risk of branch failure by weakening tree roots and decreasing the dampening effect that interior limbs provide during storms.

<p>Recommendations: Remove tree due to current condition and anticipated decline. For tree replacement it is recommended to use <i>Platanus x acerifolia</i> 'Liberty'. Replacements should be planted immediately following removals and it is recommended to form a mulch collar around the base of the tree that will prevent any future damage caused by landscape maintenance and provide additional benefits to the tree. The Town should implement a comprehensive program of tree management including soil testing.</p>	<div style="border: 1px solid black; padding: 5px;">Level of Urgency</div>
---	--

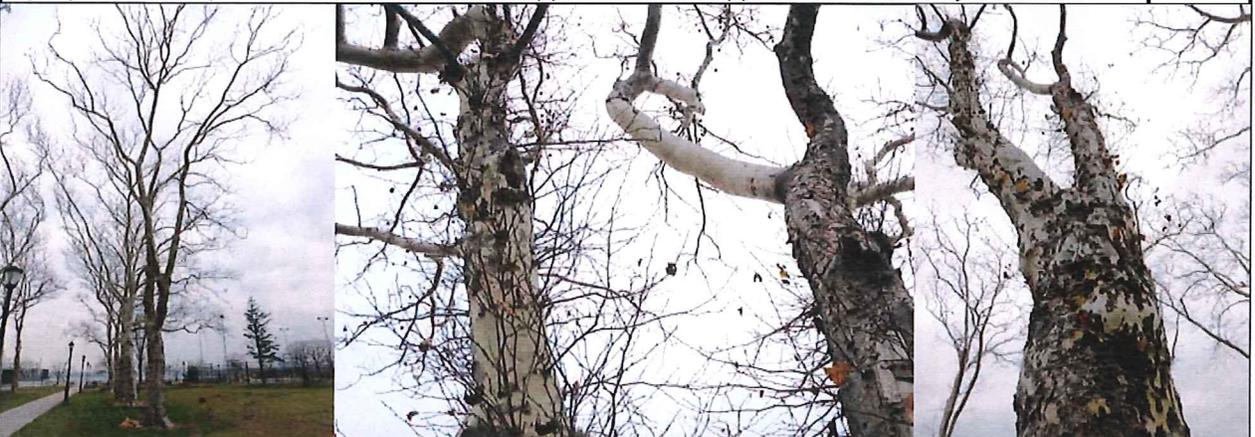
100 Crossways Park Drive West, Ste 104 Woodbury, New York 11797		t: 516.364.0660 f: 516.364.0668		www.bthayerassociates.com		Assignment:	Tree No.:
								1	15
Arborist Assessment Report				Location: Manorhaven Beach Park - Port Washington, NY				Date: 12/08/2015	
Inspector: Dan Maher				Weather: Overcast		Lat/Long: N 40° 50' 22.96" W 73° 42' 56.09"		Time: 4:20	
Specimen:		Common Name: LONDON PLANETREE		Scientific name: <i>Platanus x acerifolia</i>					
Descriptor		Value		Range					
Girth		29"		Trunk Diameter Measured at Breast Height (DBH)					
Approx. Height		55-60'		Approximate Height to top of Canopy					
Canopy		N 30' ,S 13' ,E 20' ,W 25'		Canopy Radius in Feet - North South East West					
Condition		2		Health of Specimen - 1 Dead - 2 Declining - 3 Moderate - 4 Good - 5 Excellent					
Approx. Age		E		NP=Newly Planted Within 5yrs M=Moderate 10-20 yrs old E=Existing before development

Tree/Root Base/Pit		Minor mechanical damage at base from landscape maintenance; planting bed around base of tree.							
Trunk Condition and Main Scaffold Branches		Codominant leaders; one of the leaders has major damage causing wood rot and discoloration appearing to be partially dead; trunk wounds from old pruning cuts have not completely healed and appear to have canker rot; major water sprouting on trunk and scaffold branches.							
Crown/Structure , Branches & Leaves		Thin crown; small branch die-back; poor fruiting on branches; tree was not assessed during full leaf.							
Pest / Disease		No noticeable signs.							
Setting		Along entrance path to park from Manorhaven Blvd., adjacent to baseball field.							
Character		Y		Does the tree make an important contribution to the character or amenity of the area?					
		Indigenous		Is the tree indigenous, rare, endangered, invasive or exotic?

Habitat		N		Does the tree represent important habitat for native fauna?					
		N		Is the tree part of a wildlife Corridor, Buffer, etc?					
Notes: One leader is in very poor condition and will continue to decline, the other leader has major water sprouting and dead smaller branches. Tree exhibits heavy pruning of a large number of lower branches and inner branches resulting in "Lion's-tailing" appearance which increases the risk of branch failure by weakening tree roots and decreasing the dampening effect that interior limbs provide during storms.									
Recommendations: Remove tree due to current condition of major leader and anticipated decline. For tree replacement it is recommended to use <i>Platanus x acerifolia</i> 'Liberty'. Replacements should be planted immediately following removals and it is recommended to form a mulch collar around the base of the tree that will prevent any future damage caused by landscape maintenance and provide additional benefits to the tree. The Town should implement a comprehensive program of tree management including soil testing.								Level of Urgency

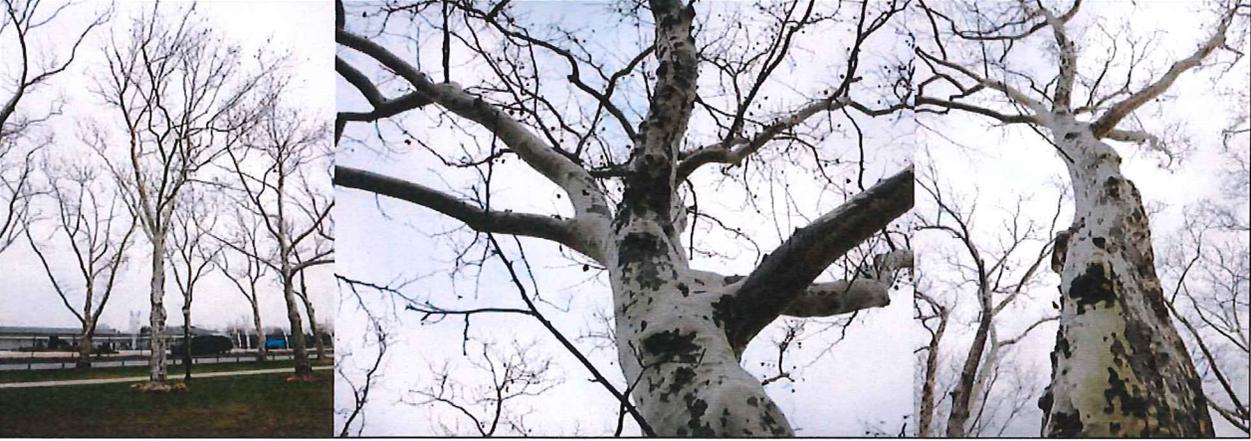
Tree/Root Base/Pit	Minor girdling roots; planting bed around base of tree; minor mechanical damage at base from landscape maintenance.
Trunk Condition and Main Scaffold Branches	Water sprouting on scaffold branches; vertical cracks on trunk; trunk wounds from old pruning cuts that have not completely healed.
Crown/Structure , Branches & Leaves	Moderate fruiting on small branches; minor dead and broken branches; tree was not assessed during full leaf.
Pest / Disease	No noticeable signs.
Setting	Along entrance path to park from Manorhaven Blvd., adjacent to baseball field.

Notes: Evidence of recent pruning of smaller branches, new branch growth from the cuts. Tree exhibits heavy pruning of a large number of lower branches and inner branches resulting in "Lion's-tailing" appearance which increases the risk of branch failure by weakening tree roots and decreasing the dampening effect that interior limbs provide during storms.

Recommendations: It is recommended to implement a program that continues to monitor this tree by an ISA Arborist and If condition continues to decline, consider removal. For recommended treatment, proper corrective pruning that follows ANSI A300 standards should be performed to remove dead and damaged branches. Vertical mulching is recommended for mitigation, this is a technique that benefits stressed trees by improving the movement of water, air, and nutrients in the root zone and should be performed by a qualified tree care professional. The Town should implement a comprehensive program of tree management including soil testing.

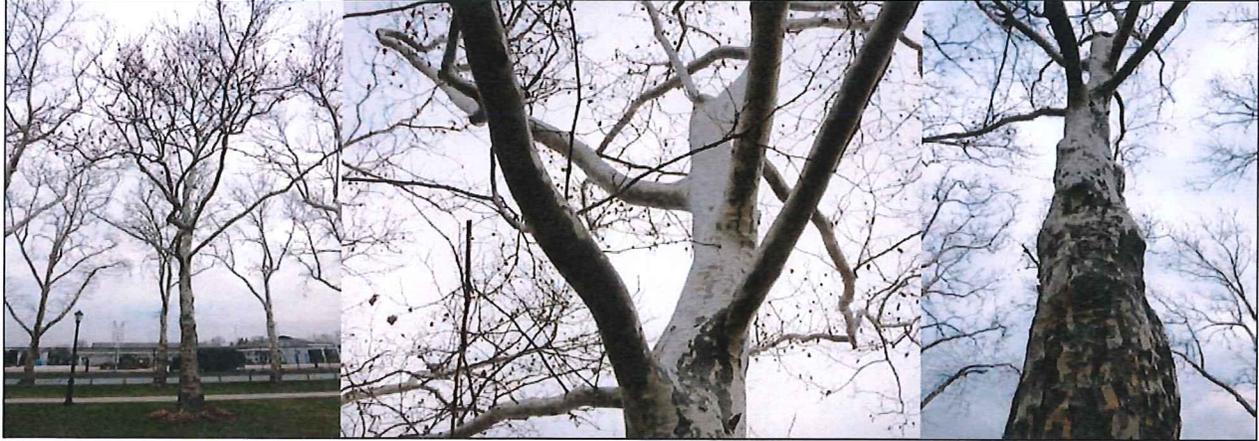
Tree/Root Base/Pit	Planting bed around base of tree; minor mechanical damage at base from landscape maintenance.
Trunk Condition and Main Scaffold Branches	Vertical cracks on trunk; major pruning has occurred to remove scaffold branches; water sprouting on trunk and scaffold branches.
Crown/Structure , Branches & Leaves	Pruning has occurred on most all of the remaining scaffold branches leaving open wounds on many of the limbs. Evidence of fallen branches off scaffold branch; moderate fruiting on small branches; tree was not assessed during full leaf.
Pest / Disease	No noticeable signs.
Setting	Along entrance path to park from Manorhaven Blvd., adjacent to baseball field.

Notes: Major pruning has occurred within the past few years to remove large scaffold branches; pruning evident on most remaining scaffold branches. Tree exhibits heavy pruning of a large number of lower branches and inner branches resulting in "Lion's-tailing" appearance which increases the risk of branch failure by weakening tree roots and decreasing the dampening effect that interior limbs provide during storms.

<p>Recommendations: It is recommended to implement a program that continues to monitor this tree by an ISA Arborist and If condition continues to decline, consider removal. For recommended treatment, proper corrective pruning that follows ANSI A300 standards should be performed to remove small dead and damaged branches. Vertical mulching is recommended for mitigation, this is a technique that benefits stressed trees by improving the movement of water, air, and nutrients in the root zone and should be performed by a qualified tree care professional. The Town should implement a comprehensive program of tree management including soil testing.</p>	Level of Urgency
--	-------------------------
