<b>Arborist Assessment Report</b>		Location: Manorhaven Beach Park - Port Washington, NY	Date: 12/09/2015
Inspector: Dan Maher		Weather: Overcast	Lat/Long: N 40° 50' 21.88" W 73° 42' 55.79" Time: 10:23
Specimen:	Common Name: LONDON PLANETREE	Scientific name: <i>Platanus x acerifolia</i>	
Descriptor	Value	Range	
Girth	29"	Trunk Diameter Measured at Breast Height (DBH)	
Approx. Height	55-60'	Approximate Height to top of Canopy	
Canopy	N 17' ,S 32' ,E 17' ,W 28'	Canopy Radius in Feet - North South East West	
Condition	3	Health of Specimen - 1 Dead - 2 Declining - 3 Moderate - 4 Good - 5 Excellent	
Approx. Age	E	NP=Newly Planted Within 5yrs M=Moderate 10-20 yrs old E=Existing before development	
Tree/Root Base/Pit	Planting bed around base of tree; minor mechanical damage at base and exposed roots from landscape maintenance.		
Trunk Condition and Main Scaffold Branches	Water sprouting on scaffold branches; evidence of pruning to remove small branches from scaffold.

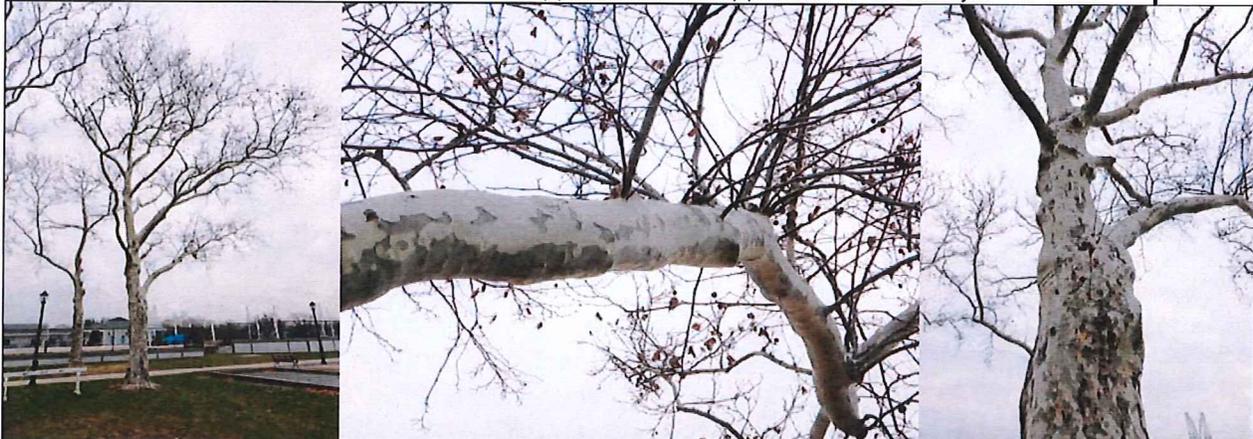
Assignment:	Tree No.:
1	19

Crown/Structure , Branches & Leaves	Moderate fruiting on branches and good small branch structure; tree was not assessed during full leaf.		
Pest / Disease	No noticeable signs.		
Setting	Along entrance path to park from Manorhaven Blvd., adjacent to bocce court.		
Character	Y	Does the tree make an important contribution to the character or amenity of the area?	
	Indigenous	Is the tree indigenous, rare, endangered, invasive or exotic?	
Habitat	N	Does the tree represent important habitat for native fauna?	
	N	Is the tree part of a wildlife Corridor, Buffer, etc?

Notes: Evidence of recent pruning to remove smaller scaffold branches. 10' from bocce court with scaffold branches leaning over court.

Recommendations: It is recommended to implement a program that continues to monitor this tree by an ISA Arborist. Vertical mulching is recommended for mitigation, this is a technique that benefits stressed trees by improving the movement of water, air, and nutrients in the root zone and should be performed by a qualified tree care professional. The Town should implement a comprehensive program of tree management including soil testing.

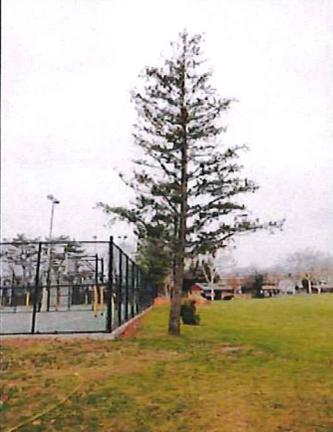
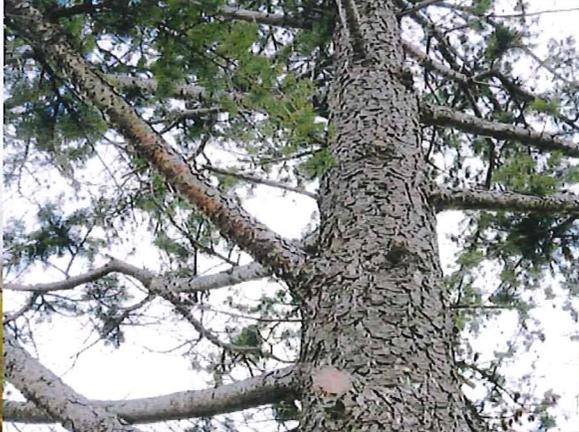
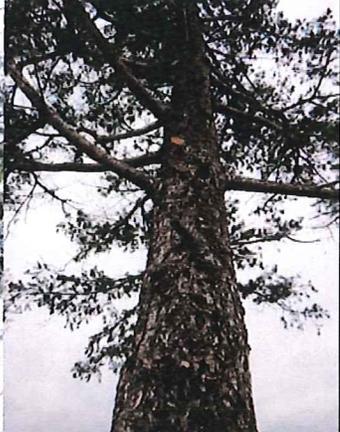
100 Crossways Park Drive West, Ste 104 Woodbury, New York 11797		t: 516.364.0660 f: 516.364.0668		www.bthayerassociates.com		Assignment:	Tree No.:
								1	20
<b>Arborist Assessment Report</b>				Location: Manorhaven Beach Park - Port Washington, NY				Date: 12/09/2015	
Inspector: Dan Maher				Weather: Overcast		Lat/Long: N 40° 50' 21.77" W 73° 42' 56.77"		Time: 10:35	
Specimen:		Common Name: DOUGLAS FIR		Scientific name: <i>Pseudotsuga menziesii</i>					
Descriptor		Value		Range					
Girth		13"		Trunk Diameter Measured at Breast Height (DBH)					
Approx. Height		35-40'		Approximate Height to top of Canopy					
Canopy		N 10' ,S 9' ,E 6' ,W 8'		Canopy Radius in Feet - North South East West					
Condition		3		Health of Specimen - 1 Dead - 2 Declining - 3 Moderate - 4 Good - 5 Excellent					
Approx. Age		E		NP=Newly Planted Within 5yrs M=Moderate 10-20 yrs old E=Existing before development					
Tree/Root Base/Pit		Minor mechanical damage at base from landscape maintenance.

Trunk Condition and Main Scaffold Branches		Minor vertical cracking on trunk with sap coming out of wounds.							
Crown/Structure , Branches & Leaves		Branch die-back and declining foliage at the top of the tree; thin crown from recent pruning.							
Pest / Disease		No noticeable signs.							
Setting		Inside park, north of basketball courts.							
Character		Y		Does the tree make an important contribution to the character or amenity of the area?					
		Indigenous		Is the tree indigenous, rare, endangered, invasive or exotic?					
Habitat		N		Does the tree represent important habitat for native fauna?					
		N		Is the tree part of a wildlife Corridor, Buffer, etc?					
Notes: The needles and branches at the top of the tree are dying back which shows evidence of the tree struggling to absorb enough nutrients from the roots. Evidence of major pruning and removal of scaffold branches due to die-back.

Recommendations: Remove tree due to evidence of continuous decline. For tree replacement it is recommended to use Picea pungens 'Glauca'. Replacements should be planted immediately following removals and it is recommended to form a mulch collar around the base of the tree that will prevent any future damage caused by landscape maintenance and provide additional benefits to the tree. The Town should implement a comprehensive program of tree management including soil testing.									Level of Urgency
									4
<b>Urgency Level:</b> 1 - Requires Immediate Attention 2 - Within (1) Month 3 - Within (6) Months 4 - Within the year 5 - None

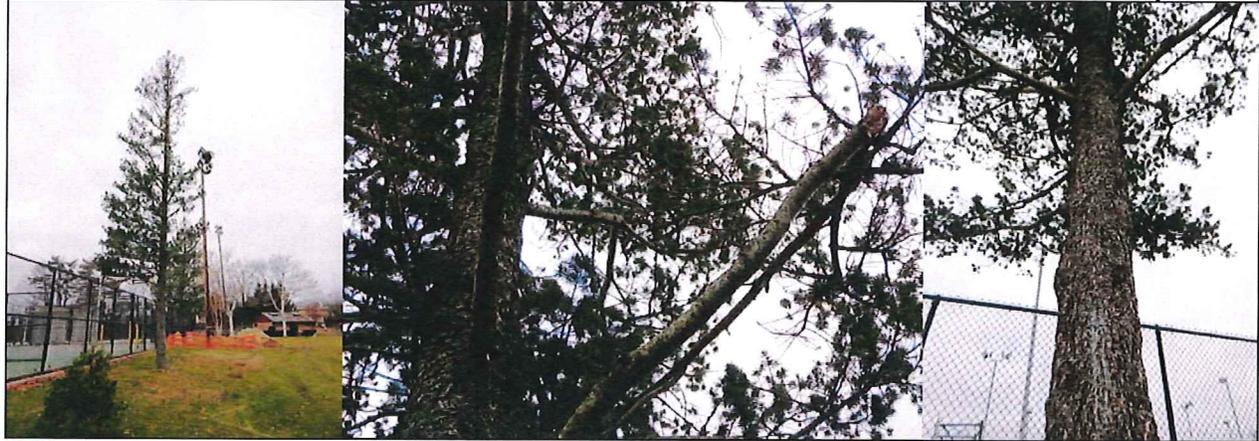
Tree/Root Base/Pit	Minor mechanical damage at base from landscape maintenance.
Trunk Condition and Main Scaffold Branches	Trunk appears to be in good condition with no signs of damage; minor broken scaffold branches.
Crown/Structure , Branches & Leaves	Uneven canopy; branch die-back at the top of the tree.
Pest / Disease	No noticeable signs.
Setting	Inside park, north of basketball courts.

<p><b>Recommendations:</b> Remove tree due to evidence of continuous decline. For tree replacement it is recommended to use Picea pungens 'Glauca'. Replacements should be planted immediately following removals and it is recommended to form a mulch collar around the base of the tree that will prevent any future damage caused by landscape maintenance and provide additional benefits to the tree. The Town should implement a comprehensive program of tree management including soil testing.</p>	<div style="background-color: #f4a460; padding: 5px; font-weight: bold;">Level of Urgency</div>
--	---

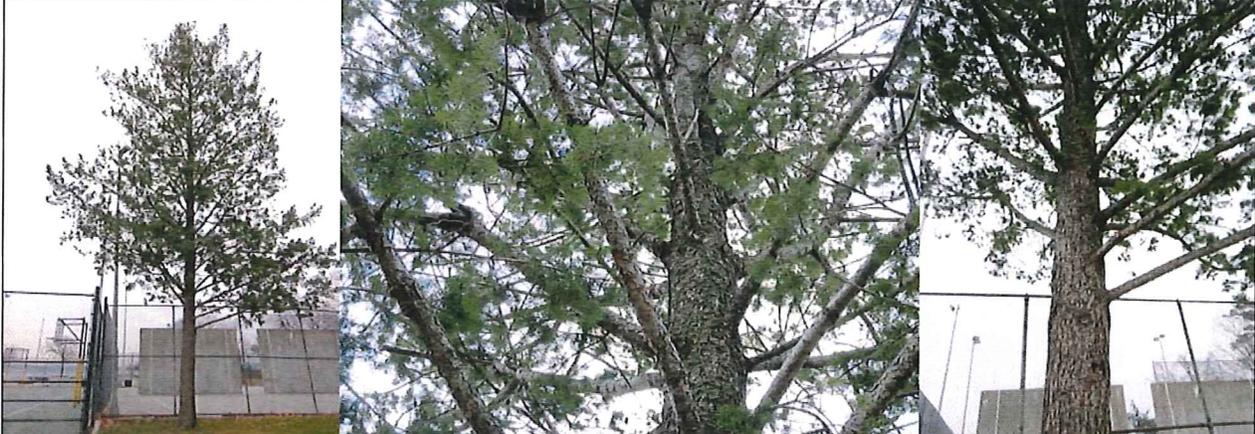
Tree/Root Base/Pit		Minor mechanical damage at base from landscape maintenance.							
Trunk Condition and Main Scaffold Branches		Good trunk and scaffold structure.							
Crown/Structure , Branches & Leaves		Full and balanced crown with good needle structure.							
Pest / Disease		No noticeable signs.							
Setting		Inside park, north of handball courts.							
Character		Y		Does the tree make an important contribution to the character or amenity of the area?					
		Indigenous		Is the tree indigenous, rare, endangered, invasive or exotic?					
Habitat		N		Does the tree represent important habitat for native fauna?					
		N		Is the tree part of a wildlife Corridor, Buffer, etc?					
<b>Notes:</b> Tree appears to be in good condition. Evidence of recent minor pruning to small branches.									
<b>Recommendations:</b> It is recommended to implement a program that continues to monitor this tree by an ISA Arborist. Vertical mulching is recommended for mitigation, this is a technique that benefits stressed trees by improving the movement of water, air, and nutrients in the root zone and should be performed by a qualified tree care professional. Additionally, it is recommended to form a mulch collar around the base of the tree that will prevent any future damage caused by landscape maintenance and provide additional benefits to the tree. The Town should implement a comprehensive program of tree management including soil testing.								Level of Urgency

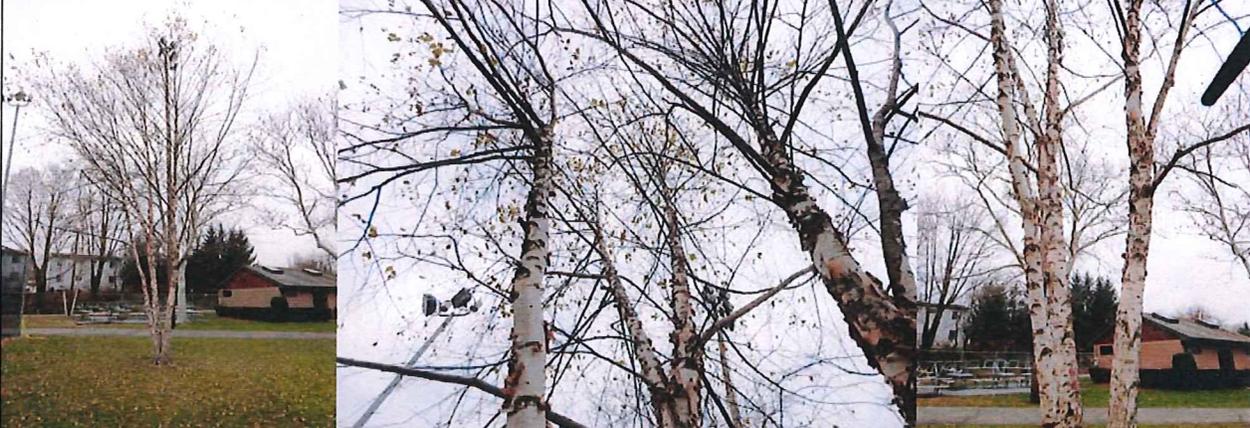
<b>Tree/Root Base/Pit</b>		Minor mechanical damage at base from landscape maintenance.							
<b>Trunk Condition and Main Scaffold Branches</b>		Multi-stem trunk in good condition.							
<b>Crown/Structure, Branches &amp; Leaves</b>		Full and balanced crown; good small branch structure; tree was not assessed during full leaf.							
<b>Pest / Disease</b>		No noticeable signs.							
<b>Setting</b>		Inside park, north of handball courts.							
<b>Character</b>		Y		<i>Does the tree make an important contribution to the character or amenity of the area?</i>					
		<b>Indigenous</b>		<i>Is the tree indigenous, rare, endangered, invasive or exotic?</i>					
<b>Habitat</b>		N		<i>Does the tree represent important habitat for native fauna?</i>					
		N		<i>Is the tree part of a wildlife Corridor, Buffer, etc?</i>					
<b>Notes:</b> Tree appears to be in excellent condition. Evidence of minor pruning to small branches.

<b>Recommendations:</b> It is recommended to implement a program that continues to monitor this tree by an ISA Arborist. Additionally, it is recommended to form a mulch collar around the base of the tree that will prevent any future damage caused by landscape maintenance and provide additional benefits to the tree. The Town should implement a comprehensive program of tree management including soil testing.								Level of Urgency	
								5	
<b>Urgency Level:</b> 1 - Requires Immediate Attention 2 - Within (1) Month 3 - Within (6) Months 4 - Within the year 5 - None

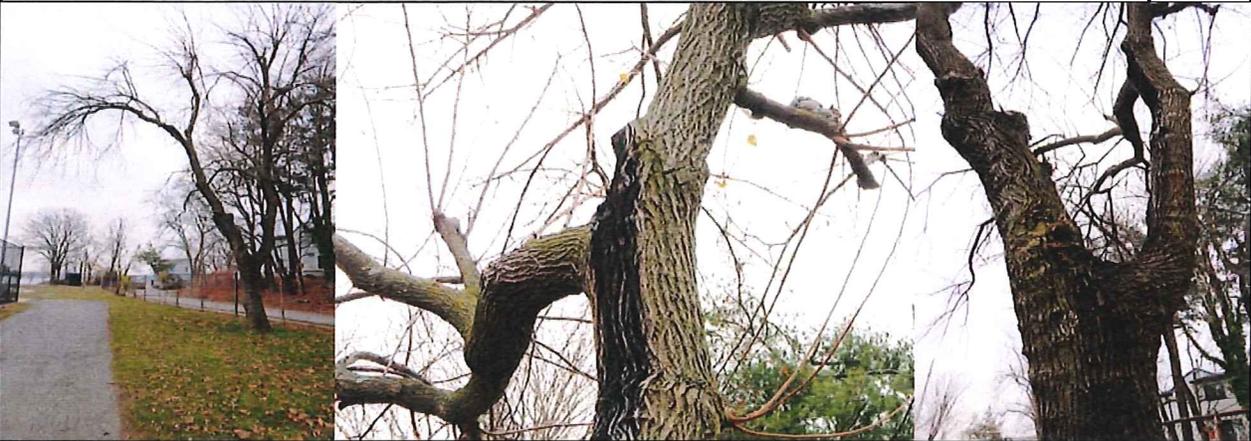
Assignment:	Tree No.:
1	24

**Tree/Root Base/Pit** Major mechanical damage at base and exposed roots from landscape maintenance.

**Trunk Condition and Main Scaffold Branches** Codominant leader; evidence of major scaffold branch removal and pruning; major open wounds from broken scaffold branches causing wet discharge staining trunk, evidence of bacterial wetwood disease.

**Notes:** The tree appears to be in declining condition and has major broken/removed branches and open wounds, the tree is unsightly however does not present an immediate hazard.

**Recommendations:** Remove tree due to evidence of continuous decline. For tree replacement it is recommended to use Liquidambar styraciflua 'Rotundiloba'. Replacements should be planted immediately following removals and it is recommended to form a mulch collar around the base of the tree that will prevent any future damage caused by landscape maintenance and provide additional benefits to the tree. The Town should implement a comprehensive program of tree management including soil testing.

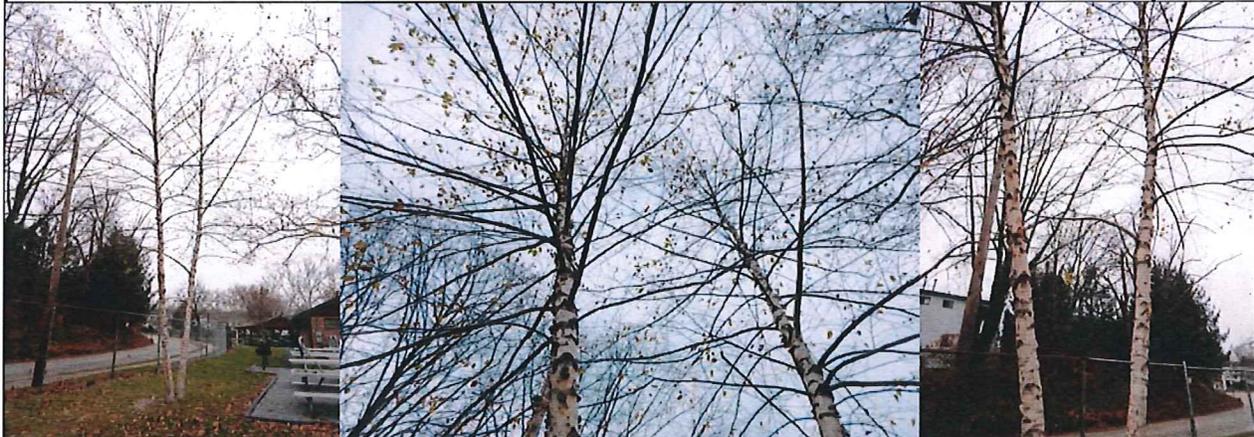
Notes: Tree appears to be in good condition.

**Recommendations:** It is recommended to implement a program that continues to monitor this tree by an ISA Arborist. Additionally, it is recommended to form a mulch collar around the base of the tree that will prevent any future damage caused by landscape maintenance and provide additional benefits to the tree. The Town should implement a comprehensive program of tree management including soil testing.

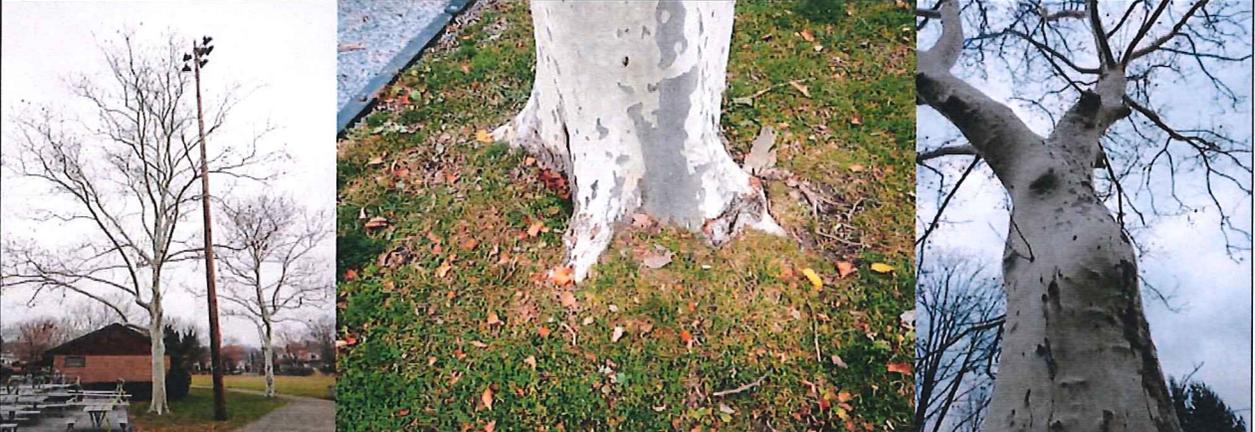
<b>Approx. Age</b>	E	<i>NP=Newly Planted Within 5yrs M=Moderate 10-20 yrs old E=Existing before development</i>							
<b>Tree/Root Base/Pit</b>									
Minor mechanical damage at base from landscape maintenance.									
<b>Trunk Condition and Main Scaffold Branches</b>									
Minor water sprouting on trunk and scaffold branches; old pruning cuts have healed well.									
<b>Crown/Structure , Branches &amp; Leaves</b>									
Full and even crown; fruiting well on small branches; good small branch structure; tree was not assessed during full leaf.									
<b>Pest / Disease</b>									
No noticeable signs.									
<b>Setting</b>									
Inside park adjacent to picnic area, west of handball courts.									
<b>Character</b>									
Y									
<i>Does the tree make an important contribution to the character or amenity of the area?</i>									
<b>Habitat</b>									
Indigenous									
<i>Is the tree indigenous, rare, endangered, invasive or exotic?</i>

N									
<i>Does the tree represent important habitat for native fauna?</i>									
N									
<i>Is the tree part of a wildlife Corridor, Buffer, etc?</i>									
<b>Notes:</b> Trunk of tree is less than 1' away from a picnic area. Scaffold branches are growing into nearby light pole. Tree exhibits recent pruning of a large number of lower branches and inner branches resulting in "Lion's-tailing" appearance which increases the risk of branch failure by weakening tree roots and decreasing the dampening effect that interior limbs provide during storms.									
<b>Recommendations:</b> It is recommended to implement a program that continues to monitor this tree by an ISA Arborist. Vertical mulching is recommended for mitigation, this is a technique that benefits stressed trees by improving the movement of water, air, and nutrients in the root zone and should be performed by a qualified tree care professional. Additionally, it is recommended to form a mulch collar around the base of the tree that will prevent any future damage caused by landscape maintenance and provide additional benefits to the tree. The Town should implement a comprehensive program of tree management including soil testing.								<b>Level of Urgency</b>

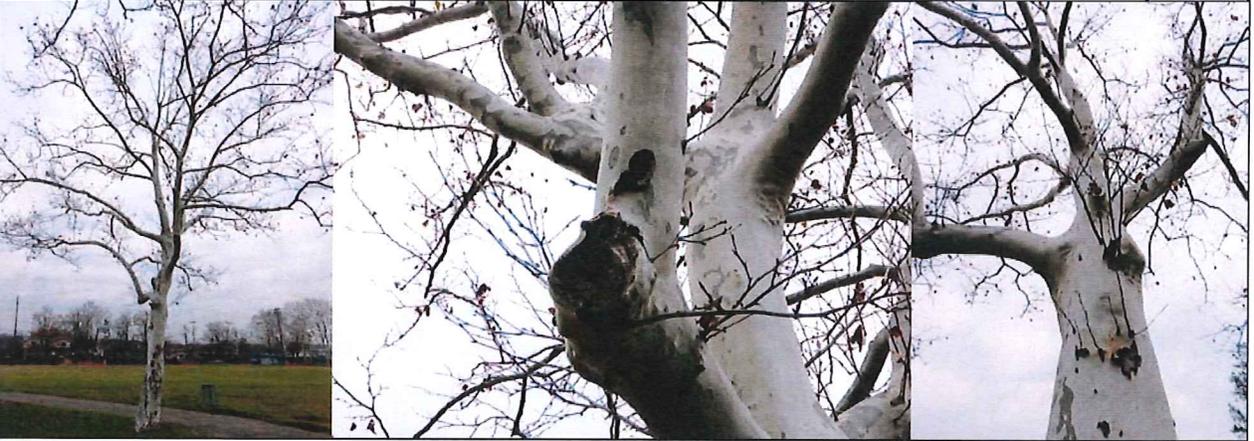
Tree/Root Base/Pit	Minor mechanical damage at base from landscape maintenance.
Trunk Condition and Main Scaffold Branches	Minor trunk damage from landscape maintenance; water sprouting on trunk and scaffold branches.
Crown/Structure , Branches & Leaves	Full and even crown; fruiting well on small branches; good small branch structure; tree was not assessed during full leaf.
Pest / Disease	No noticeable signs.
Setting	Inside park along path, adjacent to bathrooms.

<p><b>Recommendations:</b> It is recommended to implement a program that continues to monitor this tree by an ISA Arborist. Vertical mulching is recommended for mitigation, this is a technique that benefits stressed trees by improving the movement of water, air, and nutrients in the root zone and should be performed by a qualified tree care professional. Additionally, it is recommended to form a mulch collar around the base of the tree that will prevent any future damage caused by landscape maintenance and provide additional benefits to the tree. The Town should implement a comprehensive program of tree management including soil testing.</p>	<div style="background-color: #f4a460; padding: 5px; font-weight: bold;">Level of Urgency</div> <div style="border: 1px solid black; height: 60px; width: 100%;"></div>
---	---

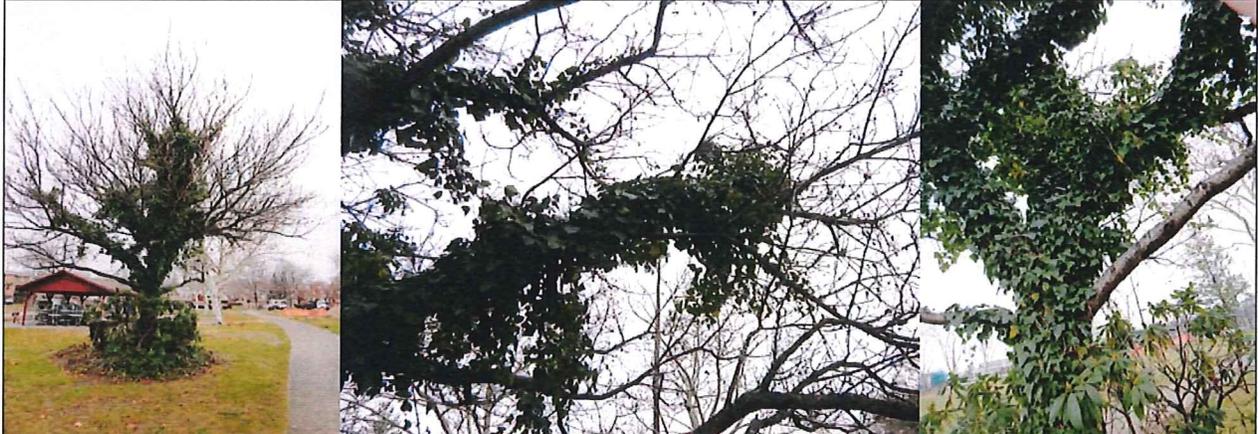
Tree/Root Base/Pit	Growing in planting bed with shrubs and groundcover planted around base.
Trunk Condition and Main Scaffold Branches	Major Ivy coverage on trunk and growing into the scaffold and small branches.
Crown/Structure , Branches & Leaves	Full canopy; good small branch structure; good bud growth; large quantity of galls on smaller branches; tree was not assessed during full leaf.
Pest / Disease	Galls present on small branches, possibly black knot that is common for this species.
Setting	Inside park along path, adjacent to bathrooms.

**Recommendations:** It is recommended to implement a program that continues to monitor this tree by an ISA Arborist. For recommended treatment, cut ivy at base of tree and remove from crown. Vertical mulching is recommended for mitigation, this is a technique that benefits stressed trees by improving the movement of water, air, and nutrients in the root zone and should be performed by a qualified tree care professional. The Town should implement a comprehensive program of tree management including soil testing.

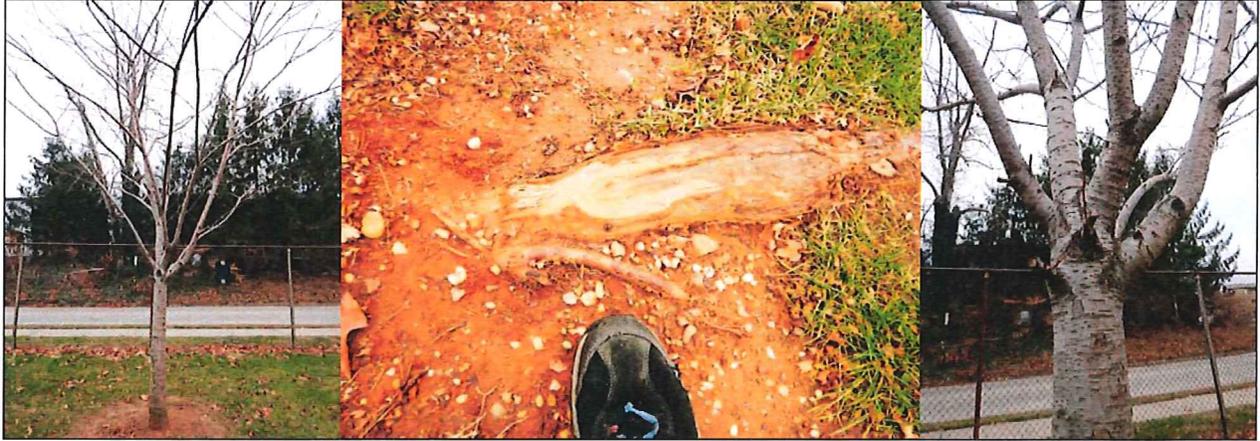
Tree/Root Base/Pit	Mechanical damage to exposed roots.
Trunk Condition and Main Scaffold Branches	Trunk and scaffold branches in good condition, minor included bark at branch unions.
Crown/Structure , Branches & Leaves	Good crown structure and branching; tree was not assessed during full leaf.
Pest / Disease	No noticeable signs.
Setting	Inside park, adjacent to bathrooms.

<p><b>Recommendations:</b> It is recommended to implement a program that continues to monitor this tree by an ISA Arborist. Additionally, it is recommended to form a mulch collar around the base of the tree that will prevent any future damage caused by landscape maintenance and provide additional benefits to the tree. The Town should implement a comprehensive program of tree management including soil testing.</p>	<div style="background-color: #f4a460; padding: 5px; font-weight: bold;">Level of Urgency</div>
--	---

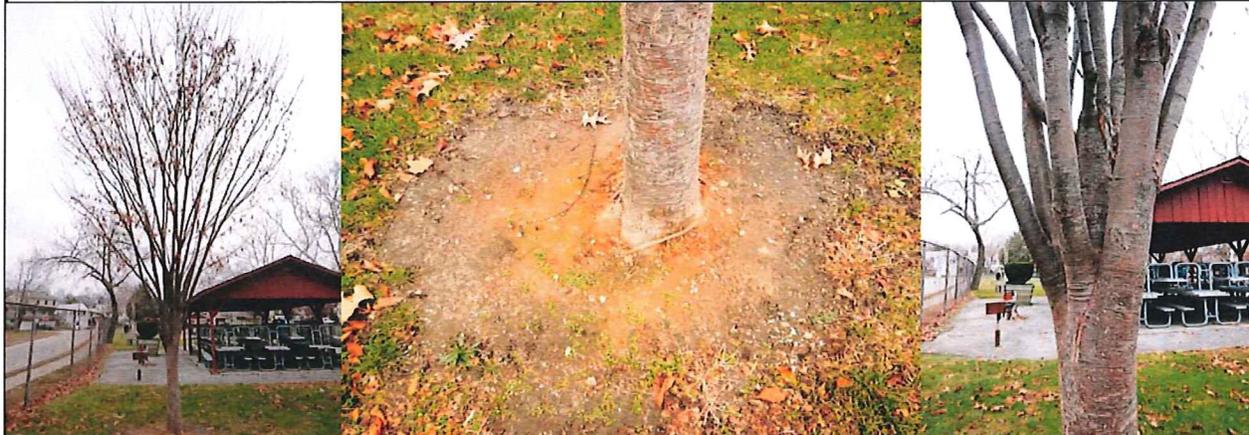
<b>Arborist Assessment Report</b>		Location: Manorhaven Beach Park - Port Washington, NY	Date: 12/09/2015
Inspector: Dan Maher		Weather: Overcast	Lat/Long: N 40° 50' 21.78" W 73° 43' 0.67" Time: 12:30
Specimen:	Common Name: ZELKOVA, JAPANESE	Scientific name: <i>Zelkova serrata</i>	
Descriptor	Value	Range	
Girth	9"	Trunk Diameter Measured at Breast Height (DBH)	
Approx. Height	20-25'	Approximate Height to top of Canopy	
Canopy	N 9' ,S 7' ,E 8' ,W 8'	Canopy Radius in Feet - North South East West	
Condition	4	Health of Specimen - 1 Dead - 2 Declining - 3 Moderate - 4 Good - 5 Excellent	
Approx. Age	E	NP=Newly Planted Within 5yrs M=Moderate 10-20 yrs old E=Existing before development	
Tree/Root Base/Pit	Minor girdling roots.		
Trunk Condition and Main Scaffold Branches	Included bark at scaffold branch unions, minor trunk damage.		
Crown/Structure , Branches & Leaves	Good crown and small branch structure; tree was not assessed during full leaf.

**Recommendations:** It is recommended to implement a program that continues to monitor this tree by an ISA Arborist. Additionally, it is recommended to form a mulch collar around the base of the tree that will prevent any future damage caused by landscape maintenance and provide additional benefits to the tree. The Town should implement a comprehensive program of tree management including soil testing.

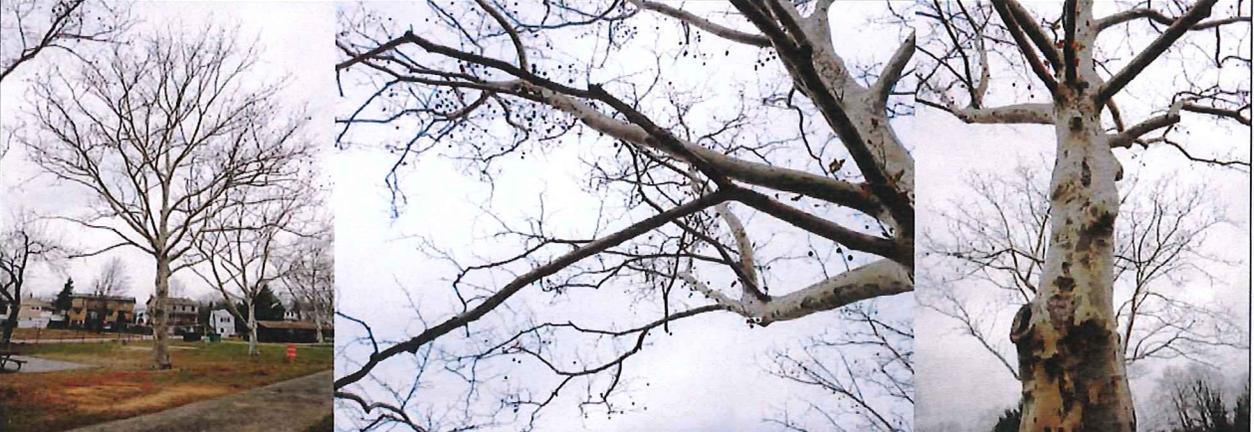
<b>Approx. Age</b>		E		<i>NP=Newly Planted Within 5yrs M=Moderate 10-20 yrs old E=Existing before development</i>					
<b>Tree/Root Base/Pit</b>		Minor mechanical damage at base from landscape maintenance.							
<b>Trunk Condition and Main Scaffold Branches</b>		Open wound on trunk from old pruning cut not completely healed appears to have canker rot; water sprouting on scaffold branches; dead branches leaning over picnic area.							
<b>Crown/Structure , Branches &amp; Leaves</b>		Full crown; moderate fruiting on branches; dead small branches; tree was not assessed during full leaf.							
<b>Pest / Disease</b>		No noticeable signs.							
<b>Setting</b>		Inside park, adjacent to picnic structure.							
<b>Character</b>		Y		<i>Does the tree make an important contribution to the character or amenity of the area?</i>					
		Indigenous		<i>Is the tree indigenous, rare, endangered, invasive or exotic?</i>

<b>Habitat</b>		N		<i>Does the tree represent important habitat for native fauna?</i>					
		N		<i>Is the tree part of a wildlife Corridor, Buffer, etc?</i>					
<b>Notes:</b> Canopy of tree is slightly over picnic area; a few dead branches are leaning over that area.									
<b>Recommendations:</b> It is recommended to implement a program that continues to monitor this tree by an ISA Arborist and If condition continues to decline, consider removal. For recommended treatment, proper corrective pruning that follows ANSI A300 standards should be performed to remove dead and damaged branches. Additionally, it is recommended to form a mulch collar around the base of the tree that will prevent any future damage caused by landscape maintenance and provide additional benefits to the tree. Vertical mulching is recommended for mitigation, this is a technique that benefits stressed trees by improving the movement of water, air, and nutrients in the root zone and should be performed by a qualified tree care professional. The Town should implement a comprehensive program of tree management including soil testing.								Level of Urgency

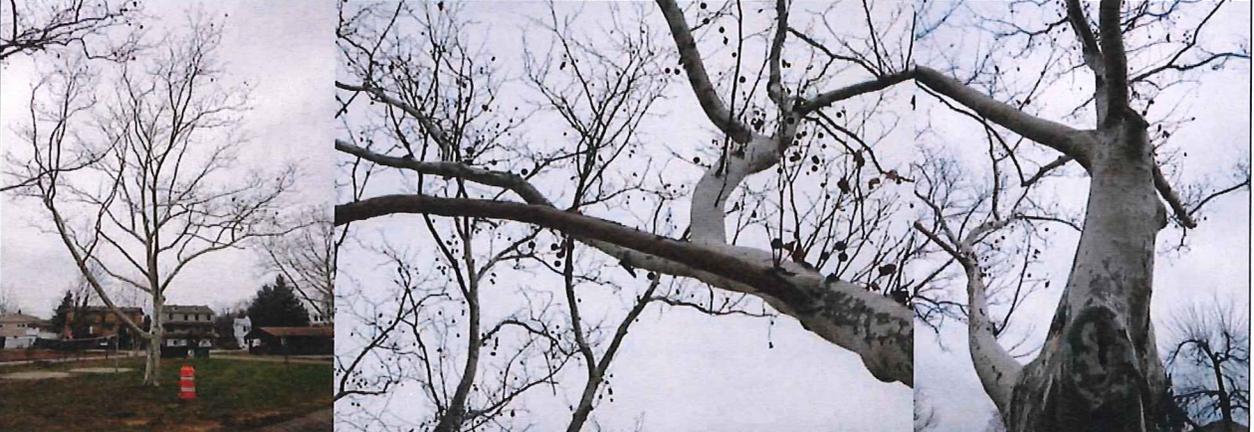
<b>Approx. Age</b>		E		<i>NP=Newly Planted Within 5yrs M=Moderate 10-20 yrs old E=Existing before development</i>					
<b>Tree/Root Base/Pit</b>		Minor mechanical damage at base from landscape maintenance.							
<b>Trunk Condition and Main Scaffold Branches</b>		Vertical cracking on trunk; water sprouting on trunk and scaffold branches; multiple dead scaffold branches							
<b>Crown/Structure , Branches &amp; Leaves</b>		Moderate fruiting on branches; dead small branches; tree was not assessed during full leaf.							
<b>Pest / Disease</b>		No noticeable signs.							
<b>Setting</b>		Inside park, adjacent to volleyball court.							
<b>Character</b>		Y		<i>Does the tree make an important contribution to the character or amenity of the area?</i>					
		Indigenous		<i>Is the tree indigenous, rare, endangered, invasive or exotic?</i>					
<b>Habitat</b>		N		<i>Does the tree represent important habitat for native fauna?</i>

N		<i>Is the tree part of a wildlife Corridor, Buffer, etc?</i>					
<b>Notes:</b> One major scaffold branch leaning over volleyball court has major water sprouting and minor dead branches.									
<b>Recommendations:</b> It is recommended to implement a program that continues to monitor this tree by an ISA Arborist and If condition continues to decline, consider removal. For recommended treatment, proper corrective pruning that follows ANSI A300 standards should be performed to remove dead scaffold branches and major scaffold branch leaning over volleyball court. Additionally, it is recommended to form a mulch collar around the base of the tree that will prevent any future damage caused by landscape maintenance and provide additional benefits to the tree. Vertical mulching is recommended for mitigation, this is a technique that benefits stressed trees by improving the movement of water, air, and nutrients in the root zone and should be performed by a qualified tree care professional. The Town should implement a comprehensive program of tree management including soil testing.								<b>Level of Urgency</b>

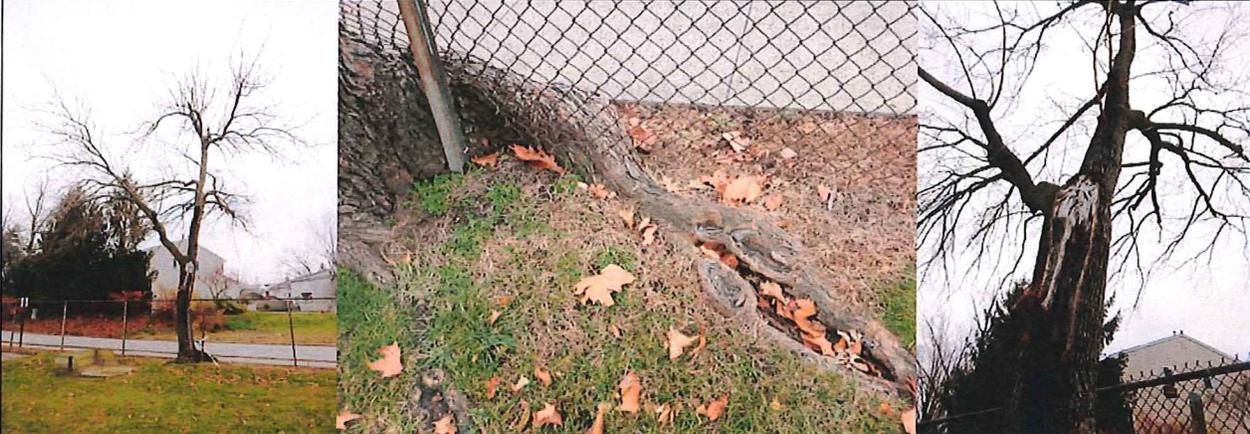
<b>Tree/Root Base/Pit</b>		Base of tree is fused with chain link fence; major mechanical damage to base and exposed roots from landscape maintenance; exposed roots on opposite side of fence have been cut short of concrete sidewalk.							
<b>Trunk Condition and Main Scaffold Branches</b>		Major trunk damage from fallen scaffold branch on park side; major open wounds from broken scaffold branches causing wet discharge staining trunk, evidence of bacterial wetwood disease.							
<b>Crown/Structure , Branches &amp; Leaves</b>		Uneven structure; most small branches are from large water sprouting on scaffold branches; tree was not assessed during full leaf.							
<b>Pest / Disease</b>		Evidence of bacterial wetwood at multiple open wounds.							
<b>Setting</b>		Northwest edge of park along chain link fence, adjacent to picnic area and volleyball court.							
<b>Character</b>		Y		<i>Does the tree make an important contribution to the character or amenity of the area?</i>

Invasive		<i>Is the tree indigenous, rare, endangered, invasive or exotic?</i>					
<b>Habitat</b>		N		<i>Does the tree represent important habitat for native fauna?</i>					
		N		<i>Is the tree part of a wildlife Corridor, Buffer, etc?</i>					
<b>Notes:</b> Horseshoe court directly underneath canopy; close proximity to barbeque pits. The tree appears to be in declining condition and has extensive damage to the trunk and scaffold branches.									
<b>Recommendations:</b> Remove tree due to evidence of continuous decline and proximity to picnic area. For tree replacement it is recommended to use Liquidambar styraciflua 'Rotundiloba'. Replacements should be planted immediately following removals and it is recommended to form a mulch collar around the base of the tree that will prevent any future damage caused by landscape maintenance and provide additional benefits to the tree. The Town should implement a comprehensive program of tree management including soil testing.									Level of Urgency

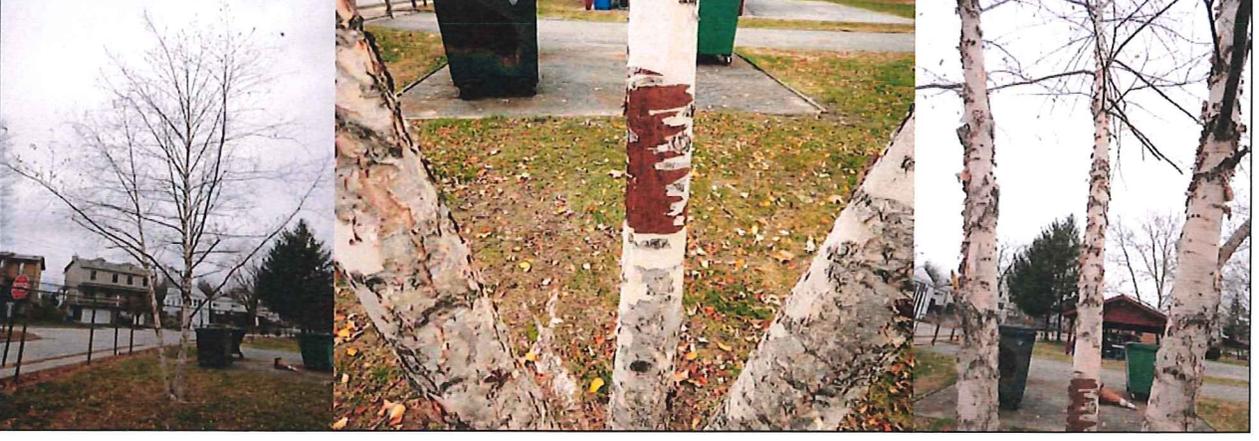
Tree/Root Base/Pit	Minor mechanical damage to exposed roots from landscape maintenance.
Trunk Condition and Main Scaffold Branches	Multi-stem; minor damage to trunk.
Crown/Structure, Branches & Leaves	Full and balanced crown; good small branch structure; tree was not assessed during full leaf.
Pest / Disease	No noticeable signs.
Setting	Northwest corner of park, adjacent to volleyball court.

**Recommendations:** It is recommended to implement a program that continues to monitor this tree by an ISA Arborist. Additionally, it is recommended to form a mulch collar around the base of the tree that will prevent any future damage caused by landscape maintenance and provide additional benefits to the tree. The Town should implement a comprehensive program of tree management including soil testing.

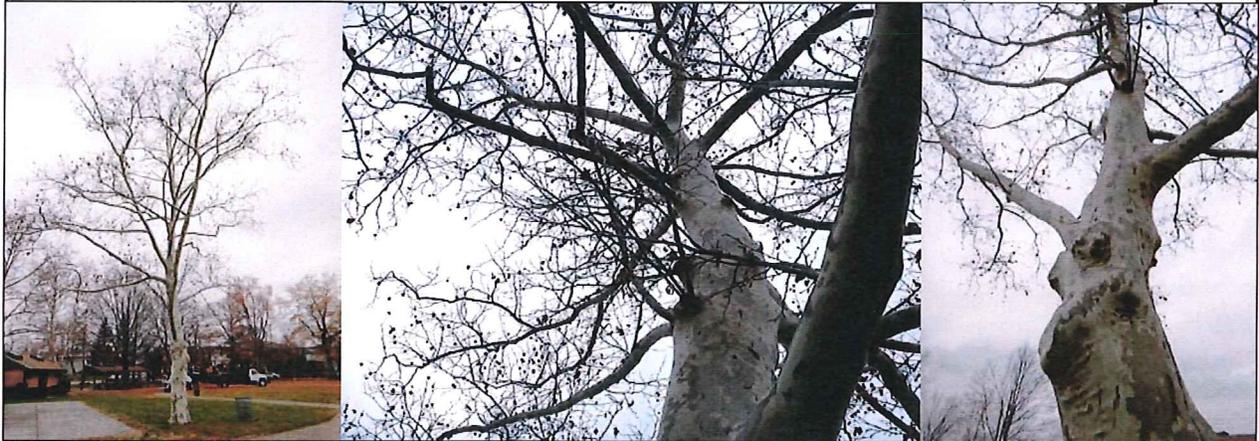
Tree/Root Base/Pit	Mechanical damage to base and exposed roots from landscape maintenance.		
Trunk Condition and Main Scaffold Branches	Water sprouting on trunk and scaffold branches; evidence of recent scaffold branch removal.		
Crown/Structure , Branches & Leaves	Uneven canopy from scaffold branch removal; fruiting well with good small branch structure; tree was not assessed during full leaf.		
Pest / Disease	No noticeable signs.		
Setting	Northwest corner of park, adjacent to picnic area and structure.

**Notes:** Picnic area directly below canopy, branches on the west side of the tree that are over the picnic area appear to be in good condition. Tree exhibits heavy pruning of a large number of lower branches and inner branches resulting in "Lion's-tailing" appearance which increases the risk of branch failure by weakening tree roots and decreasing the dampening effect that interior limbs provide during storms.

**Recommendations:** It is recommended to implement a program that continues to monitor this tree by an ISA Arborist and If condition continues to decline, consider removal. It is recommended to form a mulch collar around the base of the tree that will prevent any future damage caused by landscape maintenance and provide additional benefits to the tree. Vertical mulching is recommended for mitigation, this is a technique that benefits stressed trees by improving the movement of water, air, and nutrients in the root zone and should be performed by a qualified tree care professional. The Town should implement a comprehensive program of tree management including soil testing.

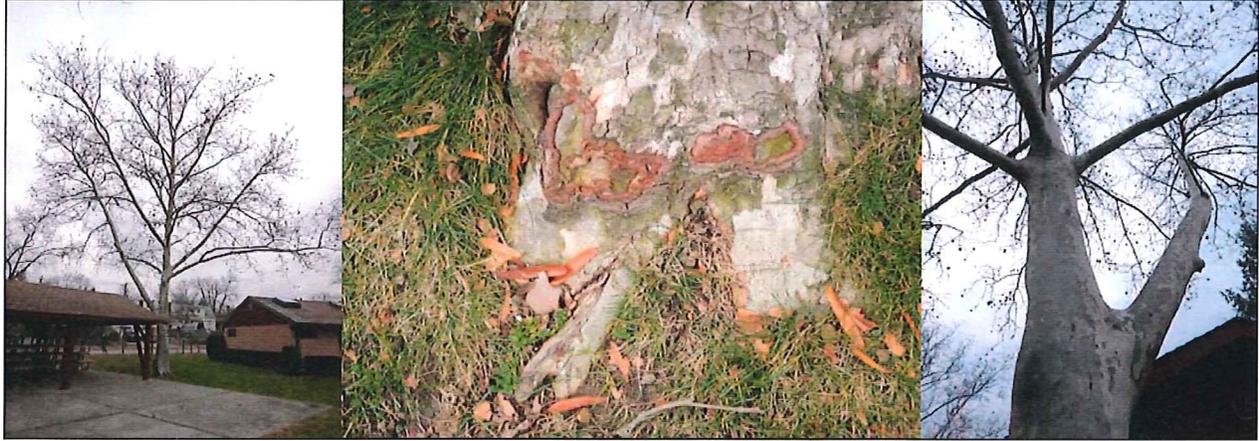
<b>Arborist Assessment Report</b>		Location: Manorhaven Beach Park - Port Washington, NY	Date: 12/09/2015
Inspector: Dan Maher		Weather: Overcast	Lat/Long: N 40° 50' 23.43" W 73° 43' 3.46"
Time: 2:30			
Specimen:	Common Name:	LONDON PLANETREE	Scientific name: <i>Platanus x acerifolia</i>
Descriptor	Value	Range	
Girth	22"	Trunk Diameter Measured at Breast Height (DBH)	
Approx. Height	60-65'	Approximate Height to top of Canopy	
Canopy	N 22' ,S 19' ,E 22' ,W 23'	Canopy Radius in Feet - North South East West	
Condition	3	Health of Specimen - 1 Dead - 2 Declining - 3 Moderate - 4 Good - 5 Excellent	
Approx. Age	E	NP=Newly Planted Within 5yrs M=Moderate 10-20 yrs old E=Existing before development	
Tree/Root Base/Pit	Mechanical damage to base and exposed roots from landscape maintenance, minor girdling roots.		
Trunk Condition and Main Scaffold Branches	Trunk is in good condition; minor water sprouting on scaffold branches.

**Recommendations:** It is recommended to implement a program that continues to monitor this tree by an ISA Arborist. The largest scaffold branch stemming 8' from the base of the tree that is leaning over the picnic structure appears to have a long lever-arm which puts most of the load at the end of the limb, this should be monitored and possibly pruned back to reduce the load on the extended limb. Additionally, it is recommended to form a mulch collar around the base of the tree that will prevent any future damage caused by landscape maintenance and provide additional benefits to the tree. Vertical mulching is recommended for mitigation, this is a technique that benefits stressed trees by improving the movement of water, air, and nutrients in the root zone and should be performed by a qualified tree care professional. The Town should implement a comprehensive program of tree management including soil testing.

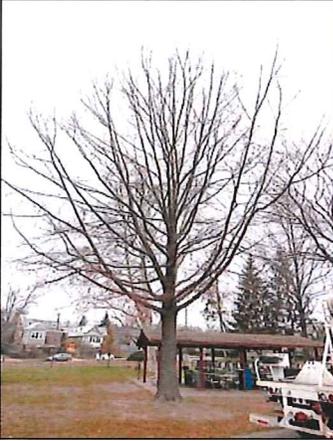
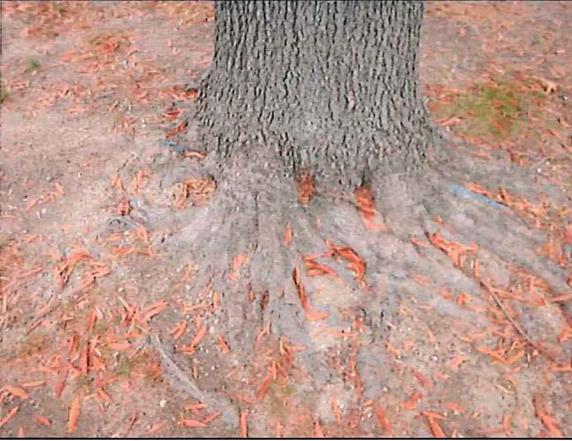
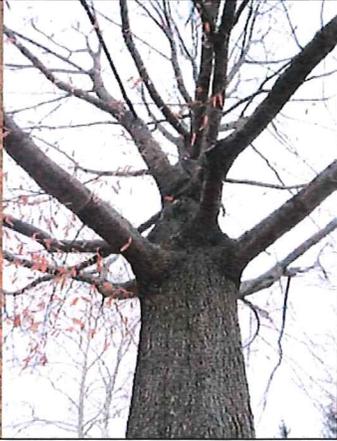
100 Crossways Park Drive West, Ste 104 Woodbury, New York 11797		t: 516.364.0660 f: 516.364.0668		www.bthayerassociates.com		Assignment:	Tree No.:
								1	38
<b>Arborist Assessment Report</b>				Location: Manorhaven Beach Park - Port Washington, NY				Date: 12/09/2015	
Inspector: Dan Maher				Weather: Overcast		Lat/Long: N 40° 50' 24.15" W 73° 43' 3.35"		Time: 2:40	
Specimen:		Common Name: OAK, WILLOW		Scientific name: <i>Quercus phellos</i>					
Descriptor		Value		Range					
Girth		25"		Trunk Diameter Measured at Breast Height (DBH)					
Approx. Height		60-65'		Approximate Height to top of Canopy					
Canopy		N 21' ,S 23' ,E 26' ,W 22'		Canopy Radius in Feet - North South East West					
Condition		5		Health of Specimen - 1 Dead - 2 Declining - 3 Moderate - 4 Good - 5 Excellent					
Approx. Age		E		NP=Newly Planted Within 5yrs M=Moderate 10-20 yrs old E=Existing before development					
Tree/Root Base/Pit		Minor mechanical damage to exposed roots from landscape maintenance.

Trunk Condition and Main Scaffold Branches		Good trunk and scaffold structure.							
Crown/Structure , Branches & Leaves		Good crown structure, good small branch structure; tree was not assessed during full leaf.							
Pest / Disease		No noticeable signs.							
Setting		Northwest corner of park, between picnic structure and bathrooms.							
Character		Y		Does the tree make an important contribution to the character or amenity of the area?					
		Indigenous		Is the tree indigenous, rare, endangered, invasive or exotic?					
Habitat		N		Does the tree represent important habitat for native fauna?					
		N		Is the tree part of a wildlife Corridor, Buffer, etc?					
Notes: Tree is in excellent condition, picnic structure directly below canopy.									
Recommendations: It is recommended to implement a program that continues to monitor this tree by an ISA Arborist. Additionally, it is recommended to form a mulch collar around the base of the tree that will prevent any future damage caused by landscape maintenance and provide additional benefits to the tree. The Town should implement a comprehensive program of tree management including soil testing.								Level of Urgency

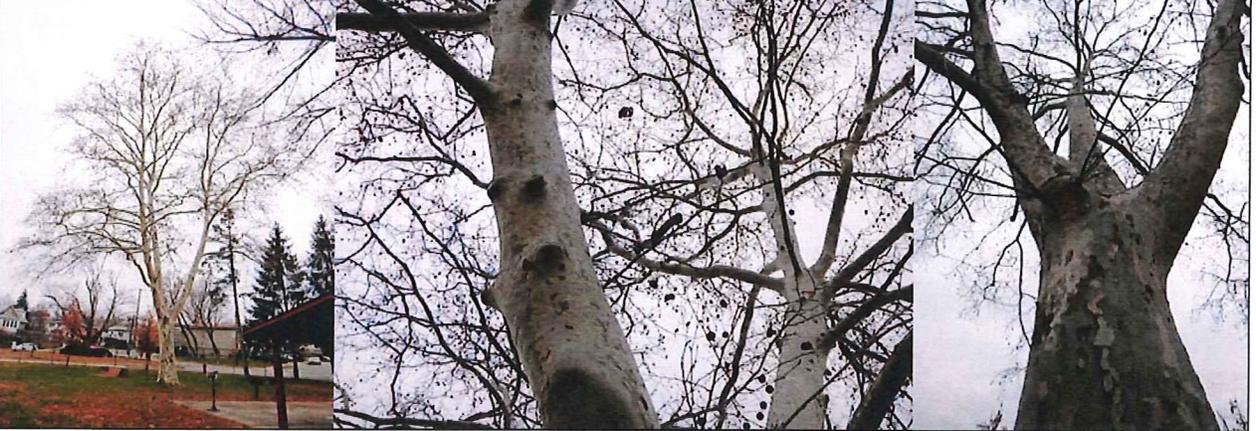
Tree/Root Base/Pit	Minor mechanical damage at base from landscape maintenance.
Trunk Condition and Main Scaffold Branches	Codominant leader; minor water sprouting on scaffold branches.
Crown/Structure , Branches & Leaves	Full crown with good small branch structure; fruiting well; minor broken branches hanging in tree crown; tree was not assessed during full leaf.
Pest / Disease	No noticeable signs.
Setting	Far northwest corner of park, between picnic structure and bathrooms.

**Notes:** Tree is in excellent condition. Evidence of scaffold branch removed.

<p><b>Recommendations:</b> It is recommended to implement a program that continues to monitor this tree by an ISA Arborist. For recommended treatment, proper corrective pruning that follows ANSI A300 standards should be performed to clean up crown by pruning dead and damaged branches. Additionally, it is recommended to form a mulch collar around the base of the tree that will prevent any future damage caused by landscape maintenance and provide additional benefits to the tree. The Town should implement a comprehensive program of tree management including soil testing.</p>	Level of Urgency
--	------------------

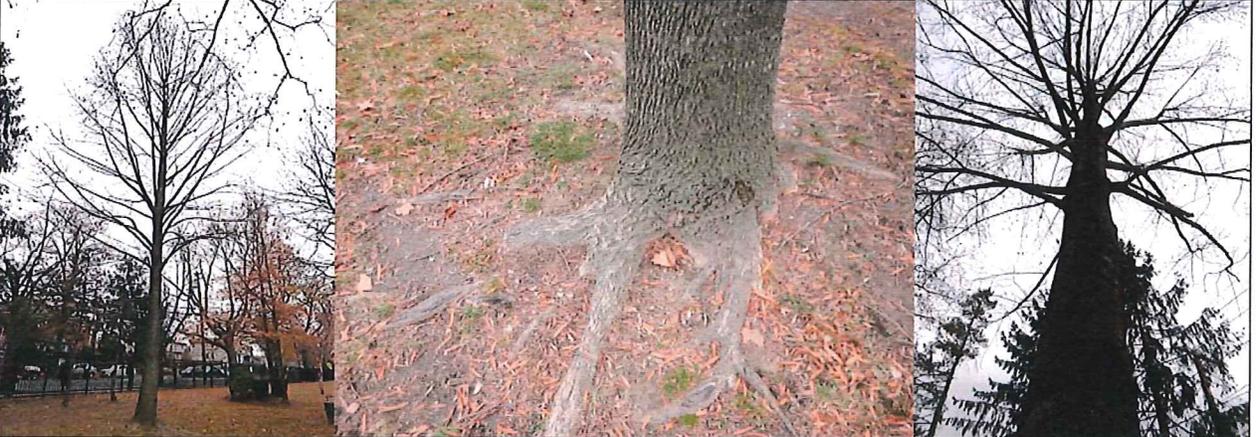
<b>Tree/Root Base/Pit</b>		Minor mechanical damage at base from landscape maintenance.							
<b>Trunk Condition and Main Scaffold Branches</b>		Good trunk and scaffold structure.							
<b>Crown/Structure , Branches &amp; Leaves</b>		Good crown structure; good small branch structure; tree was not assessed during full leaf.							
<b>Pest / Disease</b>		No noticeable signs.							
<b>Setting</b>		North west corner of park, north of last picnic structure.							
<b>Character</b>		Y		<i>Does the tree make an important contribution to the character or amenity of the area?</i>					
		Indigenous		<i>Is the tree indigenous, rare, endangered, invasive or exotic?</i>					
<b>Habitat</b>		N		<i>Does the tree represent important habitat for native fauna?</i>					
		N		<i>Is the tree part of a wildlife Corridor, Buffer, etc?</i>					
<b>Notes:</b> Tree is in excellent condition.									
<b>Recommendations:</b> It is recommended to implement a program that continues to monitor this tree by an ISA Arborist. Additionally, it is recommended to form a mulch collar around the base of the tree that will prevent any future damage caused by landscape maintenance and provide additional benefits to the tree. The Town should implement a comprehensive program of tree management including soil testing.								Level of Urgency

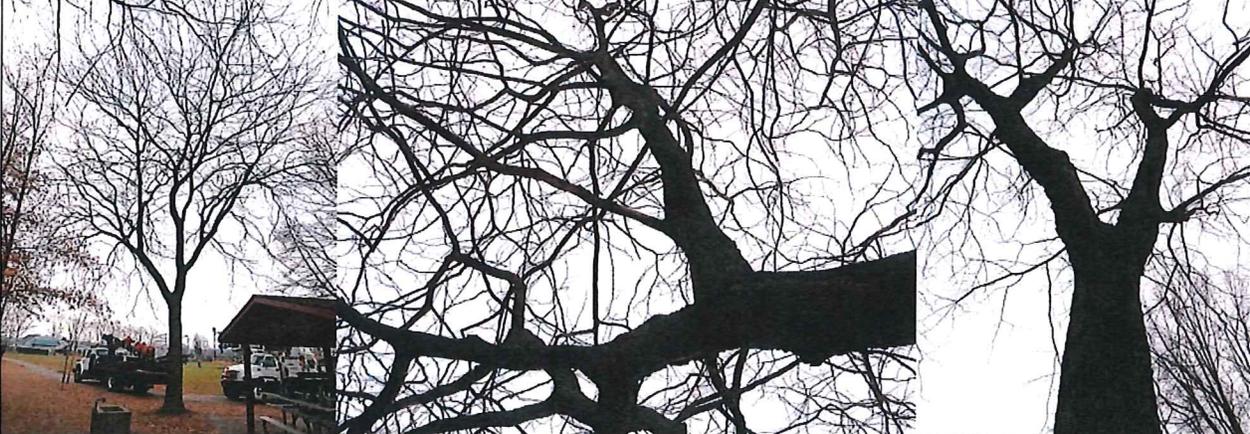
Tree/Root Base/Pit		Minor mechanical damage at base from landscape maintenance;							
Trunk Condition and Main Scaffold Branches		codominant leader; minor dead scaffold branches.							
Crown/Structure , Branches & Leaves		Good crown structure; minor dead smaller branches; tree was not assessed during full leaf.							
Pest / Disease		No noticeable signs.							
Setting		North west corner of park, north of last picnic structure.							
Character		Y	Does the tree make an important contribution to the character or amenity of the area?						
		Indigenous	Is the tree indigenous, rare, endangered, invasive or exotic?						
Habitat		N	Does the tree represent important habitat for native fauna?						
		N	Is the tree part of a wildlife Corridor, Buffer, etc?						
Notes: Trunk of tree is 2' from concrete pad for picnic area, minor dead branches above picnic area.									
Recommendations: It is recommended to implement a program that continues to monitor this tree by an ISA Arborist. For recommended treatment, proper corrective pruning that follows ANSI A300 standards should be performed to clean up crown by pruning dead and damaged branches. Additionally, it is recommended to form a mulch collar around the base of the tree that will prevent any future damage caused by landscape maintenance and provide additional benefits to the tree. The Town should implement a comprehensive program of tree management including soil testing.								Level of Urgency
