| Arborist Assessment Report | | Location: Manorhaven Beach Park - Port Washington, NY | Date: 12/09/2015 |
| Inspector: Dan Maher | | Weather: Overcast | Lat/Long: N 40° 50' 24.74" W 73° 43' 3.28" Time: 3:06 |

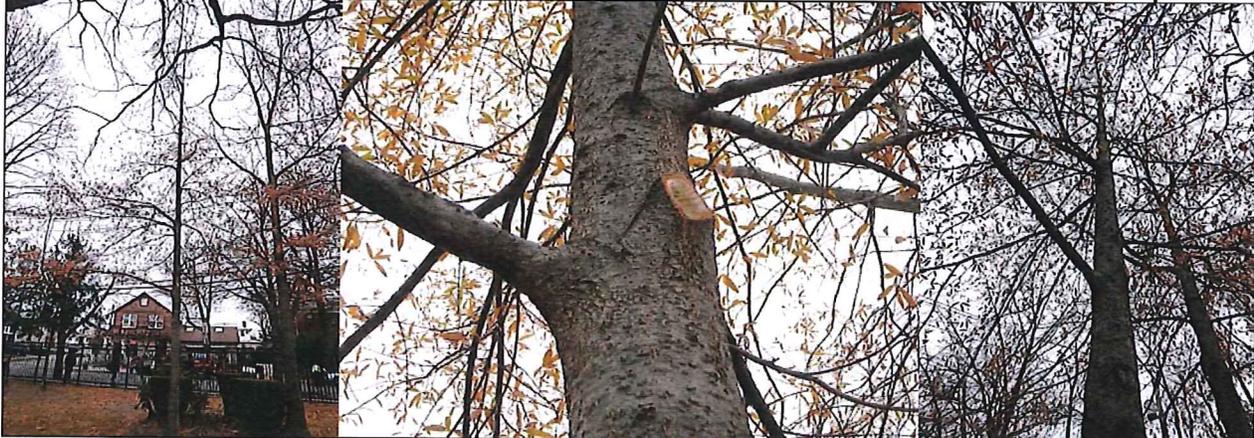
| 1 | 42 |

| Tree/Root Base/Pit | Growing in planting bed with another Willow Oak and shrubs; minor mechanical damage on exposed roots from landscape maintenance. | | |
| Crown/Structure , Branches & Leaves | Uneven canopy due to location underneath canopy of large Honeylocust and proximity to the other Willow Oak; tree was not assessed during full leaf. | | |
| <p>Notes: Growing underneath the canopy of adjacent Honeylocust. This tree was planted too close to another Willow Oak only 7' away, this will likely cause future problems for both trees due to the average full size of these species. Recent improper pruning to scaffold branches on the east side of the tree.</p> <p>Recommendations: It is recommended to implement a program that continues to monitor this tree by an ISA Arborist. The Town should implement a comprehensive program of tree management including soil testing.</p> | | | |

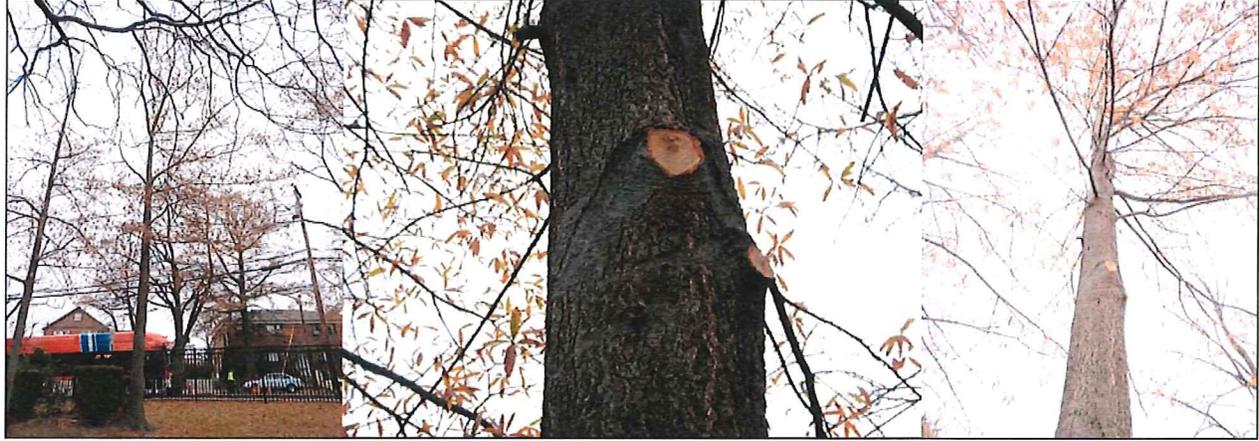
| 1 | 43 |

| Tree/Root Base/Pit | Growing in planting bed with another Willow Oak and shrubs. | | |
| Crown/Structure , Branches & Leaves | Uneven canopy due to close proximity to other Willow Oak; tree was not assessed during full leaf. | | |

Notes: This tree was planted too close to another Willow Oak only 7' away, this will likely cause future problems for both trees due to the average full size of these species. Recent improper pruning to scaffold branches on the west side of the tree.

Recommendations: It is recommended to implement a program that continues to monitor this tree by an ISA Arborist. The Town should implement a comprehensive program of tree management including soil testing.

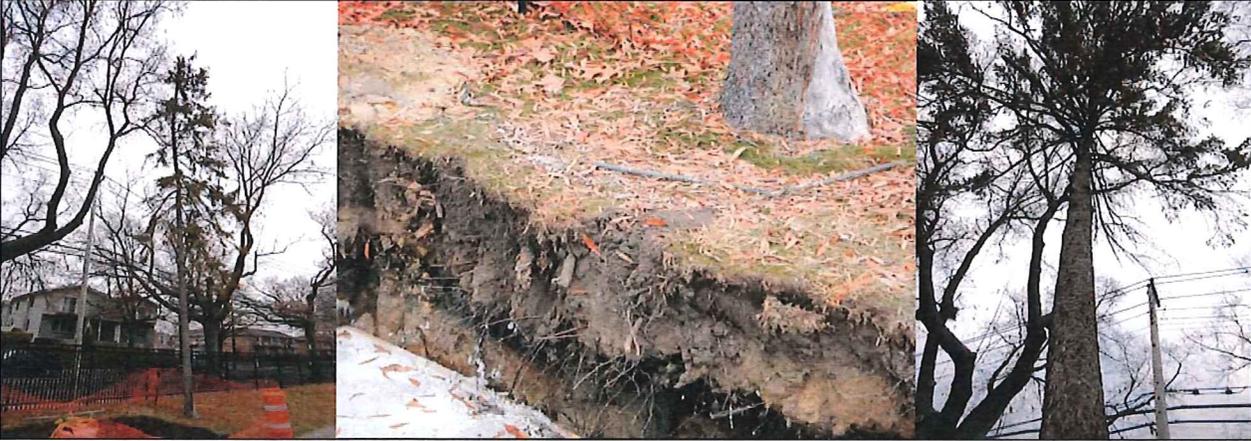
| | | | | | | | | 1 | 44 |

| Tree/Root Base/Pit | | Major root damage due to excavation for a 10' x 10' concrete foundation for new light pole less than 1' away from trunk; major basal decay. | | | | | | | |
| Trunk Condition and Main Scaffold Branches | | Major damage to trunk causing decay; dead scaffold branches. | | | | | | | |
| Notes: Recent excavation for a 10' x 10' concrete foundation for new light pole less than 1' from trunk has caused major damage to large roots and compaction from heavy machinery. | | | | | | | | | |

| Recommendations: Remove tree due to evidence of continuous decline. For tree replacement it is recommended to use Picea pungens 'Glauca'. Replacements should be planted immediately following removals and it is recommended to form a mulch collar around the base of the tree that will prevent any future damage caused by landscape maintenance and provide additional benefits to the tree. The Town should implement a comprehensive program of tree management including soil testing. | | | | | | | | Level of Urgency | |

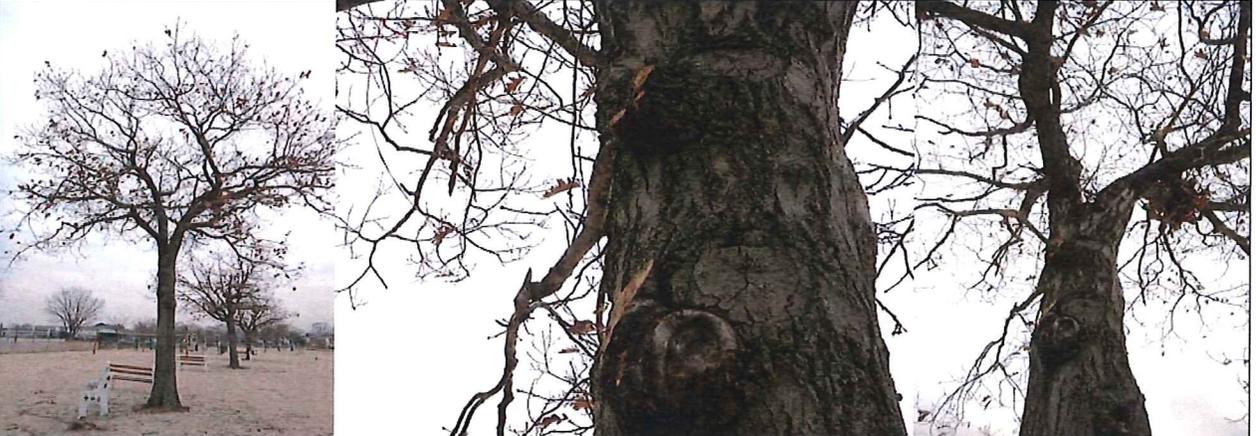
| | | | | | | | | 1 | 45 |

| Trunk Condition and Main Scaffold Branches | | Codominant leader; multiple dead scaffold branches. | | | | | | | |
| Crown/Structure , Branches & Leaves | | Small branch die-back; multiple dead and broken branches hanging in the crown; tree was not assessed during full leaf. | | | | | | | |

| Recommendations: It is recommended to implement a program that continues to monitor this tree by an ISA Arborist and If condition continues to decline, consider removal. For recommended treatment, proper corrective pruning that follows ANSI A300 standards should be performed to remove dead and damaged branches. Vertical mulching is recommended for mitigation, this is a technique that benefits stressed trees by improving the movement of water, air, and nutrients in the root zone and should be performed by a qualified tree care professional. The Town should implement a comprehensive program of tree management including soil testing. | | | | | | | | Level of Urgency | |

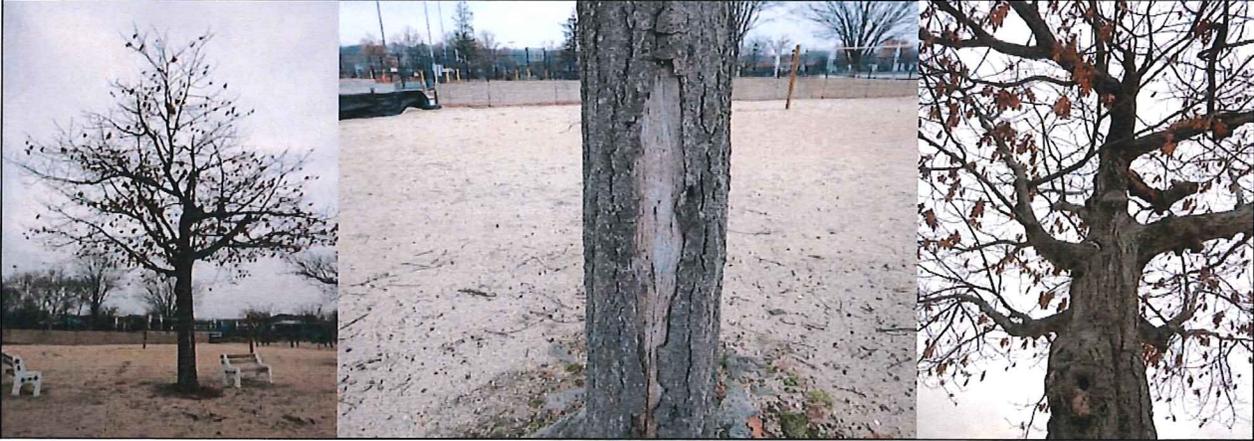
| Trunk Condition and Main Scaffold Branches | Major vertical cracks on trunk causing trunk rot; main leader has broken off entirely; major dead and broken scaffold branches. | | |
| Crown/Structure , Branches & Leaves | Poor crown structure; major small branch die-back; broken branches hanging in crown; tree was not assessed during full leaf. | | |

Recommendations: Remove tree due to current condition and anticipated decline.

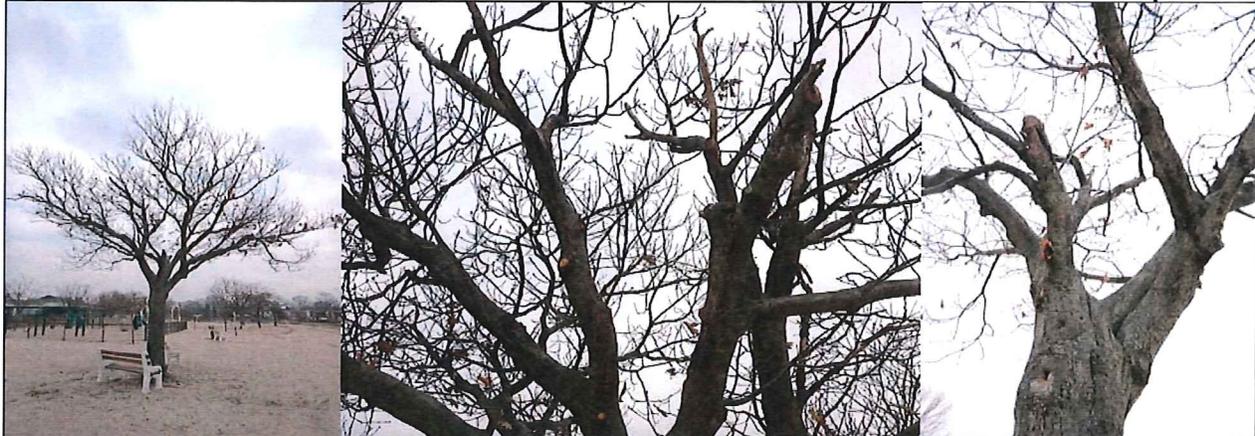
| Trunk Condition and Main Scaffold Branches | Major vertical cracks on trunk with open wounds appearing to have wetwood; main leader has broken off entirely; major dead and broken scaffold branches. | | |

Recommendations: Remove tree due to current condition and anticipated decline.

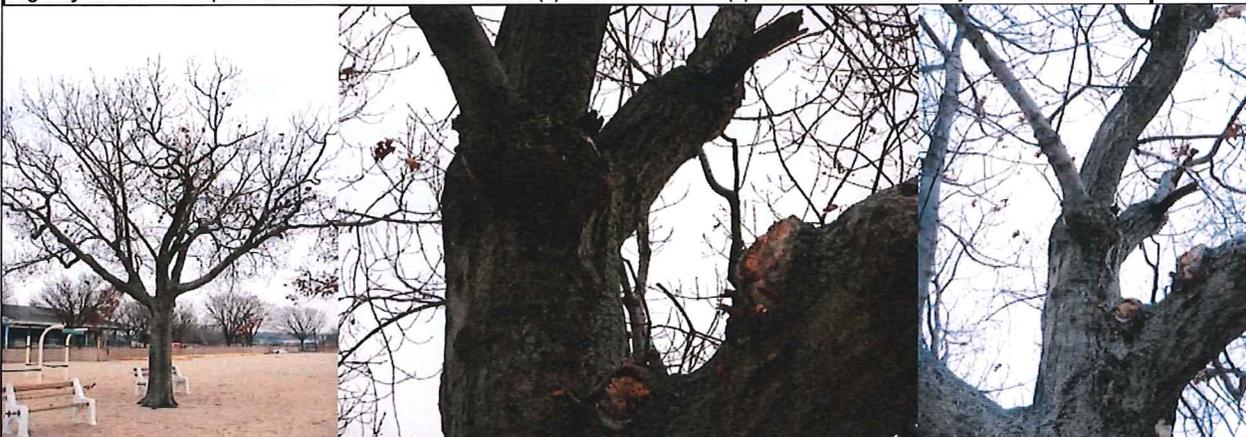
| Trunk Condition and Main Scaffold Branches | Major dead and broken scaffold branches. | | |
| Crown/Structure , Branches & Leaves | Dead and broken smaller branches, moderate fruiting; tree was not assessed during full leaf. | | |

Recommendations: It is recommended to implement a program that continues to monitor this tree by an ISA Arborist and If condition continues to decline, consider removal. For recommended treatment, proper corrective pruning that follows ANSI A300 standards should be performed to remove dead and damaged branches. Vertical mulching is recommended for mitigation, this is a technique that benefits stressed trees by improving the movement of water, air, and nutrients in the root zone and should be performed by a qualified tree care professional. The Town should implement a comprehensive program of tree management including soil testing.

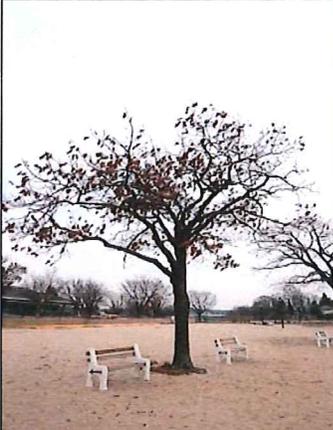
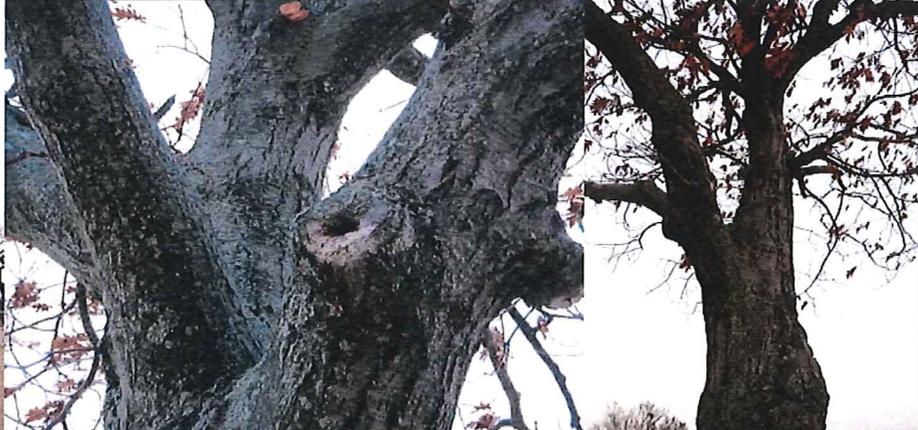
| Trunk Condition and Main Scaffold Branches | Dead scaffold branches. | | |

Recommendations: It is recommended to implement a program that continues to monitor this tree by an ISA Arborist and If condition continues to decline, consider removal. For recommended treatment, proper corrective pruning that follows ANSI A300 standards should be performed to remove dead and damaged branches. Vertical mulching is recommended for mitigation, this is a technique that benefits stressed trees by improving the movement of water, air, and nutrients in the root zone and should be performed by a qualified tree care professional. The Town should implement a comprehensive program of tree management including soil testing.

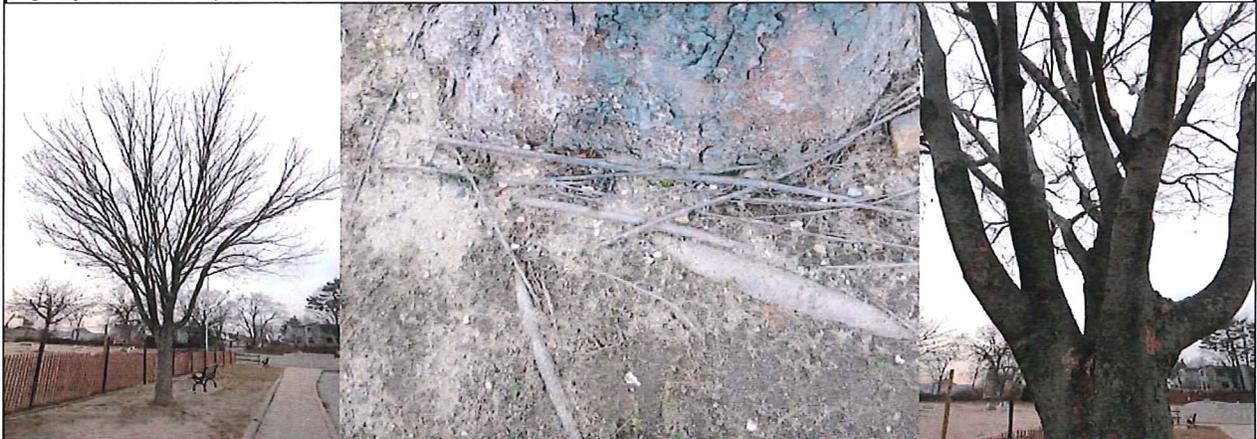
| Tree/Root Base/Pit | Girdling roots; minor damage to exposed roots from landscape maintenance. | | |

Recommendations: It is recommended to implement a program that continues to monitor this tree by an ISA Arborist. For recommended treatment, proper corrective pruning that follows ANSI A300 standards should be performed to remove dead small branches. Additionally, it is recommended to form a mulch collar around the base of the tree that will prevent any future damage caused by landscape maintenance and provide additional benefits to the tree. Vertical mulching is recommended for mitigation, this is a technique that benefits stressed trees by improving the movement of water, air, and nutrients in the root zone and should be performed by a qualified tree care professional. The Town should implement a comprehensive program of tree management including soil testing.

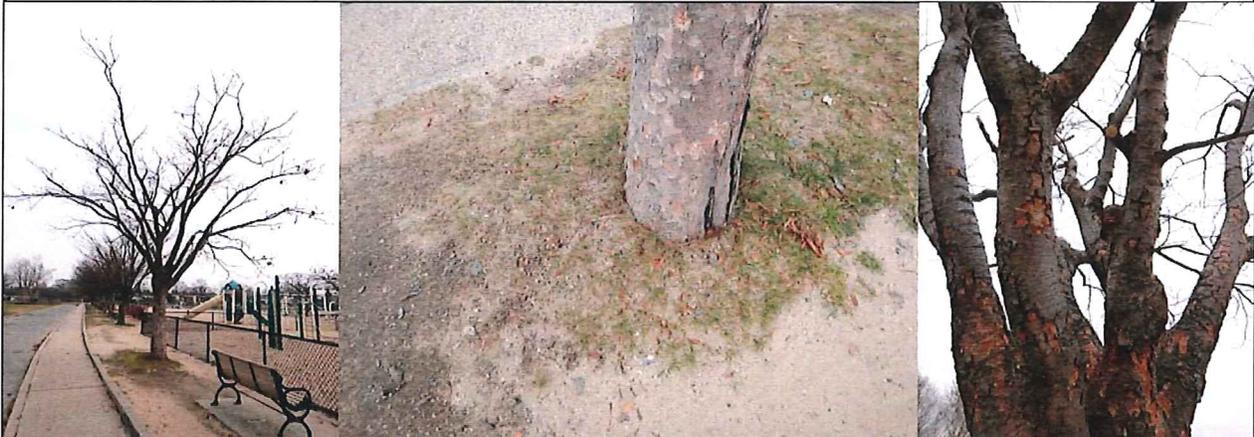
| Tree/Root Base/Pit | Buried root collar; basal decay. | | |
| Trunk Condition and Main Scaffold Branches | Major vertical crack on trunk stemming from basal decay; bark defoliation. | | |

Notes: Evidence of recent major pruning to scaffold and small branches. The condition of the tree appears to be in decline from the basal decay caused by the buried root collar, and the heavy pruning that has occurred to the crown.

Recommendations: It is recommended to implement a program that continues to monitor this tree by an ISA Arborist and If condition continues to decline, consider removal. It is recommended to perform root crown excavation by a qualified tree care professional, which is a treatment that involves the removal of excess soil from a trees root flare and main lateral roots. Vertical mulching is recommended for mitigation, this is a technique that benefits stressed trees by improving the movement of water, air, and nutrients in the root zone and should be performed by a qualified tree care professional. Additionally, it is recommended to form a mulch collar around the base of the tree that will prevent any future damage caused by landscape maintenance and provide additional benefits to the tree. The Town should implement a comprehensive program of tree management including soil testing.

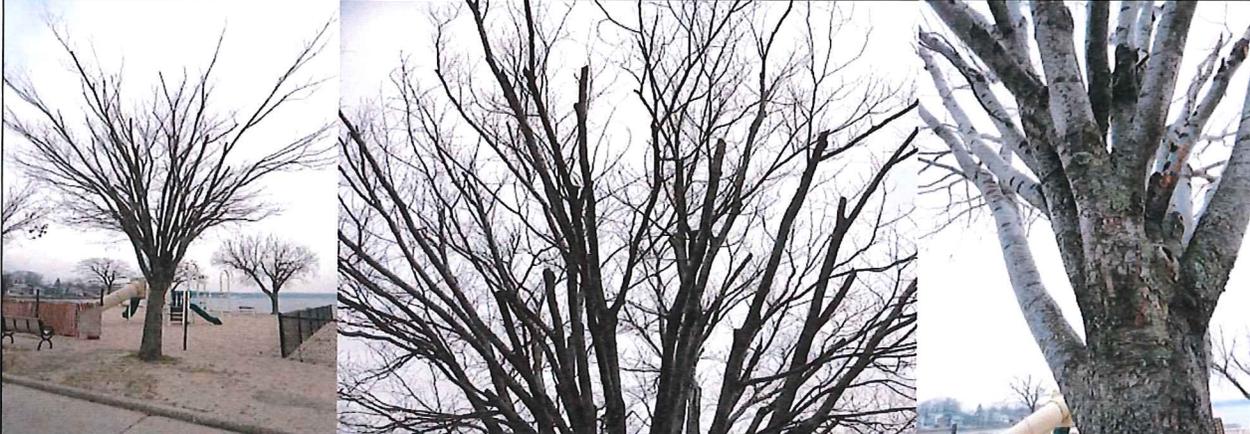
| | | | | | | | | 1 | 53 |

| Tree/Root Base/Pit | | Buried root collar; girdling roots; minor damage to exposed roots from landscape maintenance. | | | | | | | |
| Trunk Condition and Main Scaffold Branches | | Multiple open wounds on trunk from old pruning cuts that have not completely healed. | | | | | | | |
| Notes: Evidence of recent major pruning to scaffold and small branches. The condition of the tree appears to be in decline from the heavy pruning that has occurred to the crown. | | | | | | | | | |

| Recommendations: It is recommended to implement a program that continues to monitor this tree by an ISA Arborist and If condition continues to decline, consider removal. It is recommended to perform root crown excavation by a qualified tree care professional, which is a treatment that involves the removal of excess soil from a trees root flare and main lateral roots. Vertical mulching is recommended for mitigation, this is a technique that benefits stressed trees by improving the movement of water, air, and nutrients in the root zone and should be performed by a qualified tree care professional. Additionally, it is recommended to form a mulch collar around the base of the tree that will prevent any future damage caused by landscape maintenance and provide additional benefits to the tree. The Town should implement a comprehensive program of tree management including soil testing. | | | | | | | | Level of Urgency | |

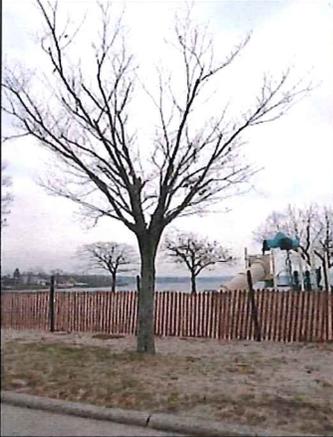
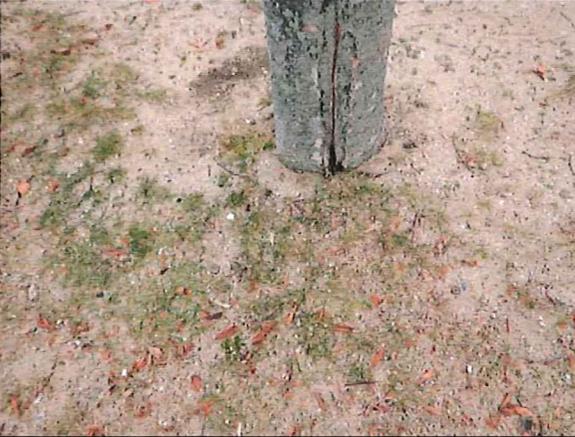
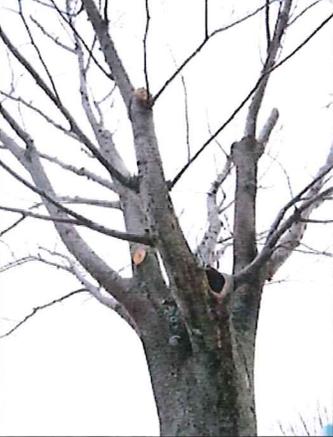
| | | | | | | | | 1 | 54 |

| Tree/Root Base/Pit | | Buried root collar; vertical cracking at base; girdling roots; minor damage to exposed roots from landscape maintenance. | | | | | | | |
| Trunk Condition and Main Scaffold Branches | | Major vertical crack on trunk continues into scaffold branch and to an open wound; trunk wounds from old pruning cuts have not completely healed and appear to have canker rot. | | | | | | | |
| Notes: Evidence of recent major pruning to scaffold and small branches. The condition of the tree appears to be in decline from the basal decay caused by the buried root collar, and the heavy pruning that has occurred to the crown. | | | | | | | | | |

| Recommendations: It is recommended to implement a program that continues to monitor this tree by an ISA Arborist and If condition continues to decline, consider removal. It is recommended to perform root crown excavation by a qualified tree care professional, which is a treatment that involves the removal of excess soil from a trees root flare and main lateral roots. Vertical mulching is recommended for mitigation, this is a technique that benefits stressed trees by improving the movement of water, air, and nutrients in the root zone and should be performed by a qualified tree care professional. Additionally, it is recommended to form a mulch collar around the base of the tree that will prevent any future damage caused by landscape maintenance and provide additional benefits to the tree. The Town should implement a comprehensive program of tree management including soil testing. | | | | | | | | | Level of Urgency |

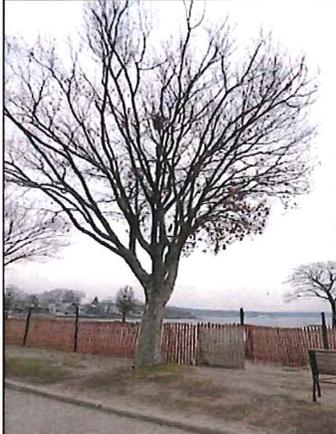
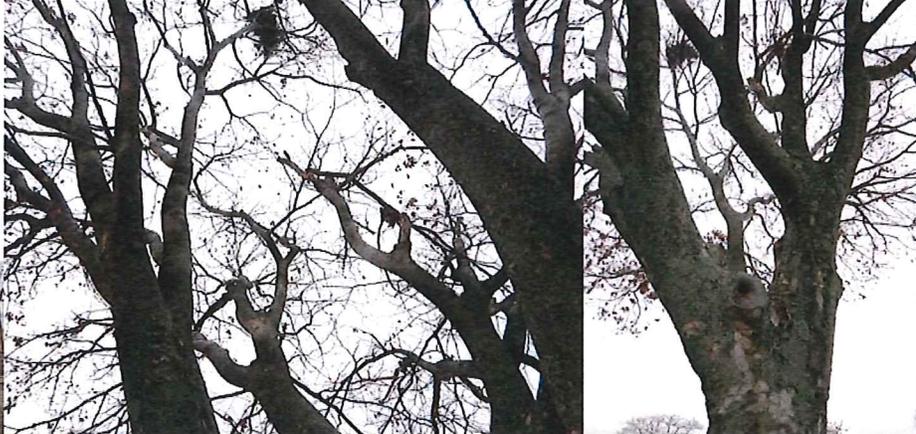
| | | | | | | | | 1 | 56 |

| Trunk Condition and Main Scaffold Branches | | Minor damage to scaffold branches; dead scaffold branches; minor bark defoliation around scaffold branch unions. | | | | | | | |

| Recommendations: It is recommended to implement a program that continues to monitor this tree by an ISA Arborist. For recommended treatment, proper corrective pruning that follows ANSI A300 standards should be performed to remove dead and damaged branches. It is recommended to perform root crown excavation by a qualified tree care professional, which is a treatment that involves the removal of excess soil from a trees root flare and main lateral roots. Vertical mulching is recommended for mitigation, this is a technique that benefits stressed trees by improving the movement of water, air, and nutrients in the root zone and should be performed by a qualified tree care professional. Additionally, it is recommended to form a mulch collar around the base of the tree that will prevent any future damage caused by landscape maintenance and provide additional benefits to the tree. The Town should implement a comprehensive program of tree management including soil testing. | | | | | | | | Level of Urgency | |

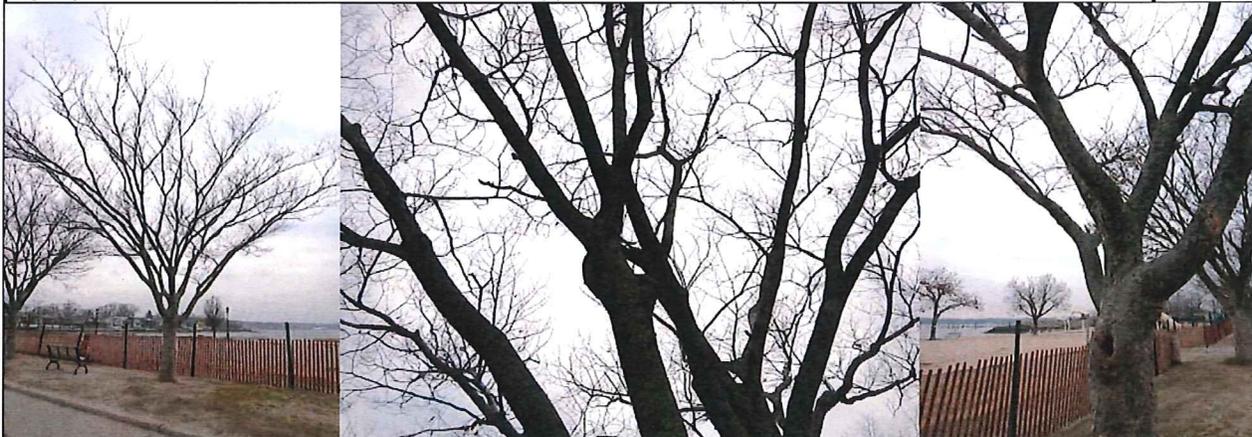
| Trunk Condition and Main Scaffold Branches | Trunk and scaffold branches are in good condition; open cavity on trunk from old pruning cut not fully healed. | | |

Recommendations: It is recommended to implement a program that continues to monitor this tree by an ISA Arborist. It is recommended to perform root crown excavation by a qualified tree care professional, which is a treatment that involves the removal of excess soil from a trees root flare and main lateral roots. Vertical mulching is recommended for mitigation, this is a technique that benefits stressed trees by improving the movement of water, air, and nutrients in the root zone and should be performed by a qualified tree care professional. Additionally, it is recommended to form a mulch collar around the base of the tree that will prevent any future damage caused by landscape maintenance and provide additional benefits to the tree. The Town should implement a comprehensive program of tree management including soil testing.

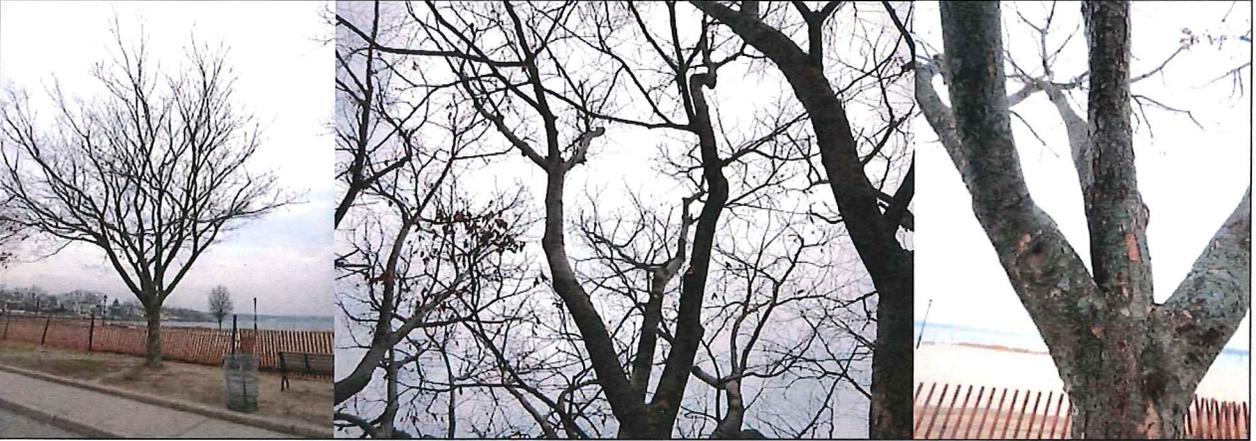
| Trunk Condition and Main Scaffold Branches | Codominant leaders; one scaffold branch appears to be declining and has discoloration and defoliation of bark; trunk cavity from old pruning cut that has not completely healed. |

| <p>Recommendations: It is recommended to implement a program that continues to monitor this tree by an ISA Arborist. For recommended treatment, proper corrective pruning that follows ANSI A300 standards should be performed to remove dead small branches. It is recommended to perform root crown excavation by a qualified tree care professional, which is a treatment that involves the removal of excess soil from a trees root flare and main lateral roots. Vertical mulching is recommended for mitigation, this is a technique that benefits stressed trees by improving the movement of water, air, and nutrients in the root zone and should be performed by a qualified tree care professional. Additionally, it is recommended to form a mulch collar around the base of the tree that will prevent any future damage caused by landscape maintenance and provide additional benefits to the tree. The Town should implement a comprehensive program of tree management including soil testing.</p> | <div style="background-color: #f4a460; padding: 5px; font-weight: bold;">Level of Urgency</div> <div style="border: 1px solid black; height: 60px; width: 100%;"></div> |

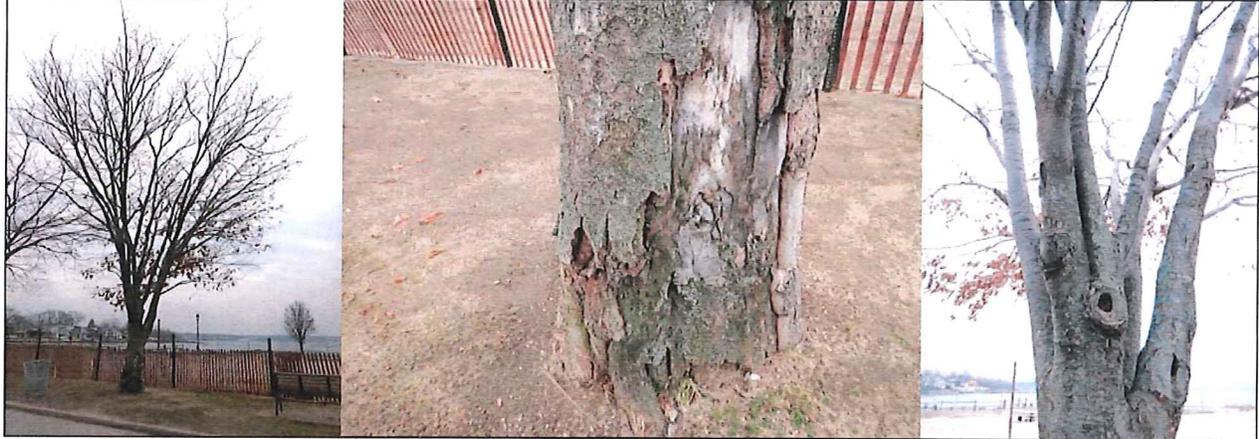
| Tree/Root Base/Pit | Major basal decay that wraps around most of the trunk. |
| Trunk Condition and Main Scaffold Branches | Major damage on trunk stemming from the basal decay; old pruning cuts to remove scaffold branches have not completely healed and show cavity rot; included bark on scaffold unions. |

Notes: Crown and scaffold branches appear to be in moderate to good condition, however the major basal decay is rotting the trunk and could be a hazard.

Recommendations: Remove tree due to evidence of continuous decline. For tree replacement it is recommended to use Zelkova serrata 'Green Vase'. Replacements should be planted immediately following removals and it is recommended to form a mulch collar around the base of the tree that will prevent any future damage caused by landscape maintenance and provide additional benefits to the tree. The Town should implement a comprehensive program of tree management including soil testing.

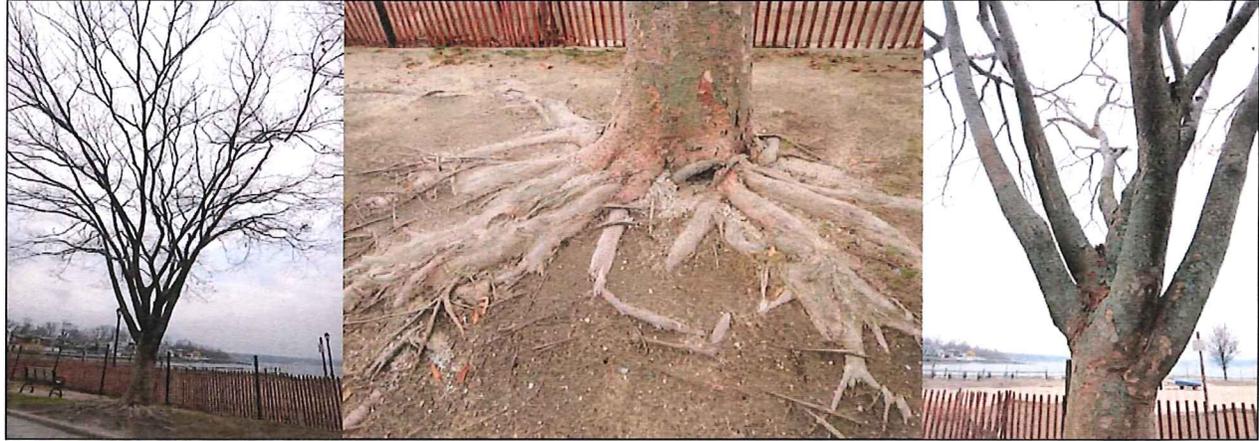
| Tree/Root Base/Pit | Girdling roots; damage to exposed roots from landscape maintenance. | | |
| Trunk Condition and Main Scaffold Branches | Minor vertical cracking on scaffold branch; included bark at scaffold branch unions. | | |
| Crown/Structure , Branches & Leaves | Minor dead and broken branches; tree was not assessed during full leaf. | | |

Recommendations: It is recommended to implement a program that continues to monitor this tree by an ISA Arborist. For recommended treatment, proper corrective pruning that follows ANSI A300 standards should be performed to remove dead and damaged branches. Vertical mulching is recommended for mitigation, it is a technique that benefits stressed trees by improving the movement of water, air, and nutrients in the root zone and should be performed by a qualified tree care professional. This is recommended to add soil around the base and of the tree as it has eroded away from a mulch collar around the base of the tree that will prevent any future damage caused by landscape maintenance and provide additional benefits to the tree. The Town should implement a comprehensive program of tree management including soil testing.

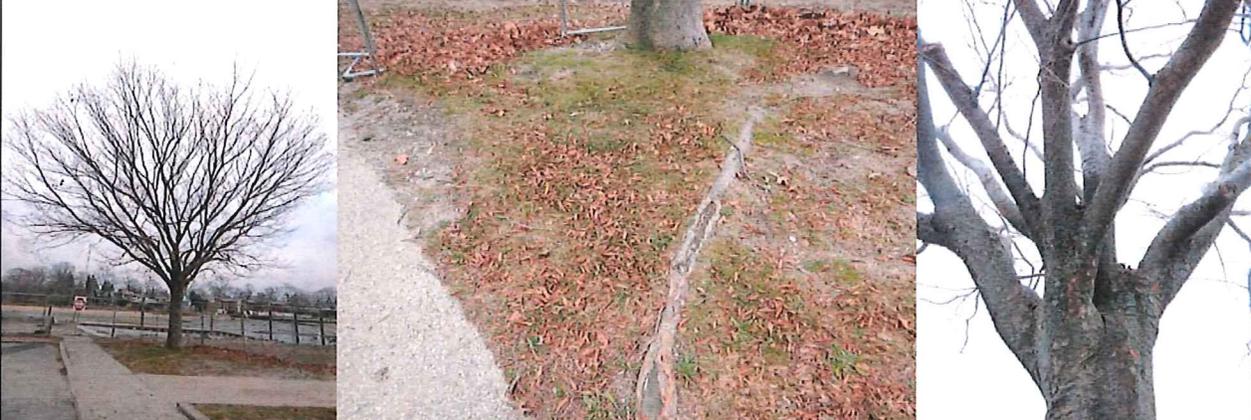
| Tree/Root Base/Pit | Damage to exposed roots from landscape maintenance. |

Recommendations: It is recommended to implement a program that continues to monitor this tree by an ISA Arborist. Vertical mulching is recommended for mitigation, this is a technique that benefits stressed trees by improving the movement of water, air, and nutrients in the root zone and should be performed by a qualified tree care professional. Additionally, it is recommended to form a mulch collar around the base of the tree that will prevent any future damage caused by landscape maintenance and provide additional benefits to the tree. The Town should implement a comprehensive program of tree management including soil testing.
