## **APPENDICES**

**Full Environmental Assessment Form**  
**Part 1 - Project and Setting**

**SURVEY OF PROPERTY WITH LOCATION MAP AT HIGH STREET**  
**MANHASSET, NASSAU COUNTY, NEW YORK**  
 SHOWN AS SECTION 2, BLOCK 347, LOTS 16 & 17 ON THE LAND AND TAX MAP OF NASSAU COUNTY

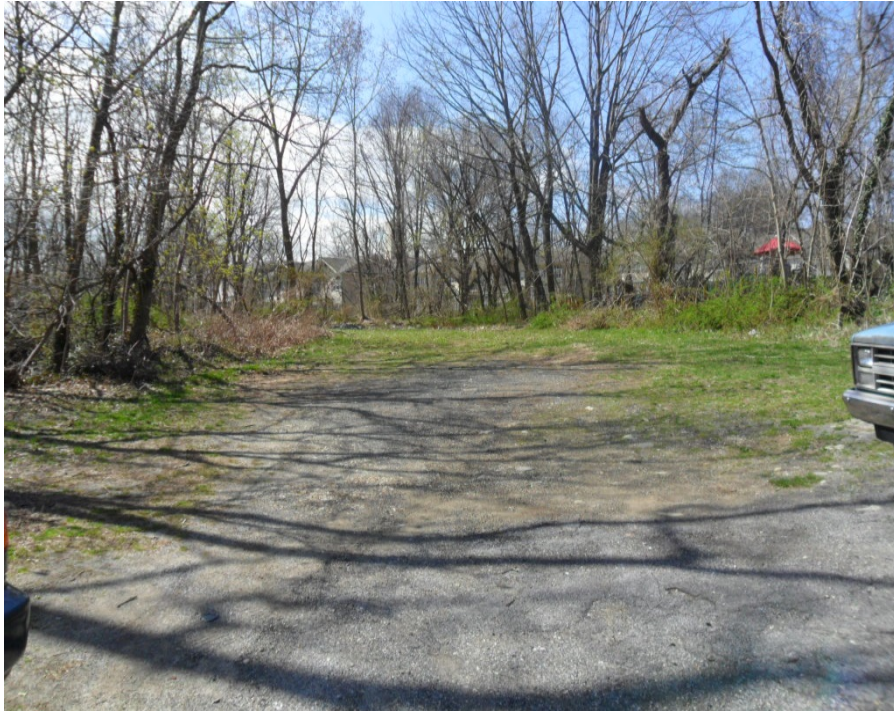
Photograph 11: Deteriorated asphalt surface area on northwestern portion of the Site; view from Hill Street looking south

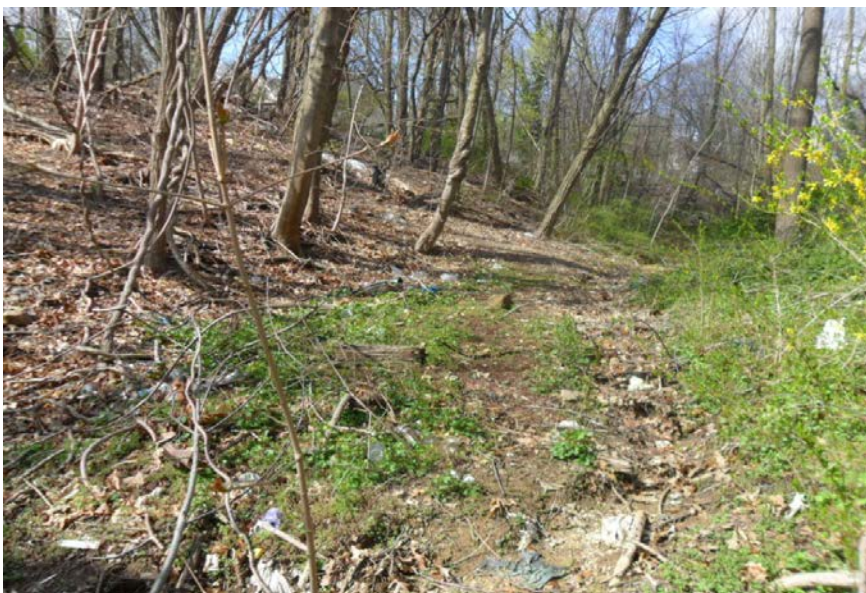
Photograph 12: Wooded sloped area of Site; view looking west

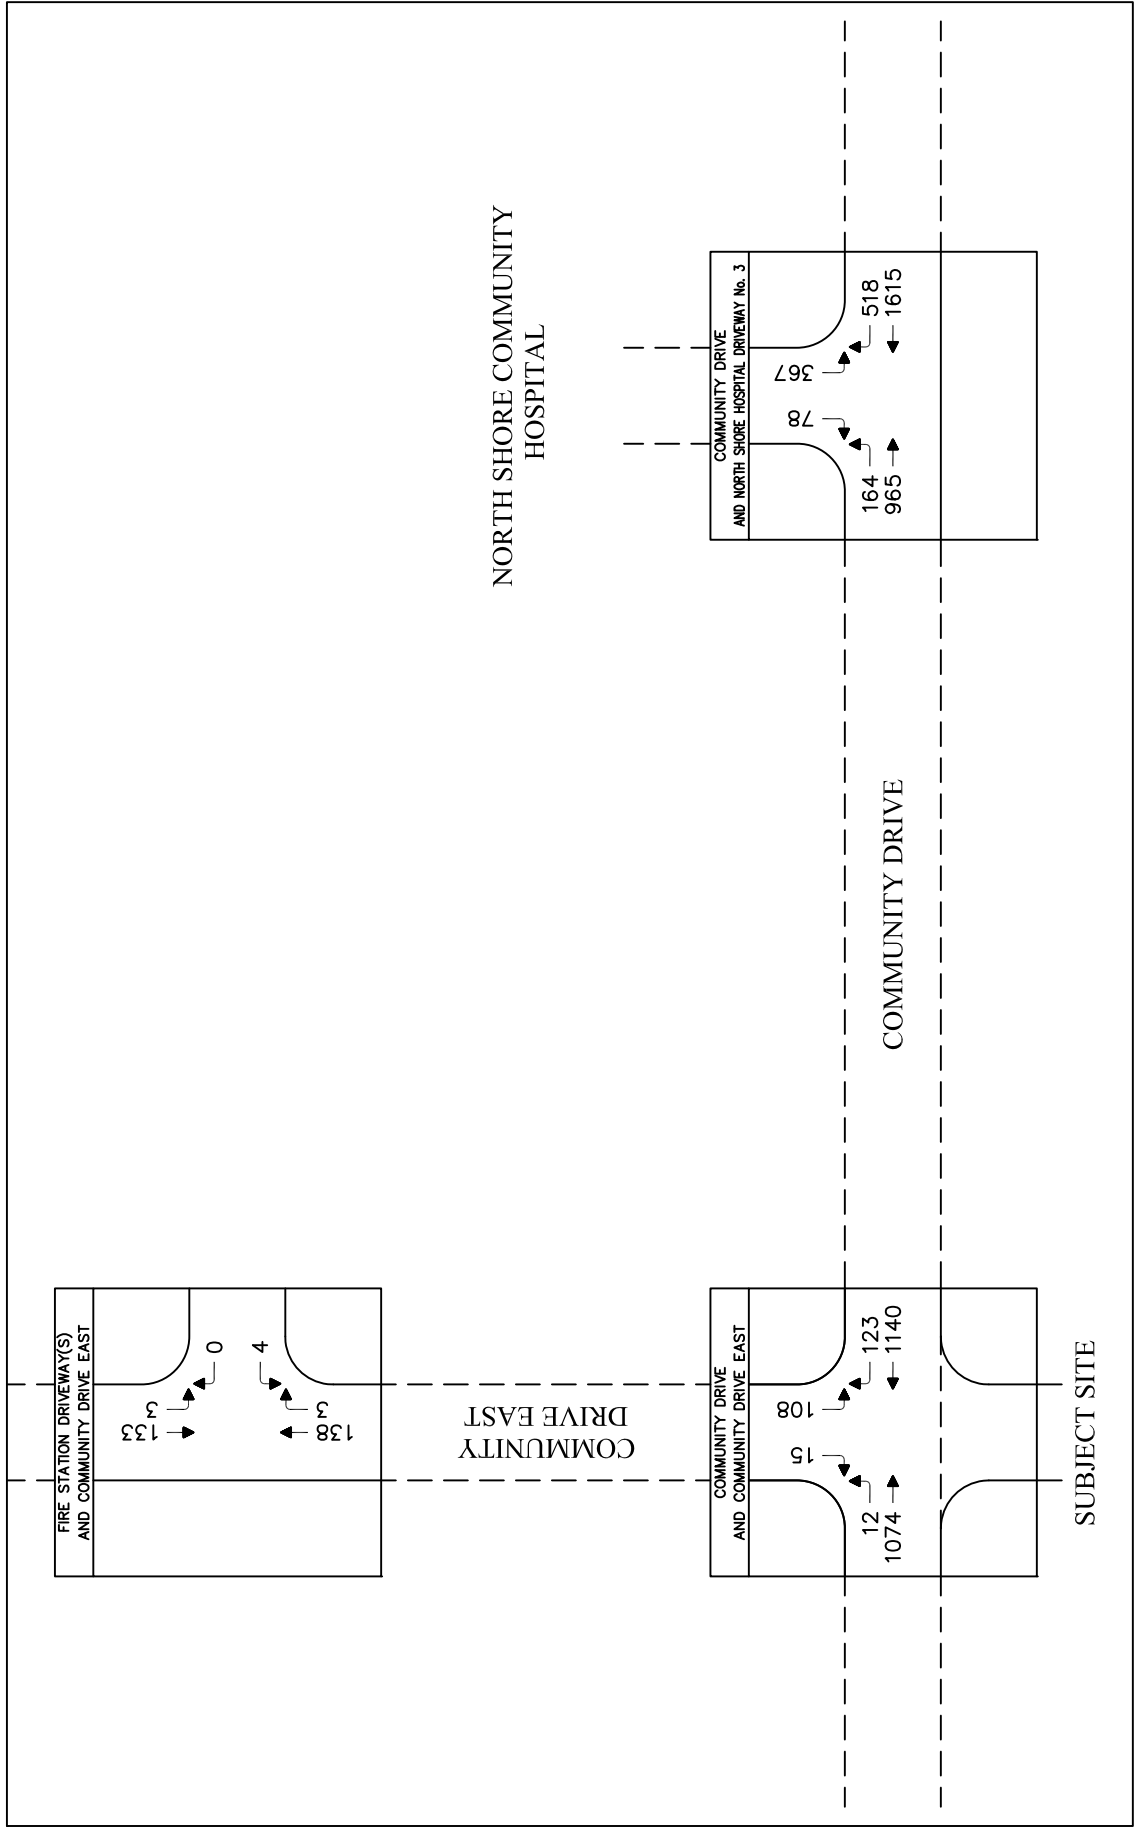
FIGURE No. 2  
PROJECT No. M14-021  
MANHASSET  
MORNING PEAK HOUR - EXISTING

EXISTING VOLUMES SHOWN REFLECT THE ADJUSTED FLOW RATE
