# DRAFT REPORT

100 Crossways Park Drive West, Ste 10- Woodbury, New York 11797	T: 516.364.0660 F: 516.364.0655	www.btnayerassociates.com	Assignment: <b>2</b>	Tree No.: <b>2</b>
Arborist Assessment Report		Location: North Hempstead Beach Park - Port Washington, NY		Date: 2/25/2016		
Inspector: Dan Maher		Weather: Mostly Cloudy	Lat/Long: N 40° 49' 41.06" W 73° 39' 2.16"		Time: 09:46	
Specimen:	Common Name: TREE OF HEAVEN		Scientific name: Ailanthus altissima			
Descriptor	Value	Range				
Girth	8"	Trunk Diameter Measured at Breast Height (DBH)				
Approx. Height	15'-20'	Approximate Height to top of Canopy				
Canopy	N 12', S 6', E 9', W 8'	Canopy Radius in Feet - North South East West				
Condition	3	Health of Specimen - 1 Dead - 2 Declining - 3 Moderate - 4 Good - 5 Excellent				
Approx. Age	M	NP=Newly Planted Within 5yrs M=Moderate 10-20 yrs old E=Existing before development				
Tree/Root Base/Pit	Growing almost entirely in sand that is eroding away and exposing roots.

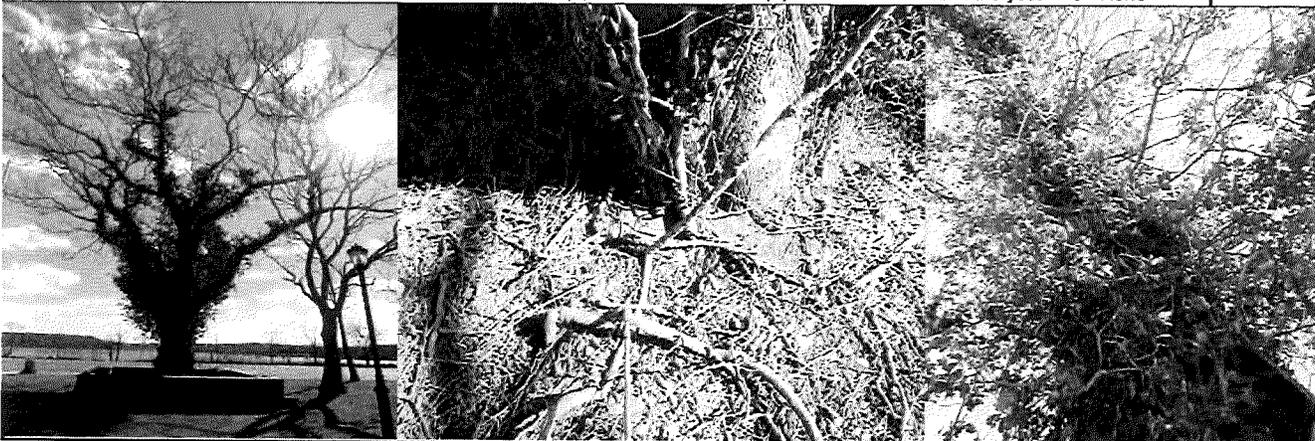
<b>Tree/Root Base/Pit</b>		Growing in a raised planter, English ivy growing at the base of planter bed and up the tree..							
<b>Trunk Condition and Main Scaffold Branches</b>		Codominant leaders, trunk and scaffold branches are covered in English ivy, broken scaffold branches.							
<b>Crown/Structure, Branches &amp; Leaves</b>		Uneven crown, minor dead branches, tree was not assessed during full leaf.							
<b>Pest / Disease</b>		No noticeable signs.							
<b>Setting</b>		Far east end of park, growing in a 4' high planter.							
<b>Character</b>		Y		Does the tree make an important contribution to the character or amenity of the area?					
		Invasive		Is the tree indigenous, rare, endangered, invasive or exotic?					
<b>Habitat</b>		N		Does the tree represent important habitat for native fauna?					
		N		Is the tree part of a wildlife Corridor, Buffer, etc?					
<b>Notes:</b> Major ivy growth around the trunk and into the scaffold branches adds weight to the crown of the tree and increases risk of ice and snow.

<b>Recommendations:</b> It is recommended to implement a program that continues to monitor this tree by an ISA Arborist and if condition continues to decline, consider removal. For recommended treatment, proper corrective pruning that follows ANSI A300 standards should be performed to remove dead and damaged branches as well as cut out ivy at base of tree and remove from crown. Additionally, it is recommended to form a mulch collar around the base of the tree that will prevent any future damage caused by landscape maintenance and provide additional benefits to the tree. Vertical mulching is recommended for mitigation, this is a technique that benefits stressed trees by improving the movement of water, air, and nutrients in the root zone and should be performed by a qualified tree care professional. The Town should implement a comprehensive program of tree management including soil testing.								Level of Urgency

2	
<b>Urgency Level:</b> 1 - Requires Immediate Attention 2 - Within (1) Month 3 - Within (6) Months 4 - Within the year 5 - None

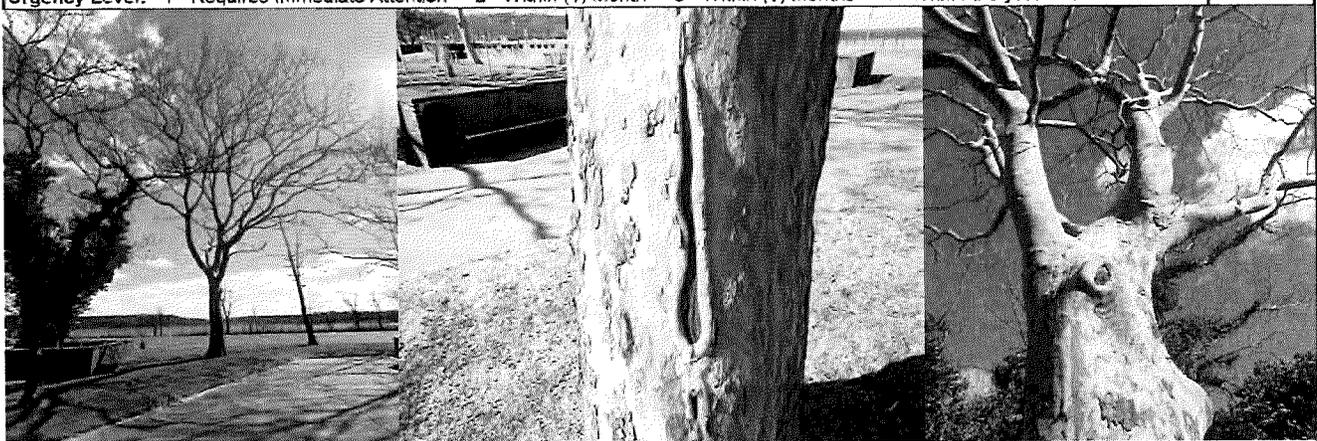
<b>Canopy</b>	N 23',S 16',E 14',W 10'	<i>Canopy Radius in Feet - North South East West</i>							
<b>Condition</b>	4	<i>Health of Specimen - 1 Dead - 2 Declining - 3 Moderate - 4 Good - 5 Excellent</i>							
<b>Approx. Age</b>	E	<i>NP=Newly Planted Within 5yrs M=Moderate 10-20 yrs old E=Existing before development</i>							
<b>Tree/Root Base/Pit</b>		Growing in grass area.							
<b>Trunk Condition and Main Scaffold Branches</b>		Moss and lichen growth on trunk, vertical cracking on trunk, minor water sprouting on scaffold branches, trunk wounds from old scaffold branches removed have not entirely healed.							
<b>Crown/Structure, Branches &amp; Leaves</b>		Dead branches, minor broken branches hanging in crown, good fruiting, tree was not assessed during full leaf.							
<b>Pest / Disease</b>		Moss and lichen growth on trunk.							
<b>Setting</b>		Far east end of park, east of concession building.

<b>Character</b>	Y	<i>Does the tree make an important contribution to the character or amenity of the area?</i>							
<b>Habitat</b>	N	<i>Is the tree indigenous, rare, endangered, invasive or exotic?</i>							
<b>Habitat</b>	N	<i>Does the tree represent important habitat for native fauna?</i>							
<b>Habitat</b>	N	<i>Is the tree part of a wildlife Corridor, Buffer, etc?</i>							
<b>Notes:</b> Minor dead branches in crown are located in close proximity above walkway.									
<b>Recommendations:</b> It is recommended to implement a program that continues to monitor this tree by an ISA Arborist and If condition continues to decline, consider removal. For recommended treatment, proper corrective pruning that follows ANSI A300 standards should be performed to remove dead and damaged branches. Additionally, it is recommended to form a mulch collar around the base of the tree that will prevent any future damage caused by landscape maintenance and provide additional benefits to the tree. Vertical mulching is recommended for mitigation, this is a technique that benefits stressed trees by improving the movement of water, air, and nutrients in the root zone and should be performed by a qualified tree care professional. The Town should implement a comprehensive program of tree management including soil testing.								<b>Level of Urgency</b>

<b>Urgency Level:</b> 1 - Requires Immediate Attention 2 - Within (1) Month 3 - Within (6) Months 4 - Within the year 5 - None								<b>3</b>

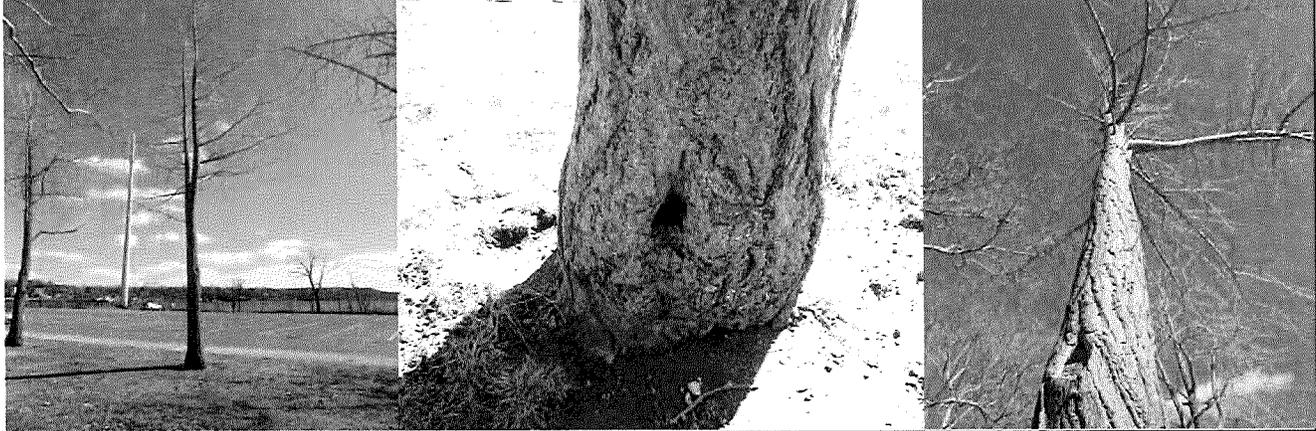
Trunk Condition and Main Scaffold Branches	Minor moss and lichen growth on trunk, codominant leaders.					
Crown/Structure, Branches & Leaves	Good crown structure, tree was not assessed during full leaf.					
Pest / Disease	Minor moss and lichen growth on trunk.					
Setting	Far east end of park, east of concession building along parking lot.					
<b>Character</b>	Y	Does the tree make an important contribution to the character or amenity of the area?				
	Indigenous	Is the tree indigenous, rare, endangered, invasive or exotic?				
<b>Habitat</b>	N	Does the tree represent important habitat for native fauna?				
	N	Is the tree part of a wildlife Corridor, Buffer, etc?				
<b>Notes:</b> Trunk cavity is small at the moment however, measures should be taken to insure the damage does not get any worse.						
<b>Recommendations:</b> It is recommended to implement a program that continues to monitor this tree by an ISA Arborist. For recommended treatment, form a mulch collar around the base of the tree that will prevent any future damage caused by landscape maintenance and provide additional benefits to the tree. Vertical mulching is recommended for mitigation, this is a technique that benefits stressed trees by improving the movement of water, air, and nutrients in the root zone and should be performed by a qualified tree care professional. The Town should implement a comprehensive program of tree management including soil testing.						Level of Urgency

<b>1</b>
<b>Urgency Level:</b> 1 - Requires Immediate Attention 2 - Within (1) Month 3 - Within (6) Months 4 - Within the year 5 - None

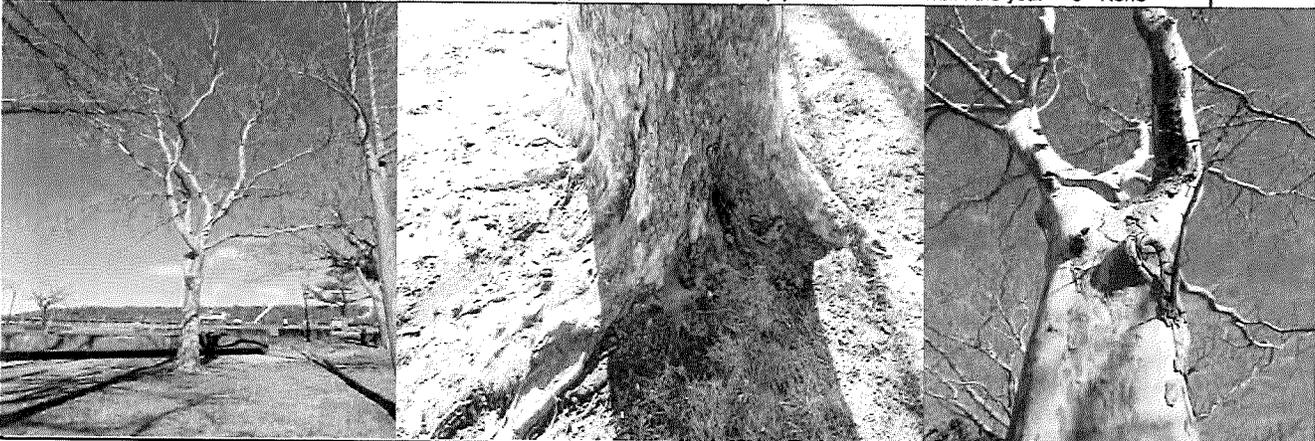
Trunk Condition and Main Scaffold Branches		Moss and lichen growth on trunk, major trunk damage stemming from base an continuing up a partially dead scaffold branch, dead scaffold branches.							
Crown/Structure , Branches & Leaves		Dead branches, good fruiting on healthy branches, tree was not assessed during full leaf.							
Pest / Disease		Moss and lichen growth on trunk.							
Setting		Far east end of park, east of concession building.							
Character		Y		Does the tree make an important contribution to the character or amenity of the area?					
Habitat		Indigenous		Is the tree indigenous, rare, endangered, invasive or exotic?					
Character		N		Does the tree represent important habitat for native fauna?					
Habitat		N		Is the tree part of a wildlife Corridor, Buffer, etc?					
Notes: The lowest large scaffold branch has major damage and discoloration that is stemming from the trunk, the limb is partially dead and it is anticipated that it will continue to decline.

Recommendations: It is recommended to implement a program that continues to monitor this tree by an ISA Arborist and If condition continues to decline, consider removal. For recommended treatment, proper corrective pruning that follows ANSI A300 standards should be performed to remove dead and damaged branches, particularly the removal of the partially dead scaffold branch. Additionally, it is recommended to form a mulch collar around the base of the tree that will prevent any future damage caused by landscape maintenance and provide additional benefits to the tree. Vertical mulching is recommended for mitigation, this is a technique that benefits stressed trees by improving the movement of water, air, and nutrients in the root zone and should be performed by a qualified tree care professional. The Town should implement a comprehensive program of tree management including soil testing.								Level of Urgency

1	
Urgency Level: 1 - Requires Immediate Attention 2 - Within (1) Month 3 - Within (6) Months 4 - Within the year 5 - None

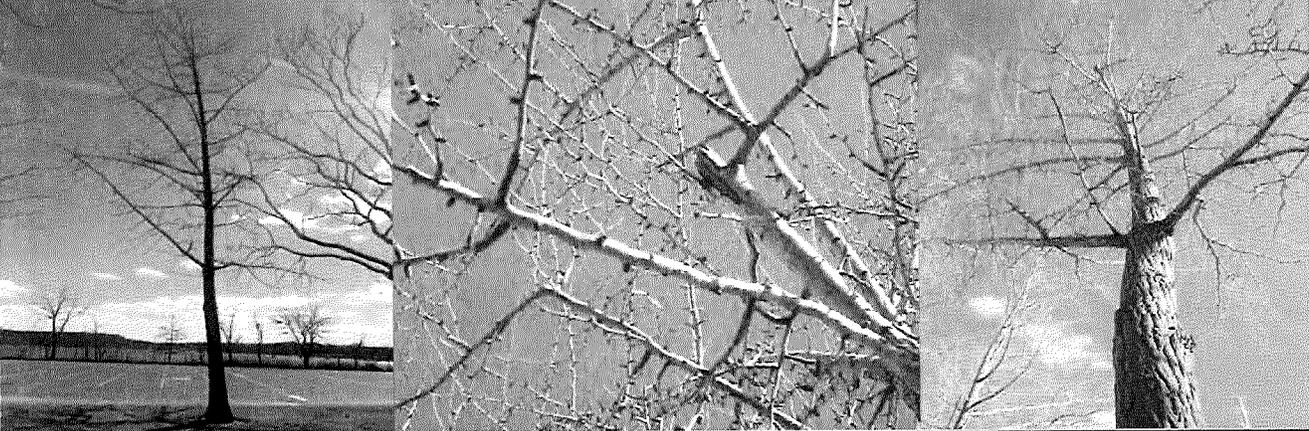
Trunk Condition and Main Scaffold Branches		Minor moss and lichen growth on trunk, minor broken scaffold branches.							
Crown/Structure, Branches & Leaves		Good crown and small branch structure, tree was not assessed during full leaf.							
Pest / Disease		Minor moss and lichen growth on trunk.							
Setting		Far east end of park, east of concession building along parking lot.							
Character		Y		Does the tree make an important contribution to the character or amenity of the area?					
		Indigenous		Is the tree indigenous, rare, endangered, invasive or exotic?					
Habitat		N		Does the tree represent important habitat for native fauna?					
		N		Is the tree part of a wildlife Corridor, Buffer, etc?					
Notes: Evidence of broken scaffold branches, evidence of recent pruning to multiple scaffold branches, new growth around the sites of pruning cuts.									
Recommendations: It is recommended to implement a program that continues to monitor this tree by an ISA Arborist. For recommended treatment, form a mulch collar around the base of the tree that will prevent any future damage caused by landscape maintenance and provide additional benefits to the tree. Vertical mulching is recommended for mitigation, this is a technique that benefits stressed trees by improving the movement of water, air, and nutrients in the root zone and should be performed by a qualified tree care professional. The Town should implement a comprehensive program of tree management including soil testing.								Level of Urgency

1	
Urgency Level: 1 - Requires Immediate Attention 2 - Within (1) Month 3 - Within (6) Months 4 - Within the year 5 - None
