DRAFT REPORT

100 Crossways Park Drive West, Ste 10A Woodbury, New York 11797		T 516 363 0661 F 516 363 0663		www.obayerassociates.com		Assignment:	Tree No.:
				2	122		
Arborist Assessment Report			Location: North Hempstead Beach Park - Port Washington, NY			Date: 3/2/2016	
Inspector: Dan Maher			Weather: Partly Sunny		Lat/Long: N 40° 49' 41.46" W 73° 39' 21.55"		Time: 13:28
Specimen:		Common Name: LONDON PLANETREE		Scientific name: Platanus x acerifolia			
Descriptor		Value		Range			
Girth		23"		Trunk Diameter Measured at Breast Height (DBH)			
Approx. Height		35'-40'		Approximate Height to top of Canopy			
Canopy		N 15', S 10', E 13', W 11'		Canopy Radius in Feet - North South East West			
Condition		3		Health of Specimen - 1 Dead - 2 Declining - 3 Moderate - 4 Good - 5 Excellent			
Approx. Age		E		NP=Newly Planted Within 5yrs M=Moderate 10-20 yrs old E=Existing before development			
Tree/Root Base/Pit		Growing in grass area, mechanical damage at base and on exposed roots from landscape maintenance.

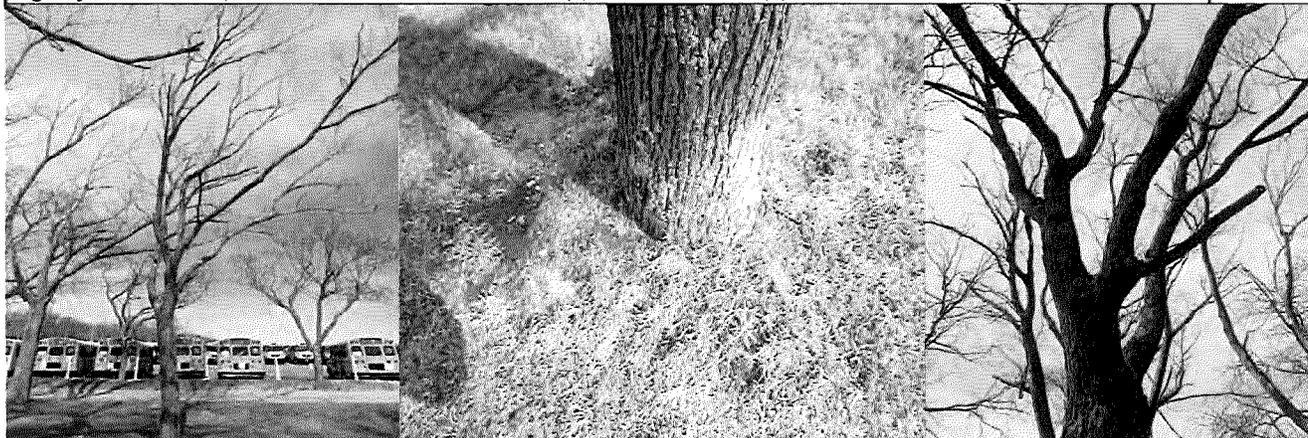
Trunk Condition and Main Scaffold Branches		Major moss and lichen growth on trunk, water sprouting on scaffold branches, major dead scaffold branches.					
Crown/Structure, Branches & Leaves		Thin crown, major dead branches, branch die-back on outer branches, tree was not assessed during full leaf.					
Pest / Disease		Moss and lichen growth on trunk.					
Setting		North end of park at main entrance allée of trees.					
Character		Y		Does the tree make an important contribution to the character or amenity of the area?			
		Indigenous		Is the tree indigenous, rare, endangered, invasive or exotic?			
Habitat		N		Does the tree represent important habitat for native fauna?			
		N		Is the tree part of a wildlife Corridor, Buffer, etc?			
Notes: Due to the amount of dead scaffold branches and die-back, it is anticipated the condition of this tree will continue to decline.							
Recommendations: Remove tree due to current condition and anticipated decline. For tree replacement it is recommended to use XXX. Replacements should be planted immediately following removals and it is recommended to form a mulch collar around the base of the tree that will prevent any future damage caused by landscape maintenance and provide additional benefits to the tree. The Town should implement a comprehensive program of tree management including soil testing.							Level of Urgency

1
Urgency Level: 1 - Requires Immediate Attention 2 - Within (1) Month 3 - Within (6) Months 4 - Within the year 5 - None

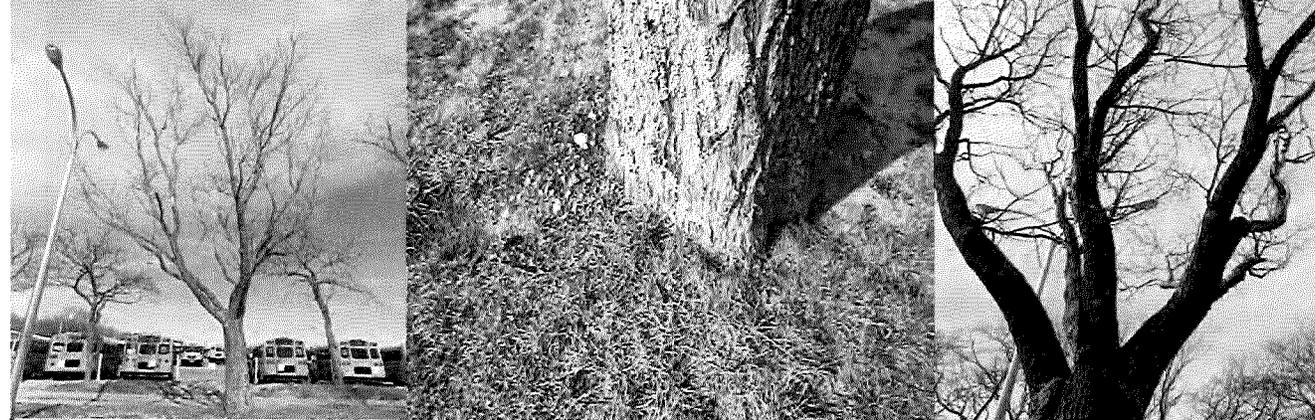
Descriptor	Value	Range
Girth	20"	Trunk Diameter Measured at Breast Height (DBH)
Approx. Height	40'-45'	Approximate Height to top of Canopy
Canopy	N 10', S 12', E 14', W 12'	Canopy Radius in Feet - North South East West
Condition	2	Health of Specimen - 1 Dead - 2 Declining - 3 Moderate - 4 Good - 5 Excellent
Approx. Age	E	NP=Newly Planted Within 5yrs M=Moderate 10-20 yrs old E=Existing before development

Tree/Root Base/Pit	Growing in a grass median, mechanical damage at base from landscape maintenance, buried root collar.
Trunk Condition and Main Scaffold Branches	Codominant leaders, major moss and lichen growth on trunk, vertical cracking on trunk, water sprouting on scaffold branches, major dead scaffold branches.
Crown/Structure, Branches & Leaves	Thin crown, major dead branches, branch die-back on outer branches, tree was not assessed during full leaf.
Pest / Disease	Moss and lichen growth on trunk.
Setting	North end of park at main entrance allée of trees.

Notes:
Due to the amount of dead scaffold branches and die-back, it is anticipated the condition of this tree will continue to decline.

Recommendations: Remove tree due to current condition and anticipated decline. For tree replacement it is recommended to use XXX. Replacements should be planted immediately following removals and it is recommended to form a mulch collar around the base of the tree that will prevent any future damage caused by landscape maintenance and provide additional benefits to the tree. The Town should implement a comprehensive program of tree management including soil testing.	Level of Urgency
	1

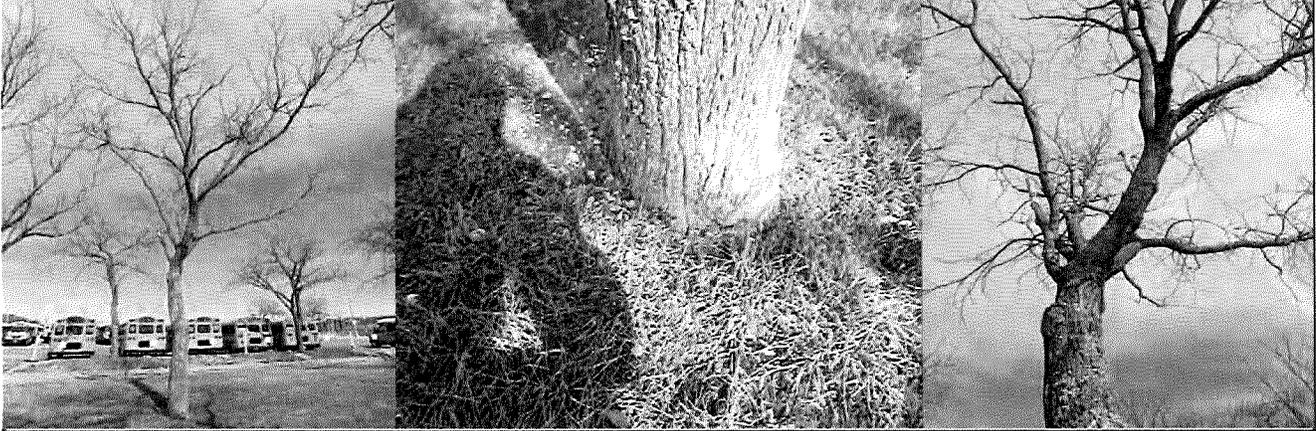
Trunk Condition and Main Scaffold Branches		Codominant leaders, major moss and lichen growth on trunk, major dead scaffold branches.							
Crown/Structure, Branches & Leaves		Thin crown, major dead branches, branch die-back on outer branches, tree was not assessed during full leaf.							
Pest / Disease		Moss and lichen growth on trunk.							
Setting		North end of park at main entrance allée of trees.							
Character		Y		Does the tree make an important contribution to the character or amenity of the area?					
		Indigenous		Is the tree indigenous, rare, endangered, invasive or exotic?					
Habitat		N		Does the tree represent important habitat for native fauna?					
		N		Is the tree part of a wildlife Corridor, Buffer, etc?					
Notes: Due to the amount of dead scaffold branches and die-back, it is anticipated the condition of this tree will continue to decline.									
Recommendations: Remove tree due to current condition and anticipated decline. For tree replacement it is recommended to use XXX. Replacements should be planted immediately following removals and it is recommended to form a mulch collar around the base of the tree that will prevent any future damage caused by landscape maintenance and provide additional benefits to the tree. The Town should implement a comprehensive program of tree management including soil testing.								Level of Urgency

1	
Urgency Level: 1 - Requires Immediate Attention 2 - Within (1) Month 3 - Within (6) Months 4 - Within the year 5 - None

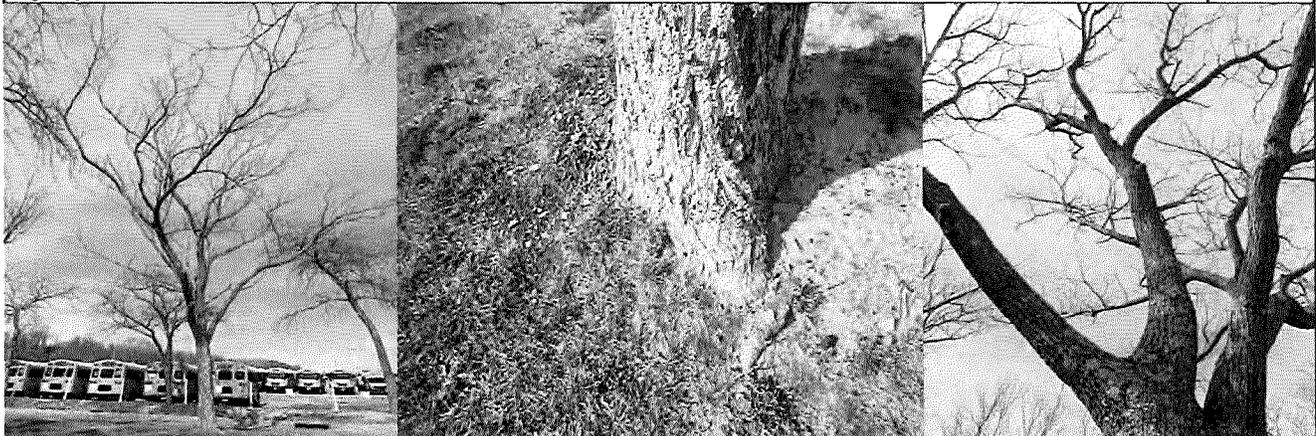
Trunk Condition and Main Scaffold Branches		Codominant leaders, included bark at trunk union, major moss and lichen growth on trunk, major dead scaffold branches.					
Crown/Structure, Branches & Leaves		Dead branches, major branch die-back, tree was not assessed during full leaf.					
Pest / Disease		Moss and lichen growth on trunk.					
Setting		North end of park at main entrance allée of trees.					
Character		Y		Does the tree make an important contribution to the character or amenity of the area?			
		Indigenous		Is the tree indigenous, rare, endangered, invasive or exotic?			
Habitat		N		Does the tree represent important habitat for native fauna?			
		N		Is the tree part of a wildlife Corridor, Buffer, etc?			
Notes: Due to the amount of dead scaffold branches and die-back, it is anticipated the condition of this tree will continue to decline.							
Recommendations: Remove tree due to current condition and anticipated decline. For tree replacement it is recommended to use XXX. Replacements should be planted immediately following removals and it is recommended to form a mulch collar around the base of the tree that will prevent any future damage caused by landscape maintenance and provide additional benefits to the tree. The Town should implement a comprehensive program of tree management including soil testing.							Level of Urgency

1
Urgency Level: 1 - Requires Immediate Attention 2 - Within (1) Month 3 - Within (6) Months 4 - Within the year 5 - None

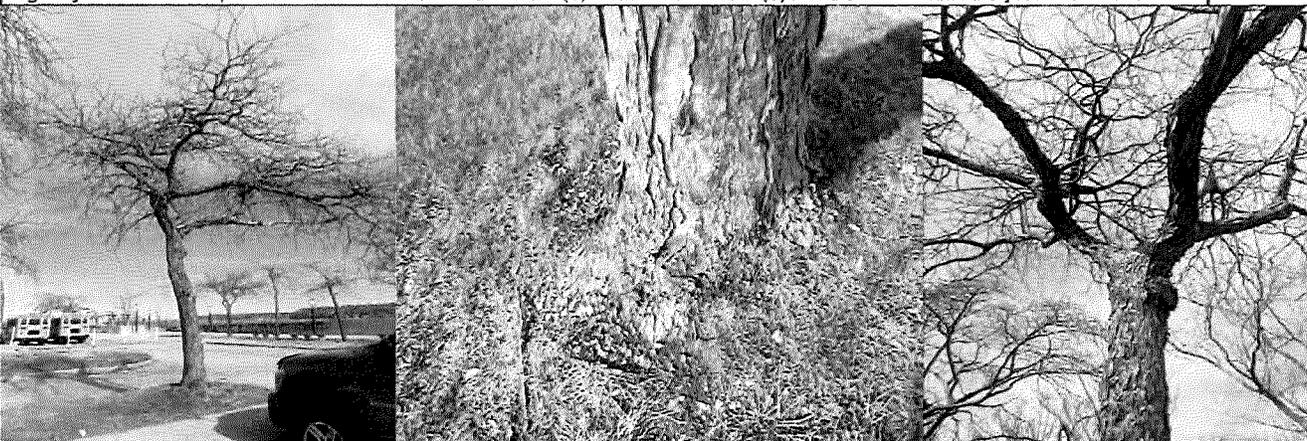
Trunk Condition and Main Scaffold Branches	Moss and lichen growth on trunk and scaffold branches, dead scaffold branches.					
Crown/Structure, Branches & Leaves	Good crown structure, dead branches, tree was not assessed during full leaf.					
Pest / Disease	Moss and lichen growth on trunk.					
Setting	North end of park at main entrance allée of trees.					
Character	Y	Does the tree make an important contribution to the character or amenity of the area?				
Habitat	Indigenous	Is the tree indigenous, rare, endangered, invasive or exotic?				
Habitat	N	Does the tree represent important habitat for native fauna?				
Habitat	N	Is the tree part of a wildlife Corridor, Buffer, etc?				
Notes: Evidence of broken scaffold branches, dead scaffold branches above roadway.						
Recommendations: It is recommended to implement a program that continues to monitor this tree by an ISA Arborist and If condition continues to decline, consider removal. For recommended treatment, proper corrective pruning that follows ANSI A300 standards should be performed to remove dead and damaged branches, specifically scaffold branches above the roadway. Additionally, it is recommended to form a mulch collar around the base of the tree that will prevent any future damage caused by landscape maintenance and provide additional benefits to the tree. Vertical mulching is recommended for mitigation, this is a technique that benefits stressed trees by improving the movement of water, air, and nutrients in the root zone and should be performed by a qualified tree care professional. The Town should implement a comprehensive program of tree management including soil testing.						Level of Urgency

Urgency Level: 1 - Requires Immediate Attention 2 - Within (1) Month 3 - Within (6) Months 4 - Within the year 5 - None						1
