# DRAFT REPORT

100 Crossways Park Drive West, Ste. 104 Woodbury, New York 11797		T 516 364 0660 F 516 364 0668		www.dthayerassociates.com		Assignment: <b>2</b>	Tree No.: <b>183</b>
<b>Arborist Assessment Report</b>			Location: North Hempstead Beach Park - Port Washington, NY		Date: 3/3/2016		
Inspector: Dan Maher		Weather: Partly Sunny		Lat/Long: N 40° 50' 1.39" W 73° 39' 38.22"		Time: 16:29	
<b>Specimen:</b>	<b>Common Name:</b> HONEYLOCUST		<b>Scientific name:</b> Gleditsia triacanthos				
<b>Descriptor</b>	<b>Value</b>	<b>Range</b>					
<b>Girth</b>	12"	<i>Trunk Diameter Measured at Breast Height (DBH)</i>					
<b>Approx. Height</b>	20'-25'	<i>Approximate Height to top of Canopy</i>					
<b>Canopy</b>	N 10',S 13',E 6',W 10'	<i>Canopy Radius in Feet - North South East West</i>					
<b>Condition</b>	3	<i>Health of Specimen - 1 Dead - 2 Declining - 3 Moderate - 4 Good - 5 Excellent</i>					
<b>Approx. Age</b>	M	<i>NP=Newly Planted Within 5yrs M=Moderate 10-20 yrs old E=Existing before development</i>

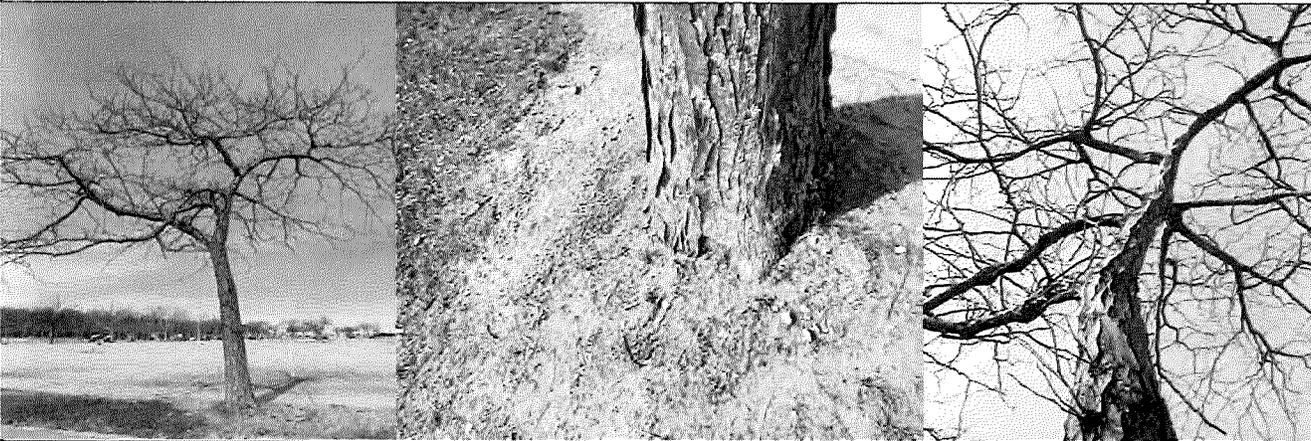
<b>Notes:</b> Previous tag #424 nailed to trunk. Evidence of pruning to scaffold branches. Dead and broken branches directly over parking spaces and sidewalk.						
<b>Recommendations:</b> It is recommended to implement a program that continues to monitor this tree by an ISA Arborist. For recommended treatment, proper corrective pruning that follows ANSI A300 standards should be performed to remove dead and damaged branches, specifically scaffold branches directly above parking spaces. Additionally, it is recommended to form a mulch collar around the base of the tree that will prevent any future damage caused by landscape maintenance and provide additional benefits to the tree. Vertical mulching is recommended for mitigation, this is a technique that benefits stressed trees by improving the movement of water, air, and nutrients in the root zone and should be performed by a qualified tree care professional. The Town should implement a comprehensive program of tree management including soil testing.						Level of Urgency

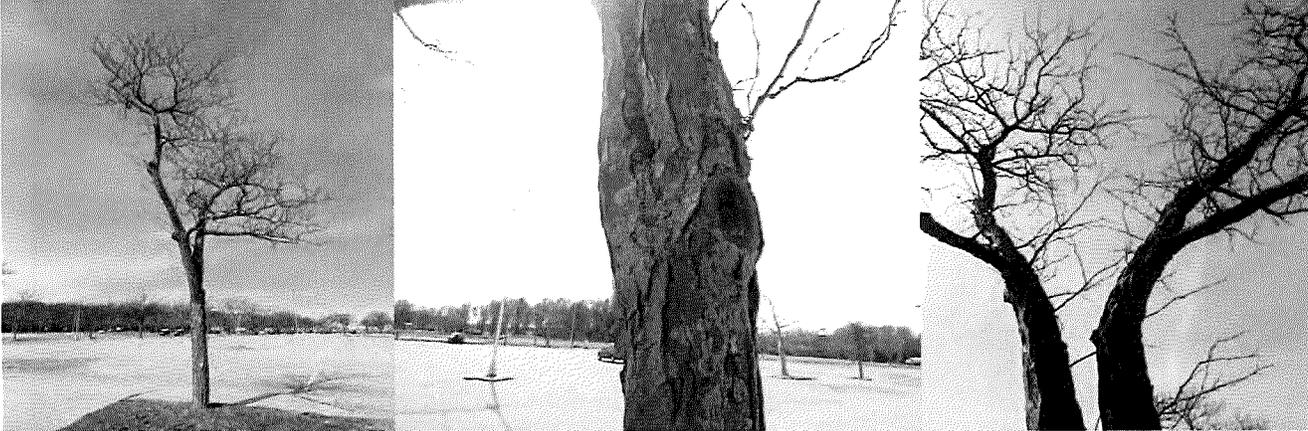
Descriptor	Value	Range																																															
Girth	10"	Trunk Diameter Measured at Breast Height (DBH)																																															
Approx. Height	15'-20'	Approximate Height to top of Canopy																																															
Canopy	N 8', S 5', E 3', W 5'	Canopy Radius in Feet - North South East West																																															
Condition	3	Health of Specimen - 1 Dead - 2 Declining - 3 Moderate - 4 Good - 5 Excellent																																															
Approx. Age	M	NP=Newly Planted Within 5yrs M=Moderate 10-20 yrs old E=Existing before development																																															
Tree/Root Base/Pit		Growing in a 6' wide grass strip in a dividing island, minor mechanical damage at base from landscape maintenance, buried root collar.																																															
Trunk Condition and Main Scaffold Branches		Codominant leaders, moss and lichen growth on trunk and scaffold branches, minor vertical cracking on trunk, water sprouting on trunk and scaffold branches, trunk wounds from removed scaffold branches have not entirely healed.

Character	Y	Does the tree make an important contribution to the character or amenity of the area?																																															
	Indigenous	Is the tree indigenous, rare, endangered, invasive or exotic?																																															
Habitat	N	Does the tree represent important habitat for native fauna?																																															
	N	Is the tree part of a wildlife Corridor, Buffer, etc?																																															
Notes: Previous tag #423 nailed to trunk. Evidence of pruning to scaffold branches.																																																	
Recommendations: It is recommended to implement a program that continues to monitor this tree by an ISA Arborist and if condition continues to decline, consider removal. For recommended treatment, proper corrective pruning that follows ANSI A300 standards should be performed to remove dead and damaged branches. It is recommended to perform root crown excavation by a qualified tree care professional, which is a treatment that involves the removal of excess soil from a tree's root flare and main lateral roots. Additionally, it is recommended to form a mulch collar around the base of the tree that will prevent any future damage caused by landscape maintenance and provide additional benefits to the tree. Vertical mulching is recommended for mitigation, this is a technique that benefits stressed trees by improving the movement of water, air, and nutrients in the root zone and should be performed by a qualified tree care professional. The Town should implement a comprehensive program of tree management including soil testing.								Level of Urgency

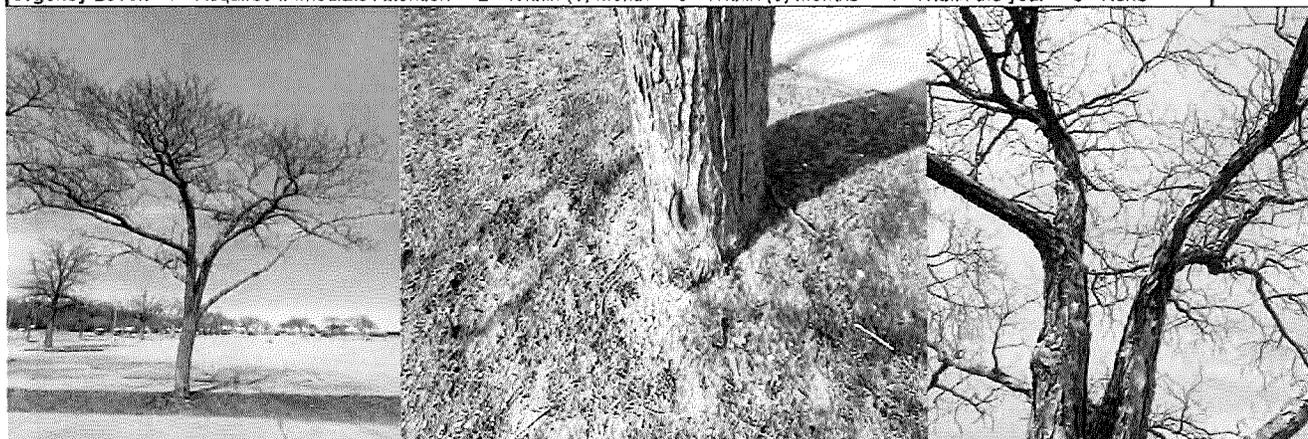
<b>Tree/Root Base/Pit</b>		Growing in a 6' wide grass strip in a dividing island, buried root collar.					
<b>Trunk Condition and Main Scaffold Branches</b>		Codominant leaders, moss and lichen growth on trunk and scaffold branches, dead scaffold branch.					
<b>Crown/Structure, Branches &amp; Leaves</b>		Good crown structure, minor dead branches, tree was not assessed during full leaf.					
<b>Pest / Disease</b>		Moss and lichen growth on trunk.					
<b>Setting</b>		North end of park in open parking lot, exposed to high winds.					
<b>Character</b>		Y		<i>Does the tree make an important contribution to the character or amenity of the area?</i>			
		Indigenous		<i>Is the tree indigenous, rare, endangered, invasive or exotic?</i>			
<b>Habitat</b>		N		<i>Does the tree represent important habitat for native fauna?</i>			
		N		<i>Is the tree part of a wildlife Corridor, Buffer, etc?</i>			
<b>Notes:</b> Previous tag #421 nailed to trunk. Dead scaffold branch is directly above sidewalk.

<b>Recommendations:</b> It is recommended to implement a program that continues to monitor this tree by an ISA Arborist. For recommended treatment, proper corrective pruning that follows ANSI A300 standards should be performed to remove dead and damaged branches, specifically scaffold branches directly above the sidewalk. It is recommended to perform root crown excavation by a qualified tree care professional, which is a treatment that involves the removal of excess soil from a trees root flare and main lateral roots. Additionally, it is recommended to form a mulch collar around the base of the tree that will prevent any future damage caused by landscape maintenance and provide additional benefits to the tree. Vertical mulching is recommended for mitigation, this is a technique that benefits stressed trees by improving the movement of water, air, and nutrients in the root zone and should be performed by a qualified tree care professional. The Town should implement a comprehensive program of tree management including soil testing.							<b>Level of Urgency</b>

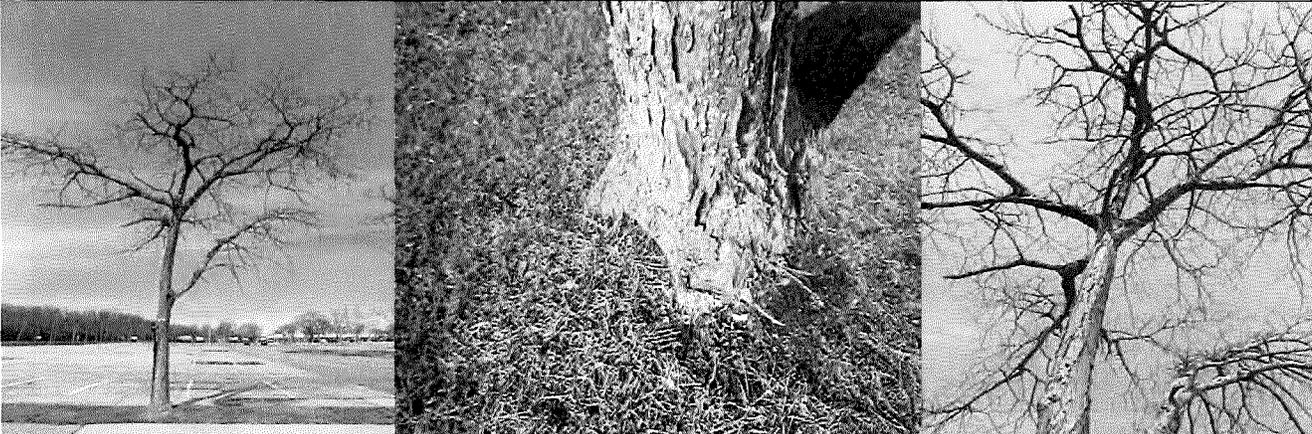
<b>Tree/Root Base/Pit</b>	Growing in a 6' wide grass strip in a dividing island, mechanical damage at base from landscape maintenance.		
<b>Trunk Condition and Main Scaffold Branches</b>	Major moss and lichen growth on trunk and scaffold branches, vertical cracking in trunk, water sprouting on scaffold branches, trunk wound from removed scaffold branch has not entirely healed and is leaking, partially dead scaffold branches.		
<b>Crown/Structure, Branches &amp; Leaves</b>	Major dead branches, broken branches hanging in crown, tree was not assessed during full leaf.		
<b>Pest / Disease</b>	Moss and lichen growth on trunk.		
<b>Setting</b>	North end of park in open parking lot, exposed to high winds.		
<b>Character</b>	Y	<i>Does the tree make an important contribution to the character or amenity of the area?</i>	
	Indigenous	<i>Is the tree indigenous, rare, endangered, invasive or exotic?</i>	
<b>Habitat</b>	N	<i>Does the tree represent important habitat for native fauna?</i>

N	<i>Is the tree part of a wildlife Corridor, Buffer, etc?</i>	
<b>Notes:</b>			
Previous tag #449 nailed to trunk. New concrete sidewalk has been installed on the south side of tree, it is expected that major root pruning has occurred during construction. Recommended to reassess this tree after bud break to evaluate the full condition of tree.			
<b>Recommendations:</b>			<b>Level of Urgency</b>
It is recommended to implement a program that continues to monitor this tree by an ISA Arborist and if condition continues to decline, consider removal. For recommended treatment, proper corrective pruning that follows ANSI A300 standards should be performed to remove dead and damaged branches. Additionally, it is recommended to form a mulch collar around the base of the tree that will prevent any future damage caused by landscape maintenance and provide additional benefits to the tree. Vertical mulching is recommended for mitigation, this is a technique that benefits stressed trees by improving the movement of water, air, and nutrients in the root zone and should be performed by a qualified tree care professional. The Town should implement a comprehensive program of tree management including soil testing. Recommended to reassess this tree after bud break to evaluate the full condition of tree.

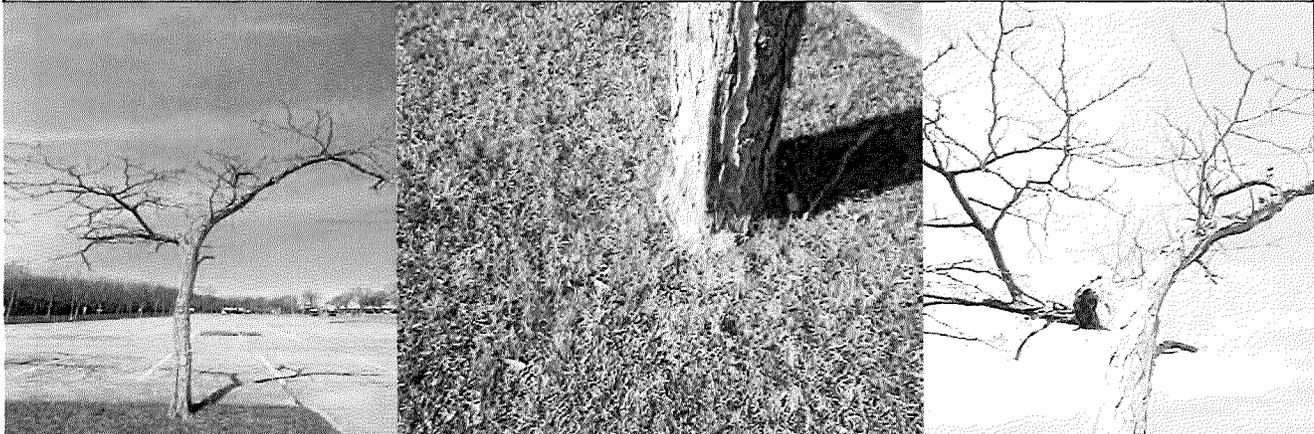
<b>Tree/Root Base/Pit</b>		Growing in a 6' wide grass strip in a dividing island, minor heaving of concrete sidewalk, mechanical damage at base and exposed roots from landscape maintenance.							
<b>Trunk Condition and Main Scaffold Branches</b>		Codominant leaders, moss and lichen growth on trunk, vertical cracking around trunk, major damage on main leader stemming down to trunk union, top of major leader is dead and causing major die-back at the top of tree crown, dead scaffold branches.							
<b>Crown/Structure, Branches &amp; Leaves</b>		Poor crown structure, die-back on top of tree crown, tree was not assessed during full leaf.							
<b>Pest / Disease</b>		Moss and lichen growth on trunk.							
<b>Setting</b>		North end of park in open parking lot, exposed to high winds.							
<b>Character</b>		Y		Does the tree make an important contribution to the character or amenity of the area?

Indigenous		Is the tree indigenous, rare, endangered, invasive or exotic?					
<b>Habitat</b>		N		Does the tree represent important habitat for native fauna?					
		N		Is the tree part of a wildlife Corridor, Buffer, etc?					
<b>Notes:</b>		Previous tag #447 nailed to trunk. Evidence of broken off scaffold branches at top of tree crown, dead scaffold branches are directly above parking spaces and sidewalk.							
<b>Recommendations:</b>		Remove tree due to current condition and anticipated decline. For tree replacement it is recommended to use XXX. Replacements should be planted immediately following removals and it is recommended to form a mulch collar around the base of the tree that will prevent any future damage caused by landscape maintenance and provide additional benefits to the tree. The Town should implement a comprehensive program of tree management including soil testing.							Level of Urgency

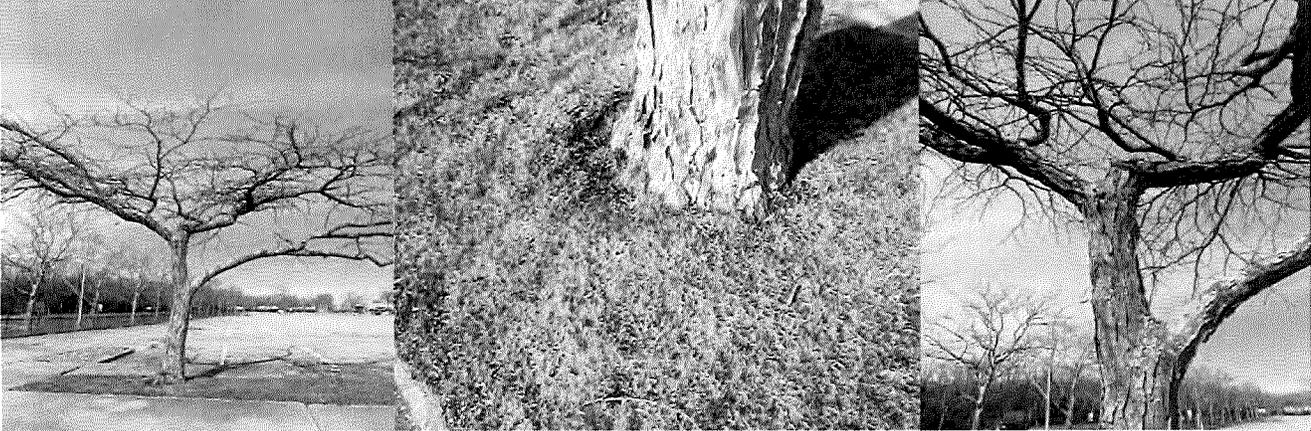
Tree/Root Base/Pit		Growing in a 6' wide grass strip in a dividing island, mechanical damage at base from landscape maintenance.							
Trunk Condition and Main Scaffold Branches		Codominant leaders, included bark at trunk union, moss and lichen growth on trunk and scaffold branches, minor dead scaffold branch.							
Crown/Structure, Branches & Leaves		Poor crown structure, dead lower branches, tree was not assessed during full leaf.							
Pest / Disease		Moss and lichen growth on trunk.							
Setting		North end of park in open parking lot, exposed to high winds.							
Character		Y		Does the tree make an important contribution to the character or amenity of the area?					
		Indigenous		Is the tree indigenous, rare, endangered, invasive or exotic?					
Habitat		N		Does the tree represent important habitat for native fauna?					
		N		Is the tree part of a wildlife Corridor, Buffer, etc?					
<b>Notes:</b> Previous tag #445 nailed to trunk. Dead branches are directly above parking spaces and sidewalk.

<b>Recommendations:</b> It is recommended to implement a program that continues to monitor this tree by an ISA Arborist and if condition continues to decline, consider removal. For recommended treatment, proper corrective pruning that follows ANSI A300 standards should be performed to remove dead and damaged branches, specifically scaffold branches directly above the sidewalk and parking spaces. Additionally, it is recommended to form a mulch collar around the base of the tree that will prevent any future damage caused by landscape maintenance and provide additional benefits to the tree. Vertical mulching is recommended for mitigation, this is a technique that benefits stressed trees by improving the movement of water, air, and nutrients in the root zone and should be performed by a qualified tree care professional. The Town should implement a comprehensive program of tree management including soil testing.								Level of Urgency

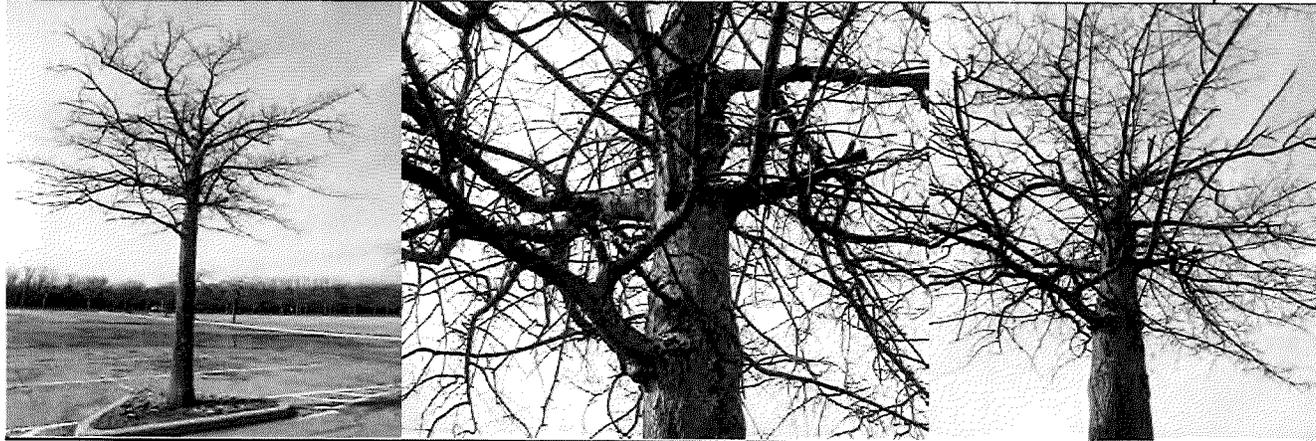
Trunk Condition and Main Scaffold Branches	Moss and lichen growth on trunk, dead top of central leader, major dead and broken scaffold branches.
--------------------------------------------	-------------------------------------------------------------------------------------------------------

Crown/Structure, Branches & Leaves	Poor crown structure, major branch die-back at top of crown, major dead branches, broken branches hanging in crown, tree was not assessed during full leaf.
------------------------------------	-------------------------------------------------------------------------------------------------------------------------------------------------------------

Previous tag #427 nailed to trunk. Dead and broken branches are directly above parking spaces.

Remove tree due to current condition and anticipated decline. For tree replacement it is recommended to use XXX. Replacements should be planted immediately following removals and it is recommended to form a mulch collar around the base of the tree that will prevent any future damage caused by landscape maintenance and provide additional benefits to the tree. The Town should implement a comprehensive program of tree management including soil testing.

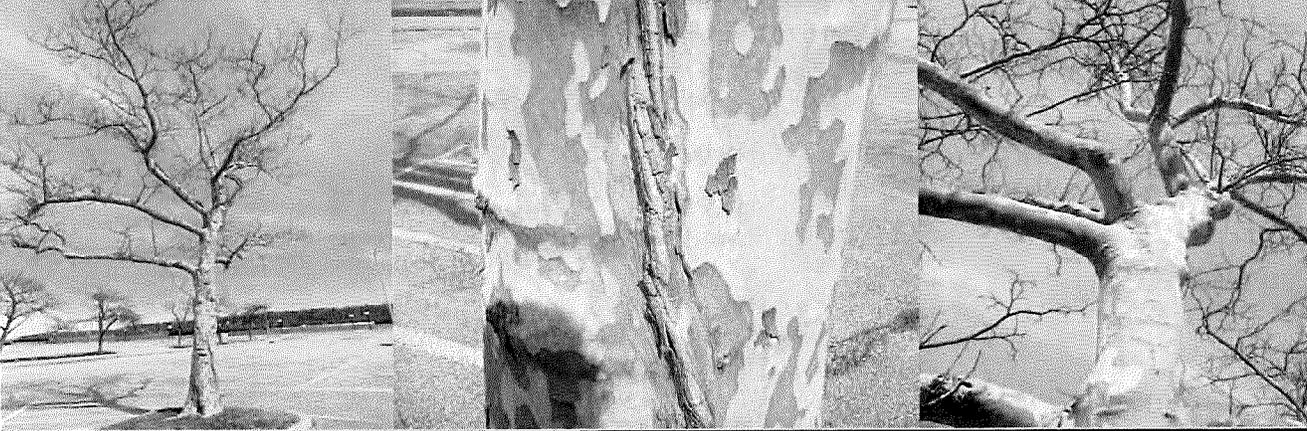
Tree/Root Base/Pit		Growing in a parking lot island surrounded by grass, mechanical damage at base from landscape maintenance, minor girdling roots.							
Trunk Condition and Main Scaffold Branches		Vertical cracking on trunk, water sprouting on trunk and scaffold branches, major scaffold wounds from removed or broken off branches have not entirely healed, major dead scaffold branches.							
Crown/Structure, Branches & Leaves		Thin crown, major die-back at top of crown and on outer branches, dead branches, poor fruiting, tree was not assessed during full leaf.							
Pest / Disease		No noticeable signs.							
Setting		North end of park in open parking lot, exposed to high winds.							
Character		Y		Does the tree make an important contribution to the character or amenity of the area?					
		Indigenous		Is the tree indigenous, rare, endangered, invasive or exotic?					
Habitat		N		Does the tree represent important habitat for native fauna?

N		Is the tree part of a wildlife Corridor, Buffer, etc?					
<b>Notes:</b> Previous tag #419 nailed to trunk. Evidence of fallen scaffold branches leaving open wounds. Numerous dead scaffold and smaller branches that will require a major pruning effort and leave the tree crown even thinner than it currently is. Major dead scaffold branches directly above parking spaces and roadway that runs through the center of the parking lot.									
<b>Recommendations:</b> Remove tree due to current condition and anticipated decline. For tree replacement it is recommended to use XXX. Replacements should be planted immediately following removals and it is recommended to form a mulch collar around the base of the tree that will prevent any future damage caused by landscape maintenance and provide additional benefits to the tree. The Town should implement a comprehensive program of tree management including soil testing.								Level of Urgency

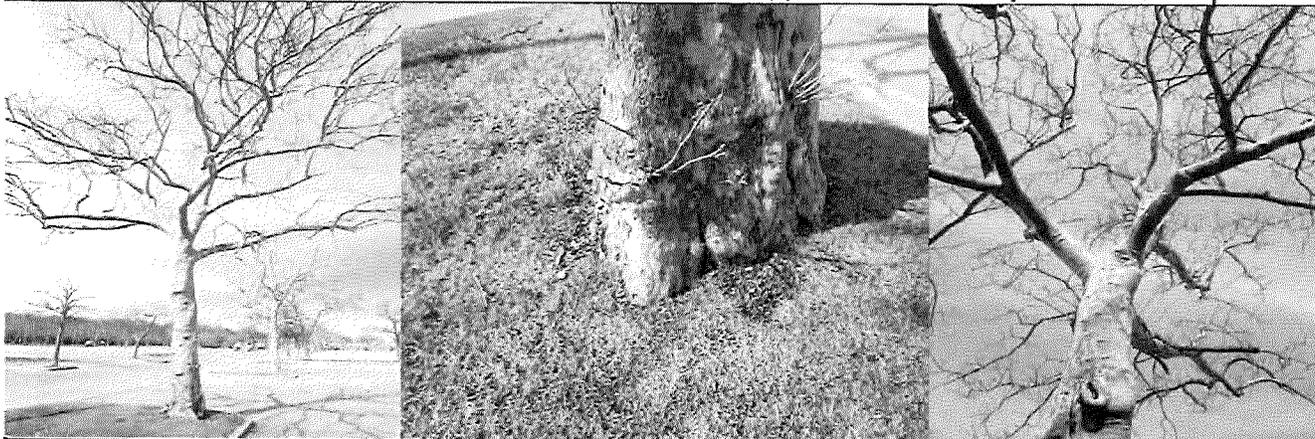
<b>Tree/Root Base/Pit</b> Growing in a parking lot island surrounded by grass, mechanical damage at base from landscape maintenance.			
<b>Trunk Condition and Main Scaffold Branches</b> Minor vertical cracking on trunk, water sprouting on trunk and scaffold branches, dead scaffold branches.			
<b>Crown/Structure , Branches &amp; Leaves</b> Branch die-back at top of crown and on outer branches, broken branches hanging in tree crown, poor fruiting, tree was not assessed during full leaf.			
<b>Pest / Disease</b> No noticeable signs.			
<b>Setting</b> North end of park in open parking lot, exposed to high winds.			
<b>Character</b>			
	Y	<i>Does the tree make an important contribution to the character or amenity of the area?</i>	
	Indigenous	<i>Is the tree indigenous, rare, endangered, invasive or exotic?</i>	
<b>Habitat</b>			
	N	<i>Does the tree represent important habitat for native fauna?</i>	
	N	<i>Is the tree part of a wildlife Corridor, Buffer, etc?</i>

<b>Notes:</b> Previous tag #418 nailed to trunk. Major dead scaffold branches directly above parking spaces.			
<b>Recommendations:</b> It is recommended to implement a program that continues to monitor this tree by an ISA Arborist and If condition continues to decline, consider removal. For recommended treatment, proper corrective pruning that follows ANSI A300 standards should be performed to remove dead and damaged branches, specifically scaffold branches directly above parking spaces. Additionally, it is recommended to form a mulch collar around the base of the tree that will prevent any future damage caused by landscape maintenance and provide additional benefits to the tree. Vertical mulching is recommended for mitigation, this is a technique that benefits stressed trees by improving the movement of water, air, and nutrients in the root zone and should be performed by a qualified tree care professional. The Town should implement a comprehensive program of tree management including soil testing.			<b>Level of Urgency</b>

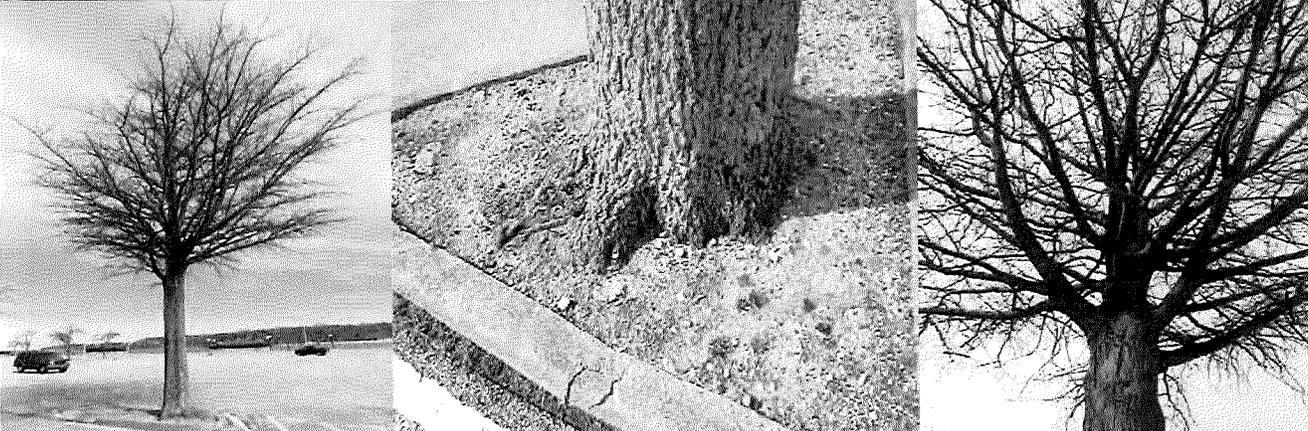
Descriptor	Value	Range																																															
Girth	20"	Trunk Diameter Measured at Breast Height (DBH)																																															
Approx. Height	30'-35'	Approximate Height to top of Canopy																																															
Canopy	N 15',S 14',E 12',W 16'	Canopy Radius in Feet - North South East West																																															
Condition	2	Health of Specimen - 1 Dead - 2 Declining - 3 Moderate - 4 Good - 5 Excellent																																															
Approx. Age	E	NP=Newly Planted Within 5yrs M=Moderate 10-20 yrs old E=Existing before development																																															
Tree/Root Base/Pit		Growing in a small parking lot island, major cracking and heaving of concrete curb and asphalt pavement surrounding the tree island.																																															
Trunk Condition and Main Scaffold Branches		Major Moss and lichen growth on trunk, major water sprouting on scaffold branches, major dead scaffold branches, top of central leader is dead and causing major die-back at the top of tree crown.

Character	Y	Does the tree make an important contribution to the character or amenity of the area?																																															
	Indigenous	Is the tree indigenous, rare, endangered, invasive or exotic?																																															
Habitat	N	Does the tree represent important habitat for native fauna?																																															
	N	Is the tree part of a wildlife Corridor, Buffer, etc?																																															
Notes: Previous tag #417 nailed to trunk. Major dead scaffold branches directly above parking spaces and roadway that runs through the center of the parking lot.																																																	
Recommendations: Remove tree due to current condition and anticipated decline. For tree replacement it is recommended to use XXX. Replacements should be planted immediately following removals and it is recommended to form a mulch collar around the base of the tree that will prevent any future damage caused by landscape maintenance and provide additional benefits to the tree. The Town should implement a comprehensive program of tree management including soil testing.								Level of Urgency

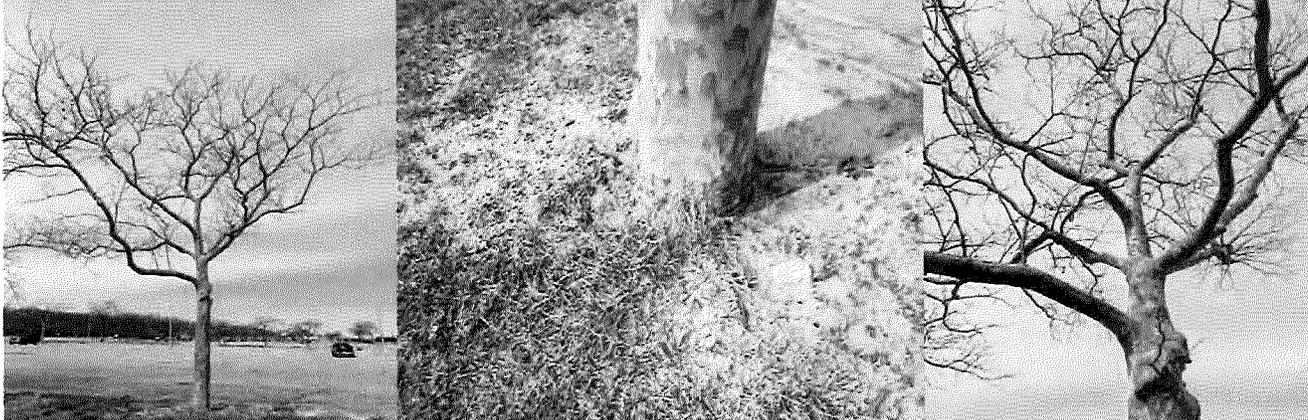
<b>Approx. Age</b>	M	<i>NP=Newly Planted Within 5yrs M=Moderate 10-20 yrs old E=Existing before development</i>				
<b>Tree/Root Base/Pit</b>	Growing in a grass strip in a dividing island with sand around base, mechanical damage at base from landscape maintenance.					
<b>Trunk Condition and Main Scaffold Branches</b>	Evidence of insect activity underneath bark on trunk, water sprouting on scaffold branches, multiple trunk wounds from removed scaffold branches have not entirely healed, dead scaffold branches.					
<b>Crown/Structure, Branches &amp; Leaves</b>	Minor dead branches, broken branches hanging in crown, moderate fruiting, tree was not assessed during full leaf.					
<b>Pest / Disease</b>	Evidence of insect activity.					
<b>Setting</b>	North end of park in open parking lot, exposed to high winds.					
<b>Character</b>	Y	<i>Does the tree make an important contribution to the character or amenity of the area?</i>

Indigenous	<i>Is the tree indigenous, rare, endangered, invasive or exotic?</i>				
<b>Habitat</b>	N	<i>Does the tree represent important habitat for native fauna?</i>				
	N	<i>Is the tree part of a wildlife Corridor, Buffer, etc?</i>				
<b>Notes:</b> Dead and broken branches are directly above parking spaces and roadway.						
<b>Recommendations:</b> It is recommended to implement a program that continues to monitor this tree by an ISA Arborist and if condition continues to decline, consider removal. For recommended treatment, proper corrective pruning that follows ANSI A300 standards should be performed to remove dead and damaged branches. Additionally, it is recommended to form a mulch collar around the base of the tree that will prevent any future damage caused by landscape maintenance and provide additional benefits to the tree. Vertical mulching is recommended for mitigation, this is a technique that benefits stressed trees by improving the movement of water, air, and nutrients in the root zone and should be performed by a qualified tree care professional. The Town should implement a comprehensive program of tree management including soil testing.						<b>Level of Urgency</b>

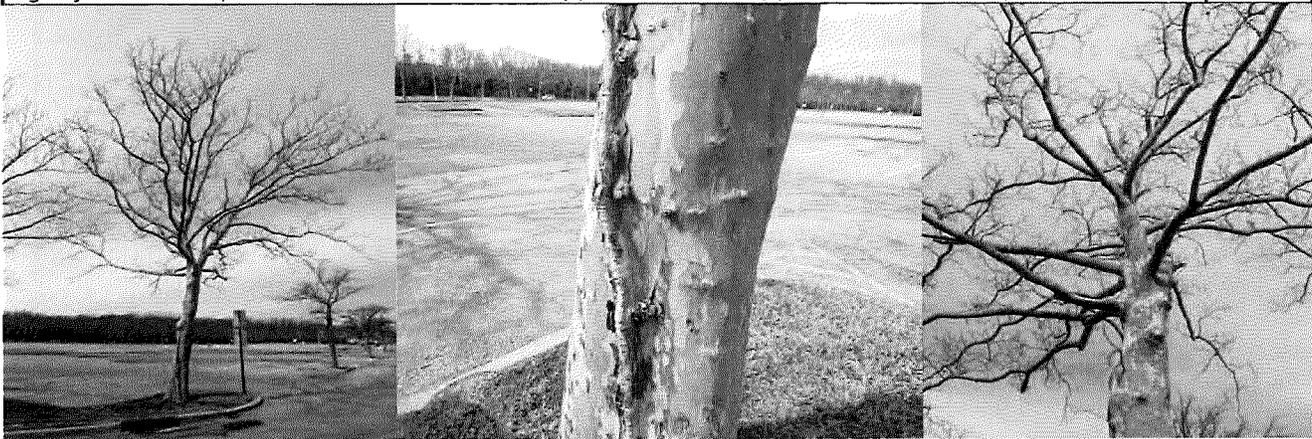
Trunk Condition and Main Scaffold Branches						
Codominant leaders, minor moss and lichen growth on trunk, vertical cracking on trunk, scaffold wounds from fallen branches have not entirely healed, water sprouting on trunk and scaffold branches, major dead scaffold branch.						
Crown/Structure, Branches & Leaves						
Branch die-back at top of crown, dead branches, poor fruiting, tree was not assessed during full leaf.						
Pest / Disease						
Moss and lichen growth on trunk.						
Setting						
North end of park in open parking lot, exposed to high winds.						
Character						
		Y	Does the tree make an important contribution to the character or amenity of the area?			
		Indigenous	Is the tree indigenous, rare, endangered, invasive or exotic?			
Habitat						
		N	Does the tree represent important habitat for native fauna?			
		N	Is the tree part of a wildlife Corridor, Buffer, etc?			
Notes:						
Major dead scaffold branches and smaller branches directly above parking spaces and roadway. Recommended to reassess this tree after bud break to evaluate the full condition of tree.

Recommendations:						Level of Urgency
It is recommended to implement a program that continues to monitor this tree by an ISA Arborist and if condition continues to decline, consider removal. For recommended treatment, proper corrective pruning that follows ANSI A300 standards should be performed to remove dead and damaged branches, specifically scaffold branches directly above parking spaces and the roadway. Additionally, it is recommended to form a mulch collar around the base of the tree that will prevent any future damage caused by landscape maintenance and provide additional benefits to the tree. Vertical mulching is recommended for mitigation, this is a technique that benefits stressed trees by improving the movement of water, air, and nutrients in the root zone and should be performed by a qualified tree care professional. The Town should implement a comprehensive program of tree management including soil testing. Recommended to reassess this tree after bud break to evaluate the full condition of tree.						1

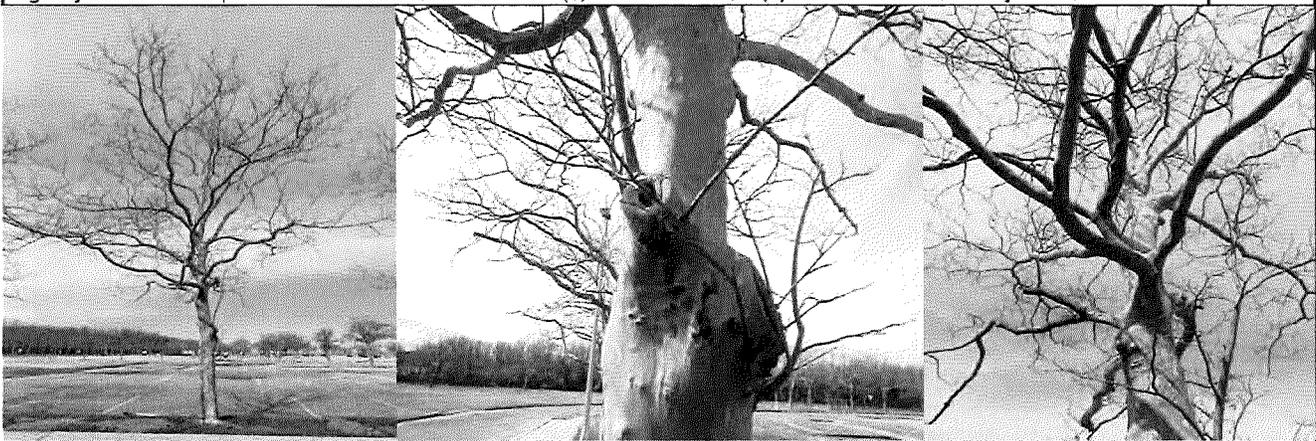
Trunk Condition and Main Scaffold Branches		Minor moss and lichen growth on trunk, vertical cracking on trunk, multiple trunk wounds from pruned scaffold branches have not entirely healed, minor water sprouting on trunk and scaffold branches, multiple dead scaffold branches.							
Crown/Structure, Branches & Leaves		Minor branch die-back at top of crown, dead branches, broken branches hanging in crown, poor fruiting, tree was not assessed during full leaf.							
Pest / Disease		Moss and lichen growth on trunk.							
Setting		North end of park in open parking lot, exposed to high winds.							
Character		Y		Does the tree make an important contribution to the character or amenity of the area?					
		Indigenous		Is the tree indigenous, rare, endangered, invasive or exotic?					
Habitat		N		Does the tree represent important habitat for native fauna?					
		N		Is the tree part of a wildlife Corridor, Buffer, etc?

Notes: Previous tag #432 nailed to trunk. Major dead scaffold branches and smaller branches directly above parking spaces, sidewalk and roadway.									
Recommendations: It is recommended to implement a program that continues to monitor this tree by an ISA Arborist and if condition continues to decline, consider removal. For recommended treatment, proper corrective pruning that follows ANSI A300 standards should be performed to remove dead and damaged branches, specifically scaffold branches directly above accessible spaces. Additionally, it is recommended to form a mulch collar around the base of the tree that will prevent any future damage caused by landscape maintenance and provide additional benefits to the tree. Vertical mulching is recommended for mitigation, this is a technique that benefits stressed trees by improving the movement of water, air, and nutrients in the root zone and should be performed by a qualified tree care professional. The Town should implement a comprehensive program of tree management including soil testing.								Level of Urgency

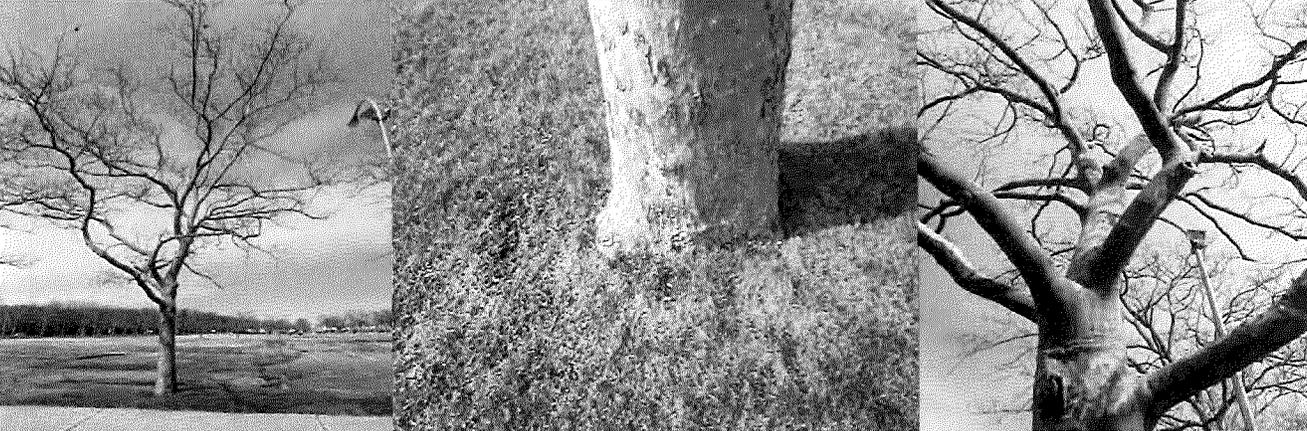
<b>Habitat</b>						
	N	Does the tree represent important habitat for native fauna?				
	N	Is the tree part of a wildlife Corridor, Buffer, etc?				
<b>Notes:</b> Previous tag #434 nailed to trunk. Major dead scaffold branches and smaller branches directly above parking spaces, sidewalk and roadway.						
<b>Recommendations:</b> It is recommended to implement a program that continues to monitor this tree by an ISA Arborist and if condition continues to decline, consider removal. For recommended treatment, proper corrective pruning that follows ANSI A300 standards should be performed to remove dead and damaged branches, specifically scaffold branches directly above accessible spaces. Additionally, it is recommended to form a mulch collar around the base of the tree that will prevent any future damage caused by landscape maintenance and provide additional benefits to the tree. Vertical mulching is recommended for mitigation, this is a technique that benefits stressed trees by improving the movement of water, air, and nutrients in the root zone and should be performed by a qualified tree care professional. The Town should implement a comprehensive program of tree management including soil testing.						<b>Level of Urgency</b>

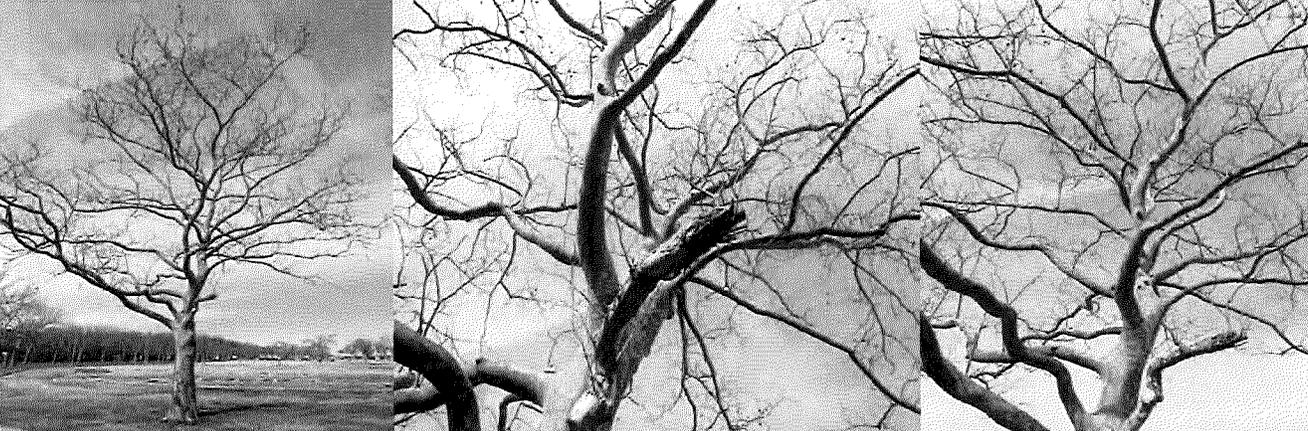
N	Does the tree represent important habitat for native fauna?				
	N	Is the tree part of a wildlife Corridor, Buffer, etc?				
<b>Notes:</b>						
Previous tag #436 nailed to trunk. Smaller branches directly above sidewalk and roadway.						
<b>Recommendations:</b>						<b>Level of Urgency</b>
It is recommended to implement a program that continues to monitor this tree by an ISA Arborist. For recommended treatment, proper corrective pruning that follows ANSI A300 standards should be performed to remove dead and damaged branches, specifically scaffold branches directly above the sidewalk and roadway. Additionally, it is recommended to form a mulch collar around the base of the tree that will prevent any future damage caused by landscape maintenance and provide additional benefits to the tree. Vertical mulching is recommended for mitigation, this is a technique that benefits stressed trees by improving the movement of water, air, and nutrients in the root zone and should be performed by a qualified tree care professional. The Town should implement a comprehensive program of tree management including soil testing.						1
